CONDITION & VALUATION SURVEY REPORT

**76 GRT / 61 NRT
Passenger Vessel**

ADVENTURE

November 26, 2018

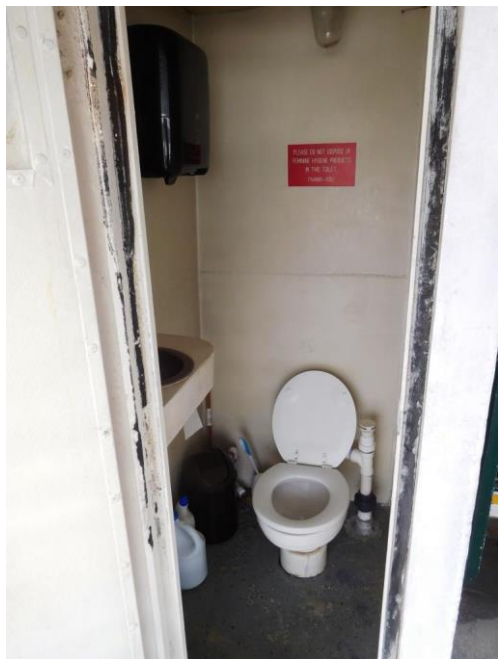
The men's and women's toilet spaces were notice to have loose ceiling panels with no batten strips to secure them around the perimeter. Also noted was that the wash basins in both spaces are only provided with cold water connections and no "P-traps" to prevent the passage of odors.

Photo # 15 – Woman's toilet space

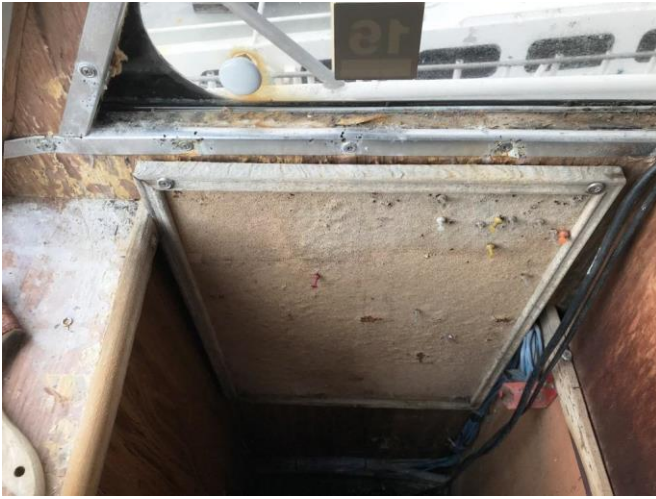
The pilot house was observed to have a significant amount of deterioration to the joiner paneling throughout, the trim around the windows, and in some areas of the console top.

Photo # 23(a) – Deterioration of joiner work

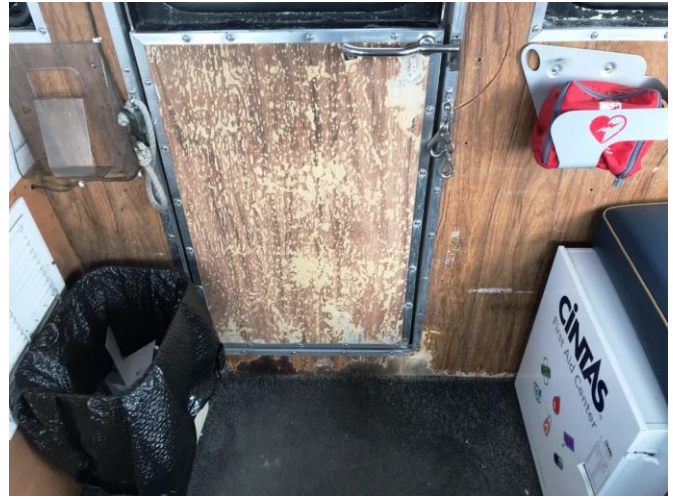
Photo # 24(a) – deterioration of joiner work at doorway

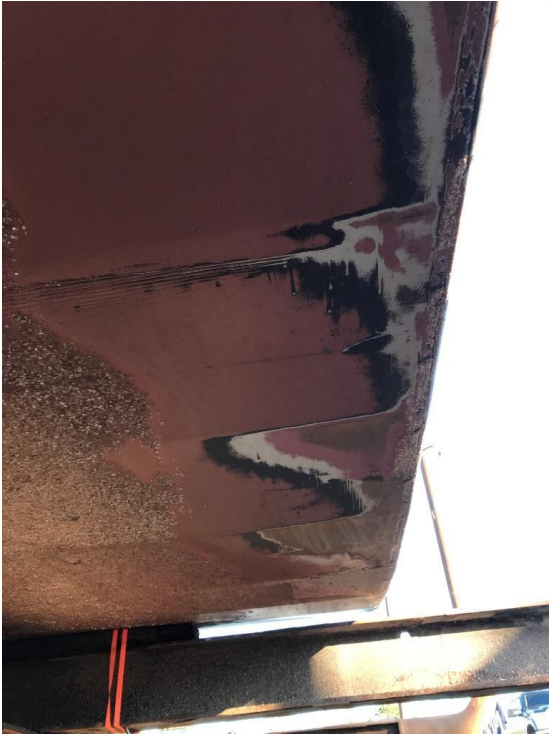
Photo # 9 – Bottom hull showing coating wear from grounding

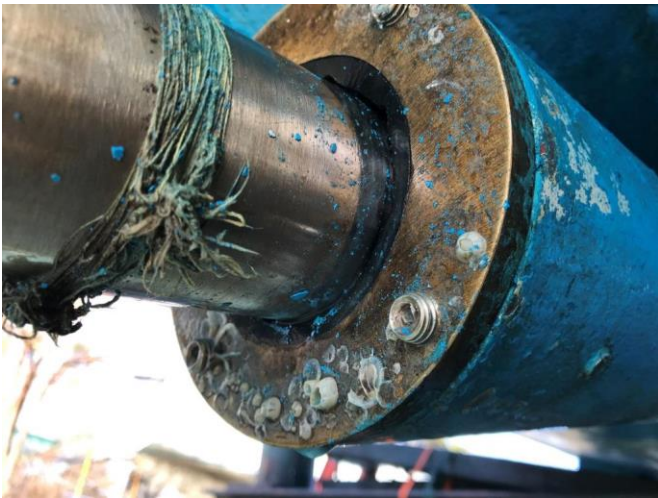
Photo # 11 – Typ. condition of cutlass bearing at stern tube

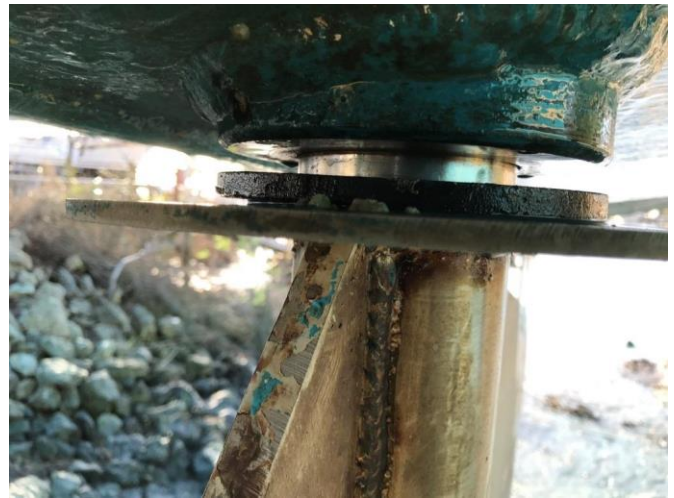
Photo # 12 – Typical condition of rudder bushing

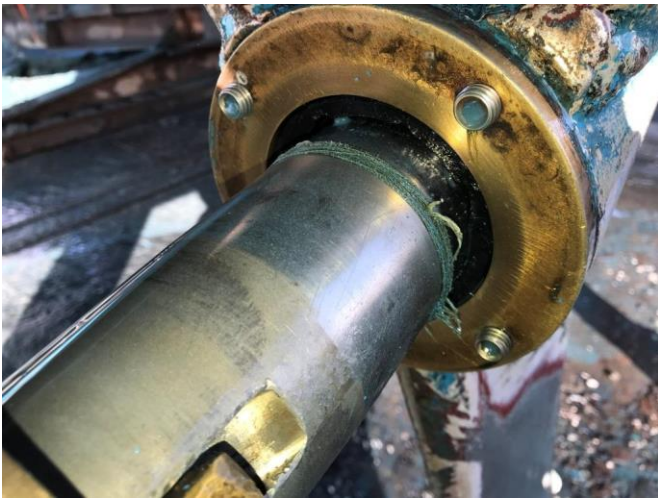
Photo # 13 – Typ. Condition of cutlass bearing at ‘V-strut’

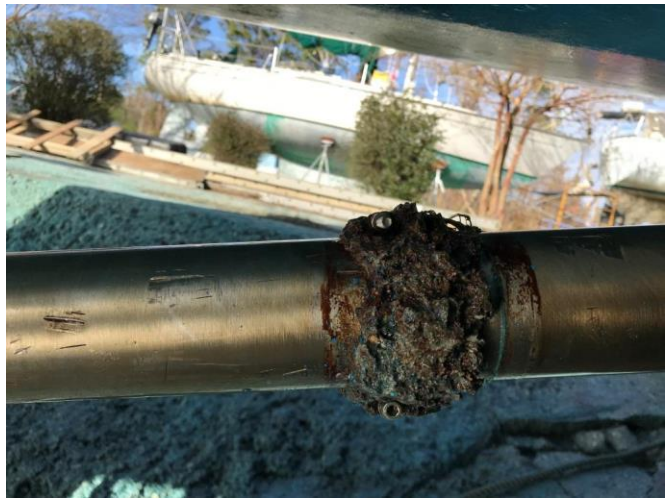
Photo # 14 – Wasted anode condition on propeller shaft

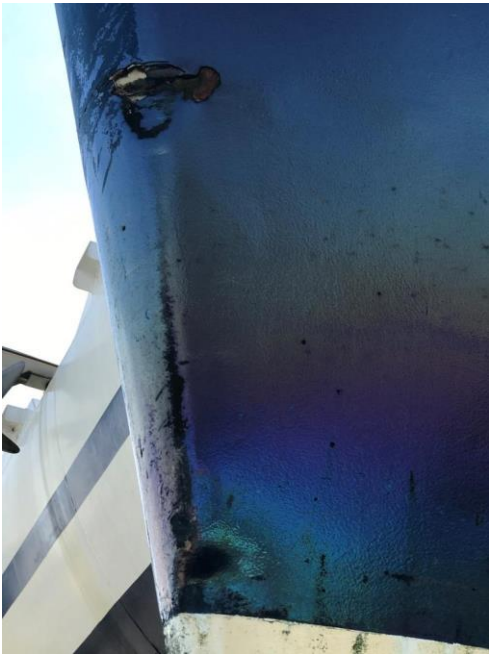
Photo # 15 – View of port bow damage

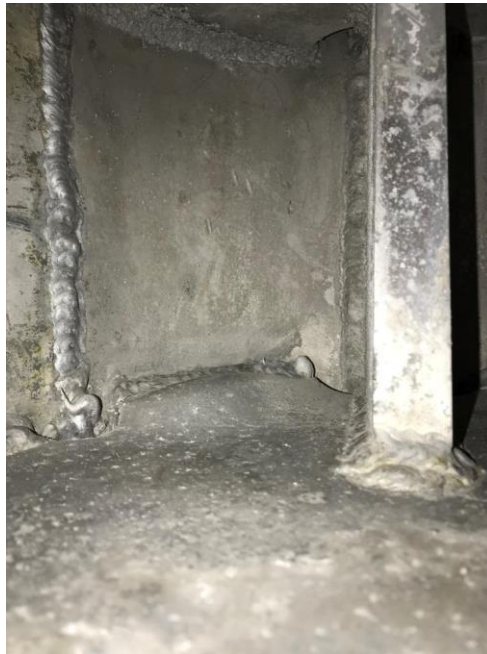
Photo # 16 – View of port bow damage from inside the fore peak

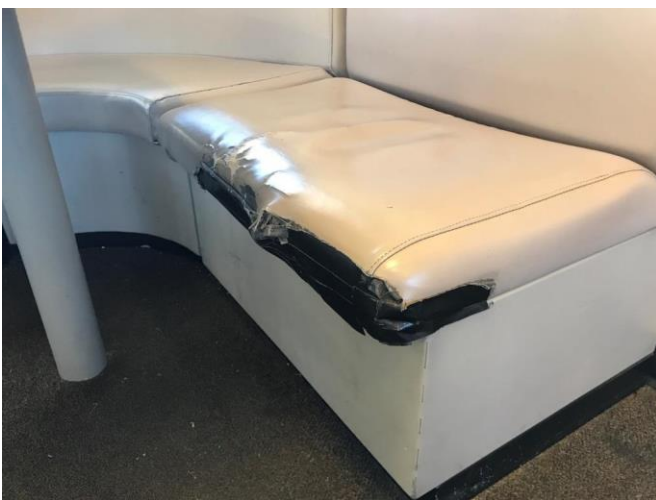
Photo # 29 – Typical upholstery damage

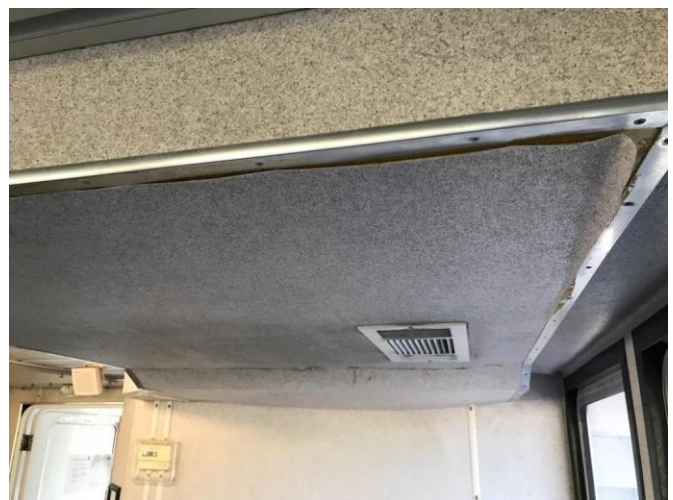
Photo # 30 – Typical condition of wall coverings

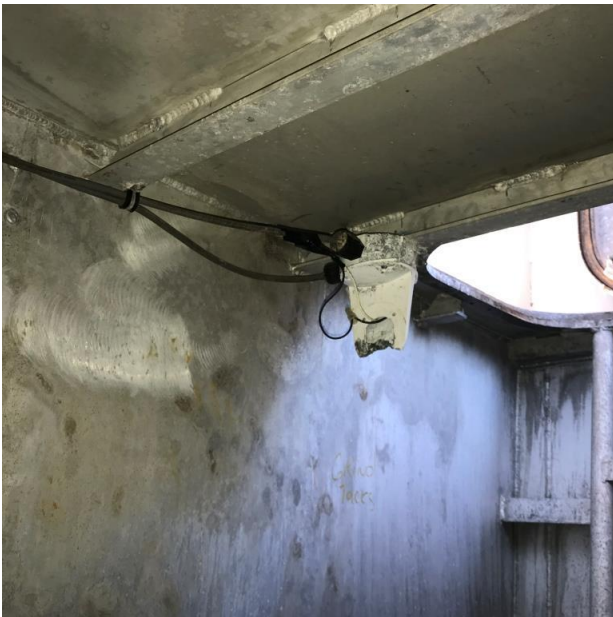
Photo # 45 – Comp. # 3P – Broken lighting fixture

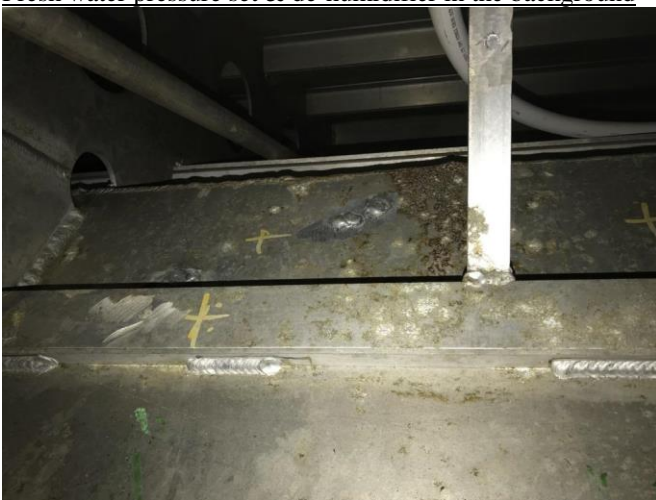
Photo # 59 – Comp. # 6S – Clad welding repairs to hull

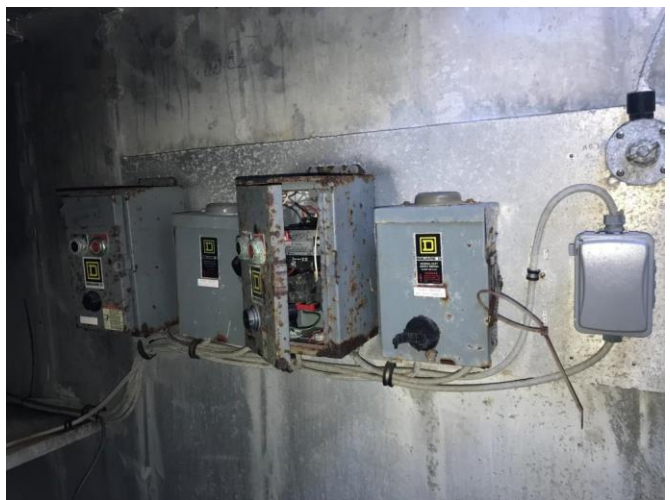
Photo # 60 – Comp. # 3P – Condition of various electrical starters, components, and exposed connections

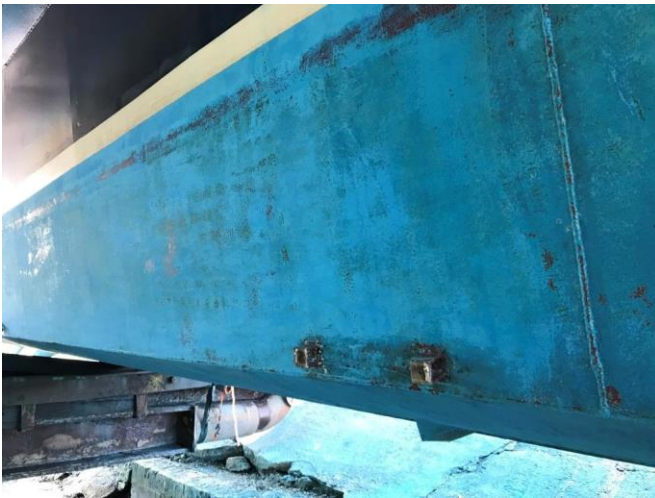
Photo # 9 – Missing anode on port hull

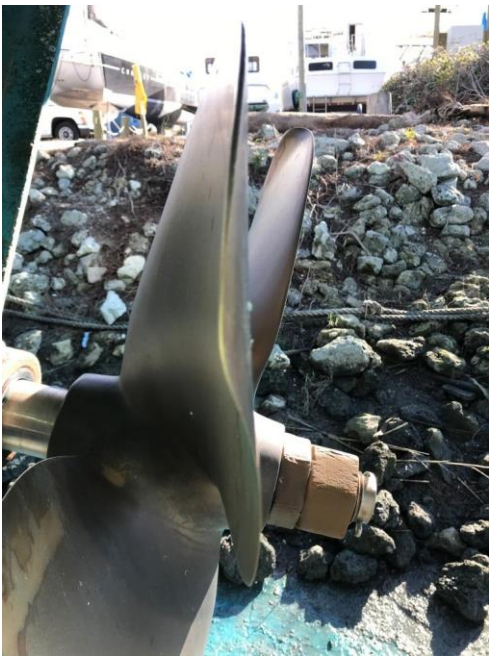
1. The starboard propeller was observed with distortion to the edges of four blades.
2. The P&S rudders visually appear to be at slightly different degrees.
3. The starboard hull bow wrap-around flat bar at the 7’ 8” waterline was damaged and torn.
4. The main engine exhausts appear to have reinforcing plates added to the exterior and interior of the hull.
5. The condition of the remaining sacrificial anodes was about 50% used. The anodes which were attached to the propeller shafts and rudders were in poor condition. Anodes were totally missing in serval other locations.
6. All of the sea chest grills and sea suction pipes were heavily fouled.
7. The underwater A/F coating was with deterioration.

Photo # 13 – Starboard propeller damage

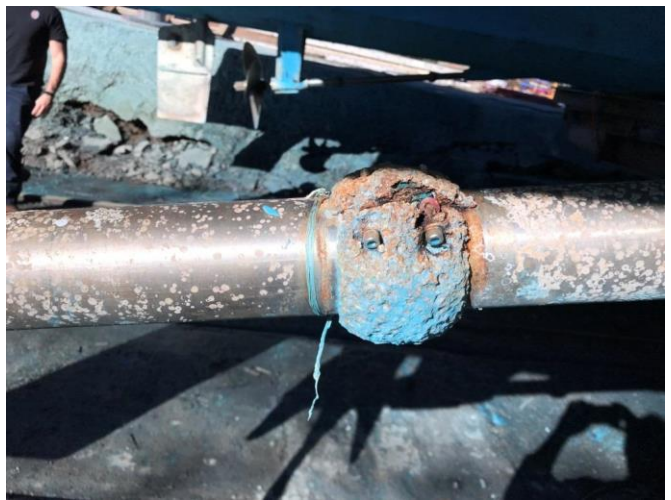
Photo # 14 – Wasted anode condition on propeller shaft

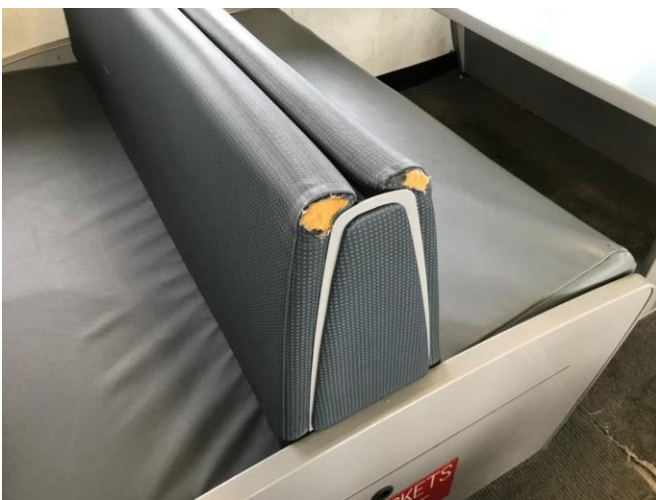
Photo # 27 – Typical upholstery damage

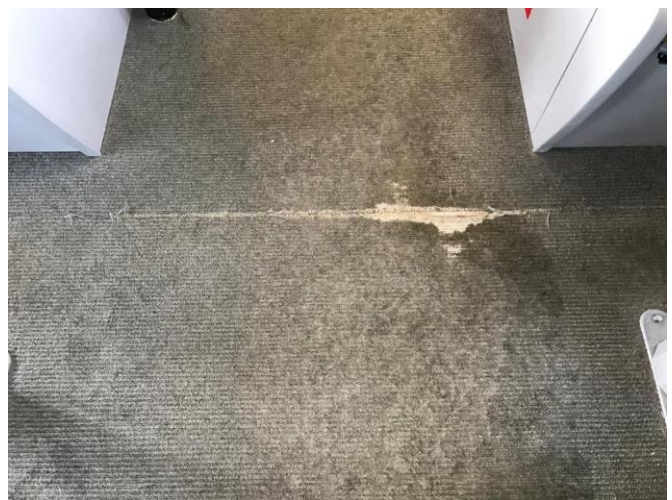
Photo # 28 – Typical condition of carpeting

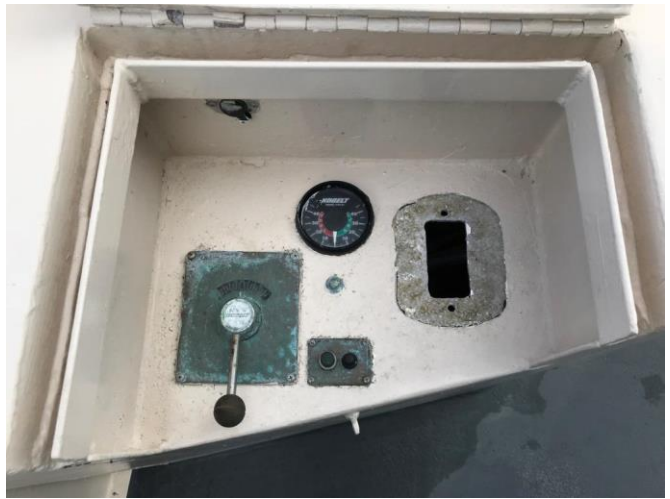
Photo # 34 – (P) Wing steering station with missing throttle control

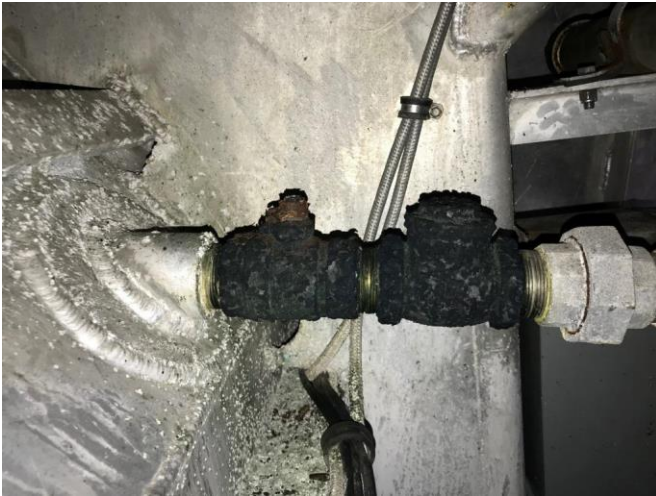
Photo # 57 – Comp. # 4 – Corrosion at overboard discharge

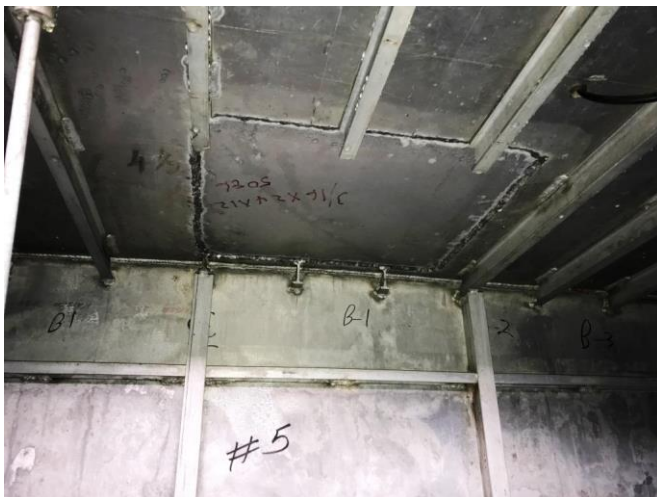
Photo # 35 – Fore peak deck insert with missing structure
