Deep Point Ferry Terminal & Parking Facility

1301 Ferry Road
Southport, Brunswick County, NC 28461

Appraisal Report Prepared For:

Client	Bald Head Island Transportation Authority
Project name	BHITA Due Diligence Assessment
Document title	Due Diligence Assessment Report
Document sub-title	–
Status	Report
Date	March 5, 2019
Project number	10413
File reference	2019-03-05 BHITA Due Diligence Report.docx

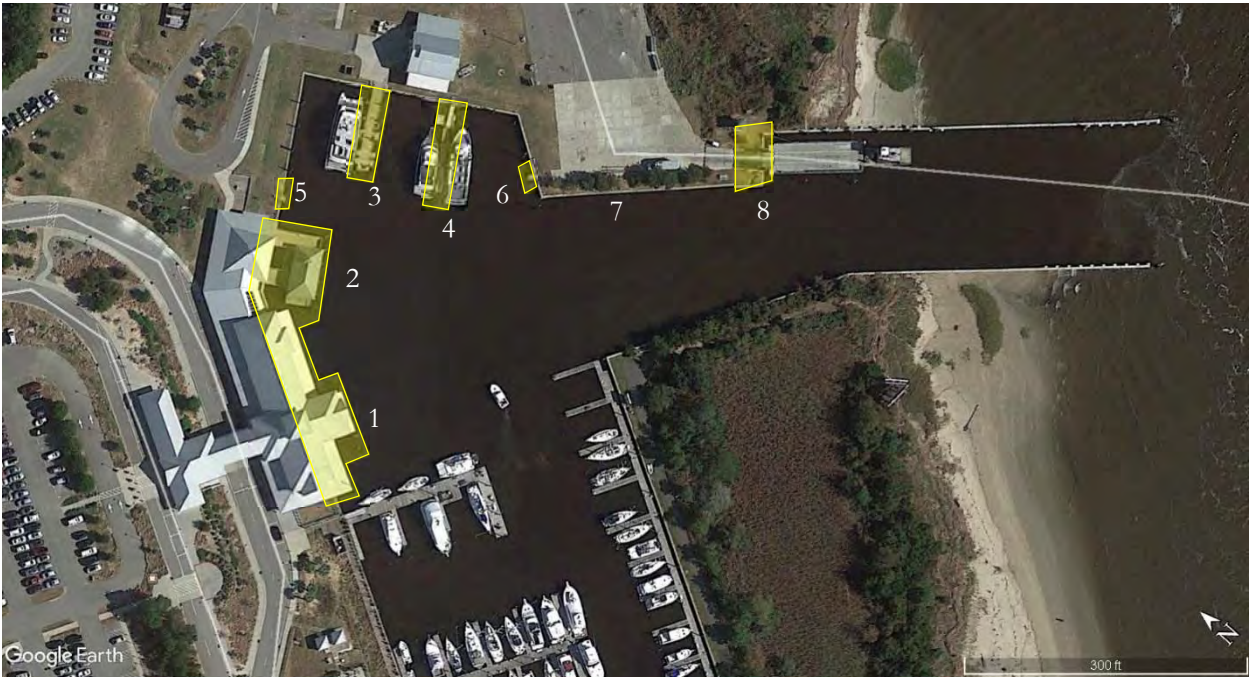
FIGURE 1-2: DEEP POINT MARINA

No.	Facility
1	A-Gate Passenger Landing
2	B-Gate Contractor Landing
3	Maintenance Fixed Pier
4	Maintenance Finger Dock
5	"G" Berthing Platform
6	"H" Berthing Platform
7	Bulkhead Wall (See Figure 2-10)
8	DPM Barge Ramp
9	BHI Barge Ramp
10	BHI Contractor Landing
11	BHI Passenger Landing

Facilities Inspected highlighted in yellow. Limits of Bulkhead Wall shown separately in

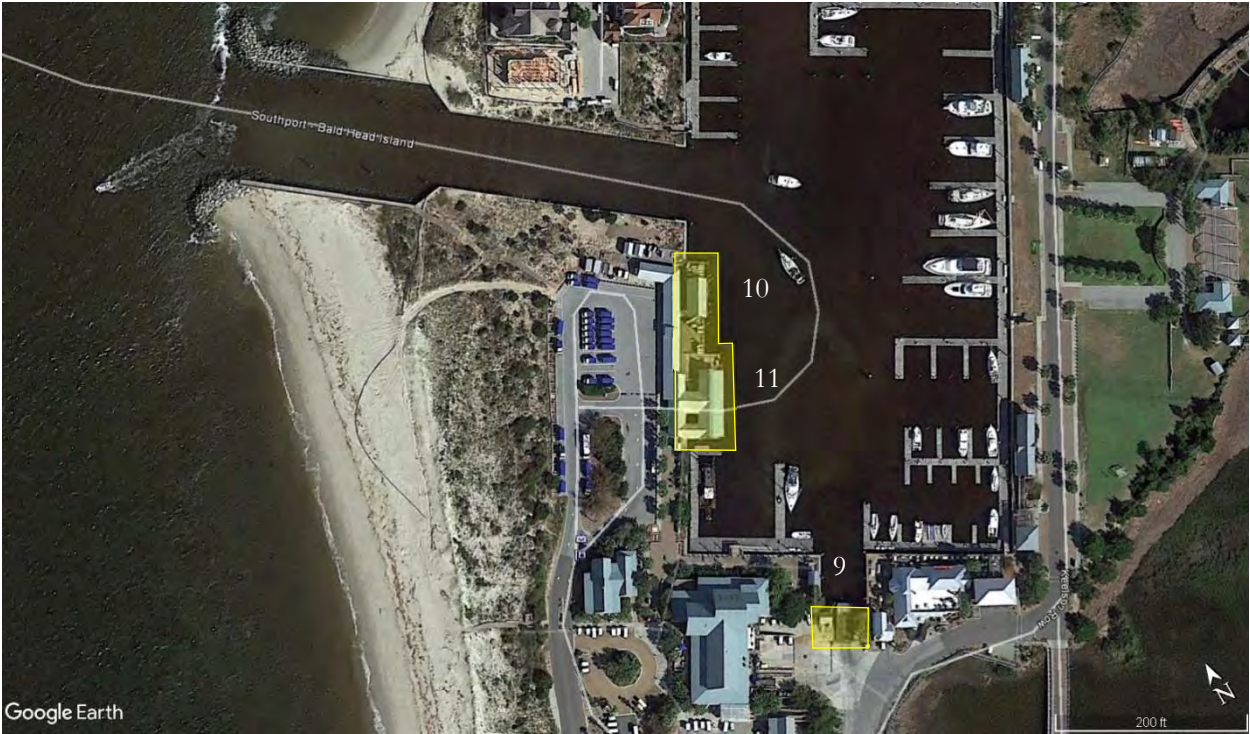
FIGURE 1-3: BALD HEAD ISLAND MARINA

Facilities Inspected highlighted in yellow.

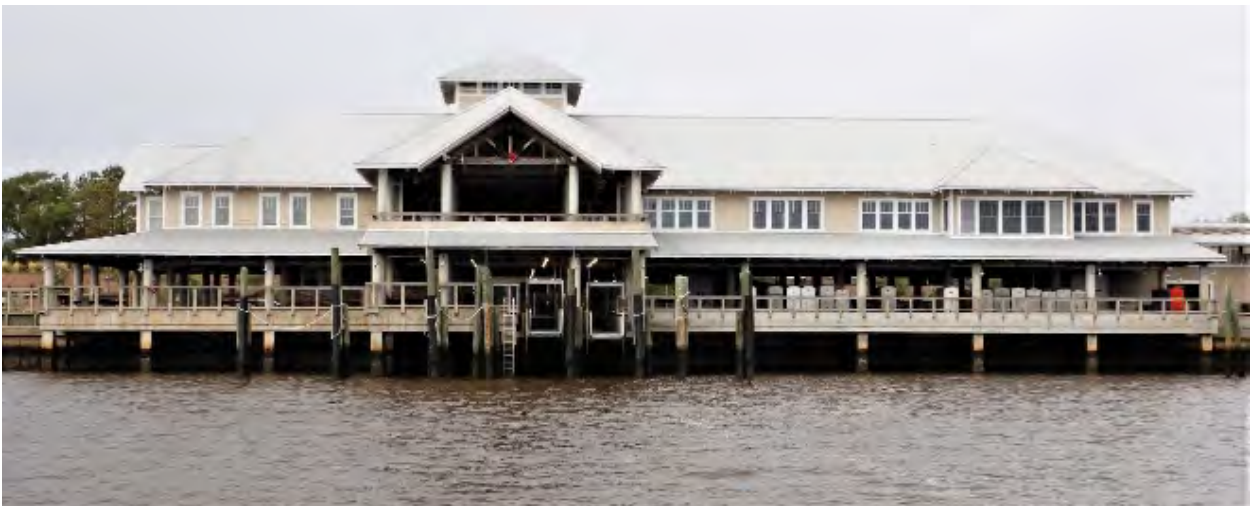
FIGURE 2-1: DPM A-GATE PASSENGER LANDING ELEVATION VIEW (LOOKING WEST)

Summary	
Construction	Concrete
Overall Condition	Good
Repair Priority	Low
Significant Defects	None
Recommendations	Routine Inspection & Maintenance
Recommended Repairs Estimate	\$0

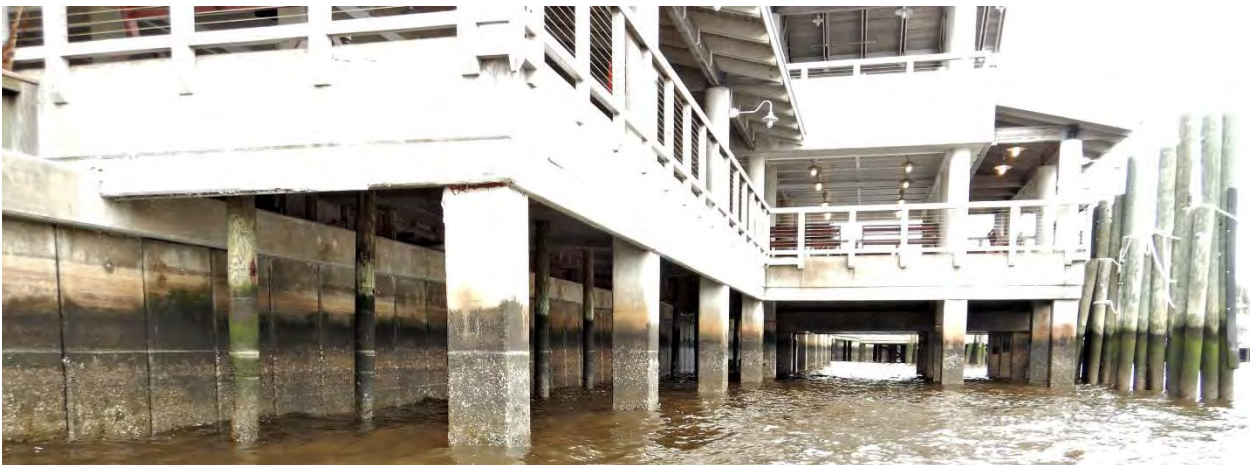
FIGURE 2-2: DPM A-GATE PASSENGER LANDING (LOOKING NORTH)

End view of concrete support piles, timber fender piles (right), and adjacent concrete bulkhead (left)

Seven of the 24 concrete support piles have been retrofitted with fiberglass and epoxy jackets, reportedly following original construction (pile driving). These were found to be good condition with no signs of deterioration or damage. A series of timber piles along the bulkhead wall were installed to support construction loads and are no longer serving any function. The mudline along the bulkhead wall has been fortified at the south end with cut off sections of concrete pile laid sideways and rip rap stone at the north end between Bent 1 and Bent 5. See the marine pile plan layout (FIG-A1) in Appendix A for more detail.

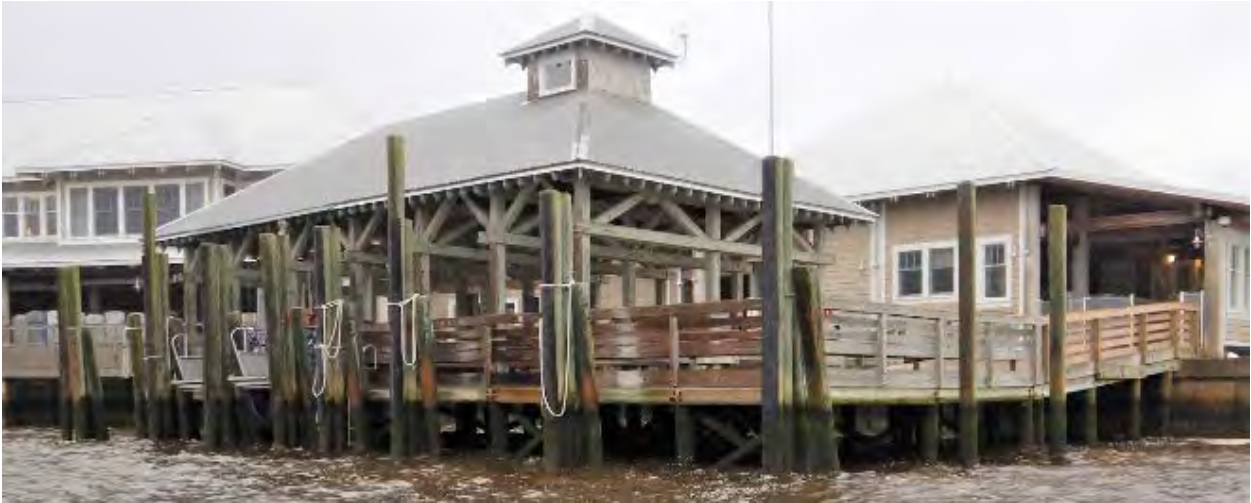
FIGURE 2-3: DPM B-GATE CONTRACTOR LANDING ELEVATION VIEW (LOOKING WEST)

Summary	
Construction	Timber
Overall Condition	Satisfactory
Repair Priority	Medium
Significant Defects	Steel tie straps are corroded/ wasted. Joist boards split 2 places
Recommendations	Repair minor timber framing defects and corroded steel tie straps.
Recommended Repairs Estimate	\$11,000

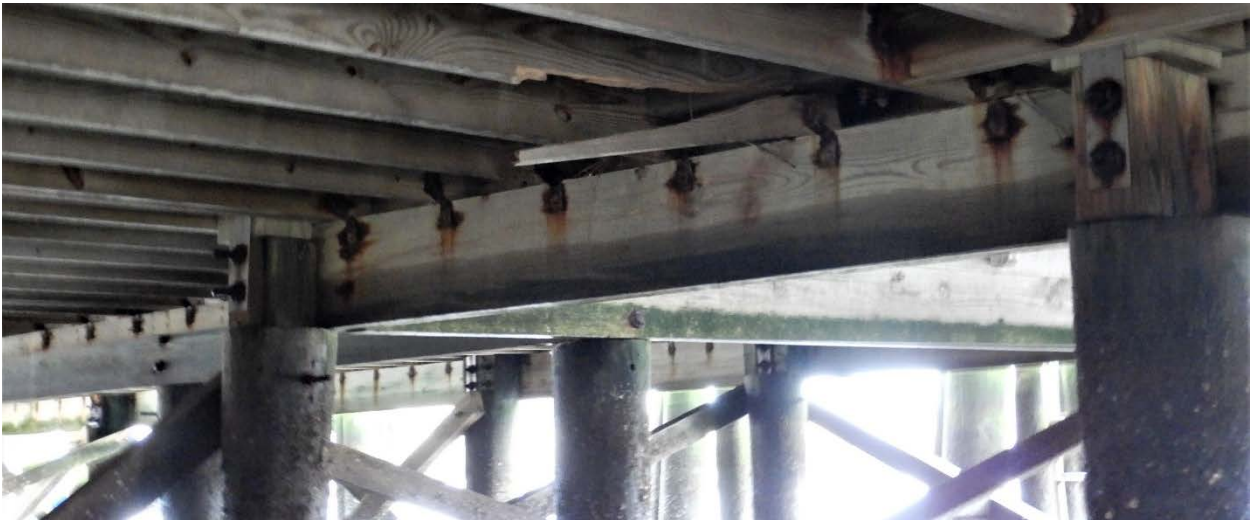
FIGURE 2-4: DPM B-GATE CONTRACTOR LANDING UNDER DECK FRAMING

Note the corroded tie straps at each joist and broken joist at one location

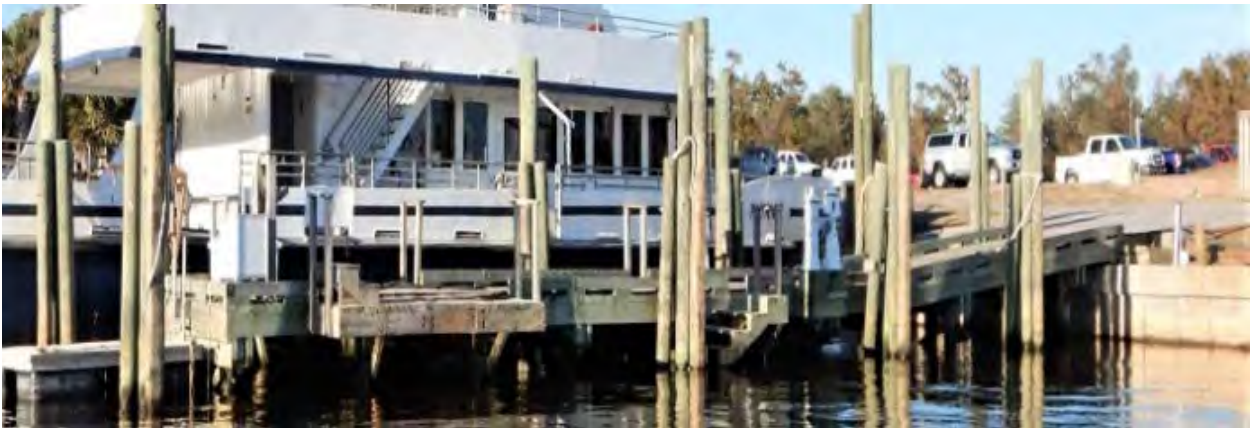
FIGURE 2-5: DPM MAINTENANCE FIXED PIER ELEVATION VIEW (LOOKING WEST)

Summary	
Construction	Timber
Overall Condition	Good
Repair Priority	Low
Significant Defects	Open bolt holes in piles.
Recommendations	Repair minor defects including bolt holes in timber piles and split bracing.
Recommended Repairs Estimate	\$1,000

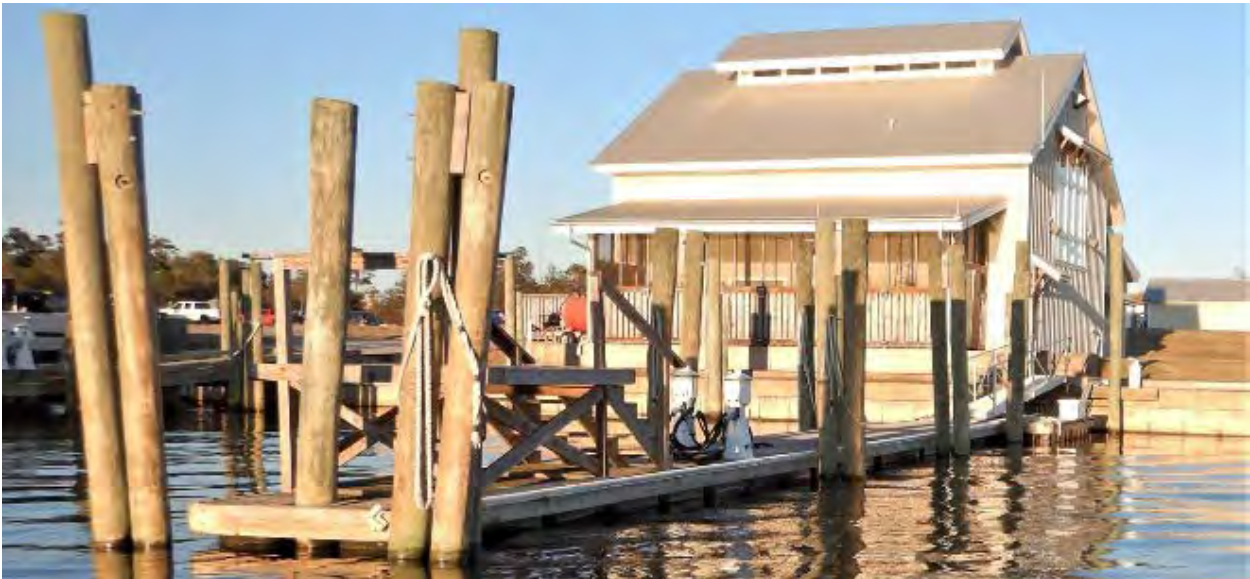
FIGURE 2-7: DPM MAINTENANCE FINGER ELEVATION VIEW (LOOKING NORTHWEST)

The Maintenance Finger Dock is a floating dock captured by timber piles and accessed from the bulkhead wall by a gangway. The scope of inspection for this structure included only the gangway support piles, which were found to be in satisfactory condition with abrasion/loss of section and should be repaired or replaced within the 10-year planning horizon. The timber mooring/fender piles, floating dock guide piles, and floating dock were not included in the scope of this assessment.

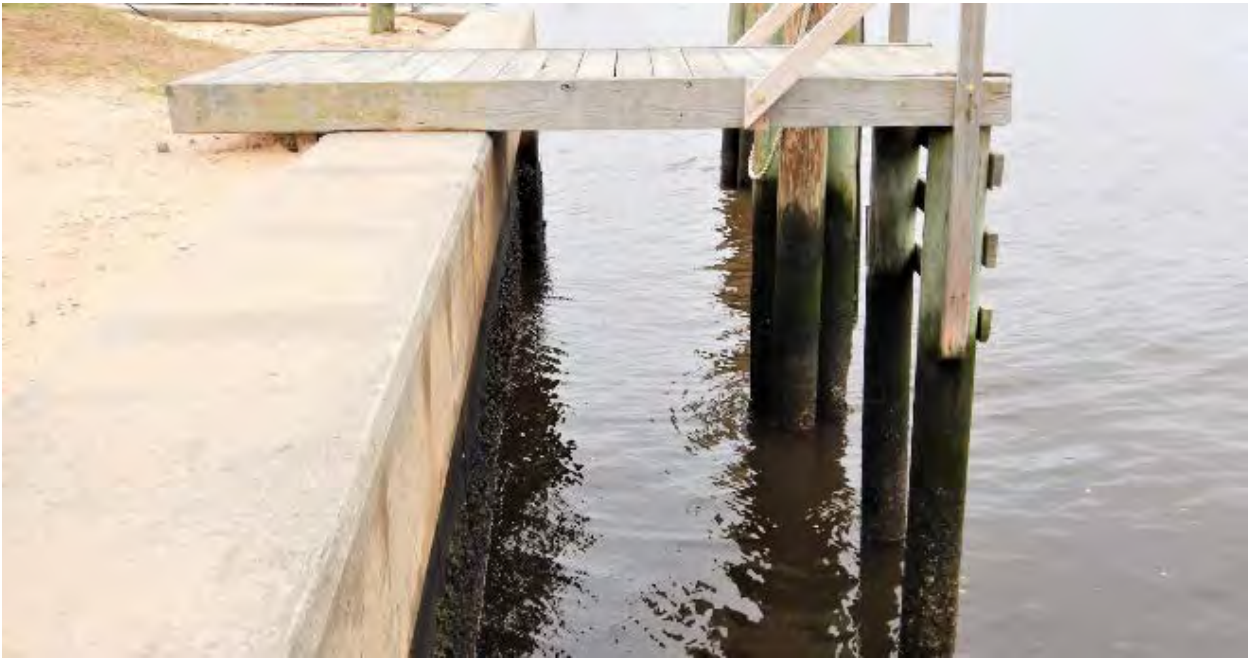
FIGURE 2-8: DPM “G” BERTHING PLATFORM ELEVATION VIEW (LOOKING SOUTH)

“G” Berthing platform is constructed of a timber deck supported by the marina bulkhead cap on the landside and a timber piles in the water. An above and below water inspection found the structure to be in good overall condition with no visible signs of damage or repairs needed.

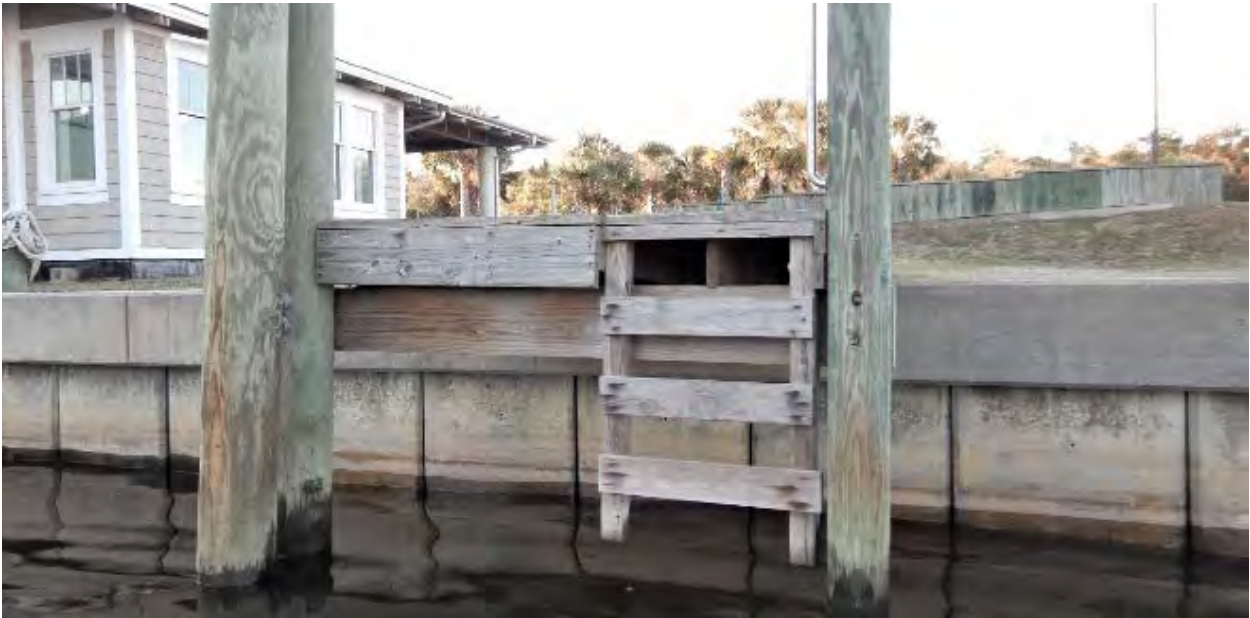
FIGURE 2-9: DPM “H” BERTHING PLATFORM ELEVATION VIEW (LOOKING WEST)

“H” Berthing platform is constructed of a timber deck supported by the marina bulkhead cap on the landside and a timber piles in the water. An above and below water inspection found the structure to be in good overall condition with minor abrasions (up to 3/4” deep) on the piles above water.

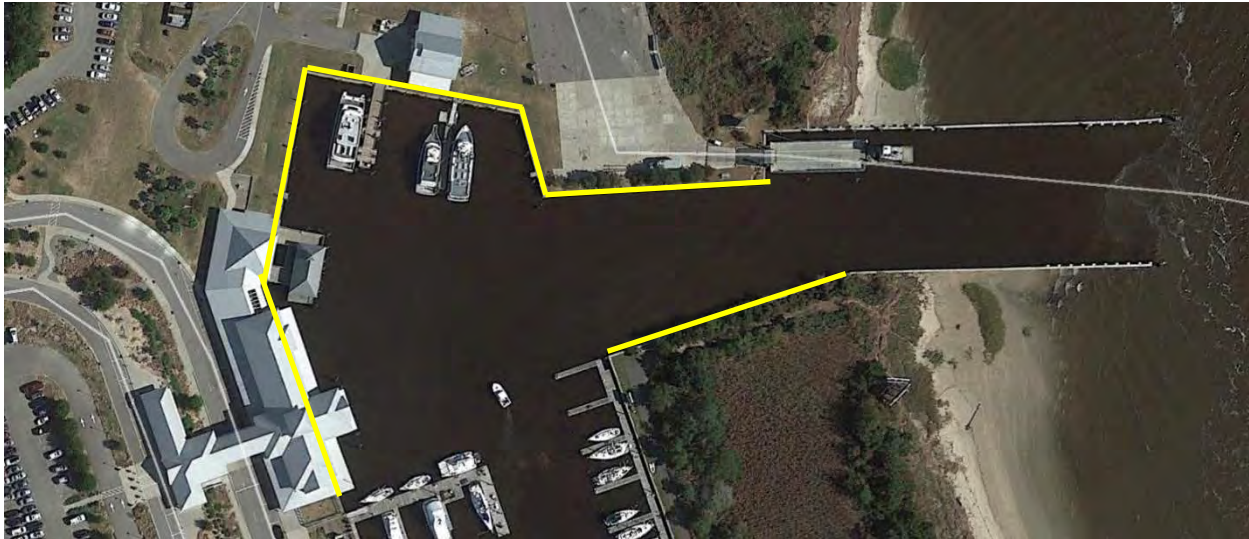
FIGURE 2-10: DEEP POINT MARINA PLAN VIEW

The shoreline at DPM is comprised of a concrete sheet pile bulkhead wall with a reinforced concrete cap. The limits of the bulkhead wall are shown in Figure 2-10. On the north and west perimeter of the marina, the bulkhead extends from the barge ramp around to just beyond the “A” Gate Ferry Terminal Building. The bulkhead wall along the south bank of the inlet channel is also included in this assessment. Segments to the south of the yellow highlighted walls in Figure 2-10 along the marina floating docks are not part of the scope for this assessment.

Ferry Terminal bulkhead wall scope limits highlighted in yellow

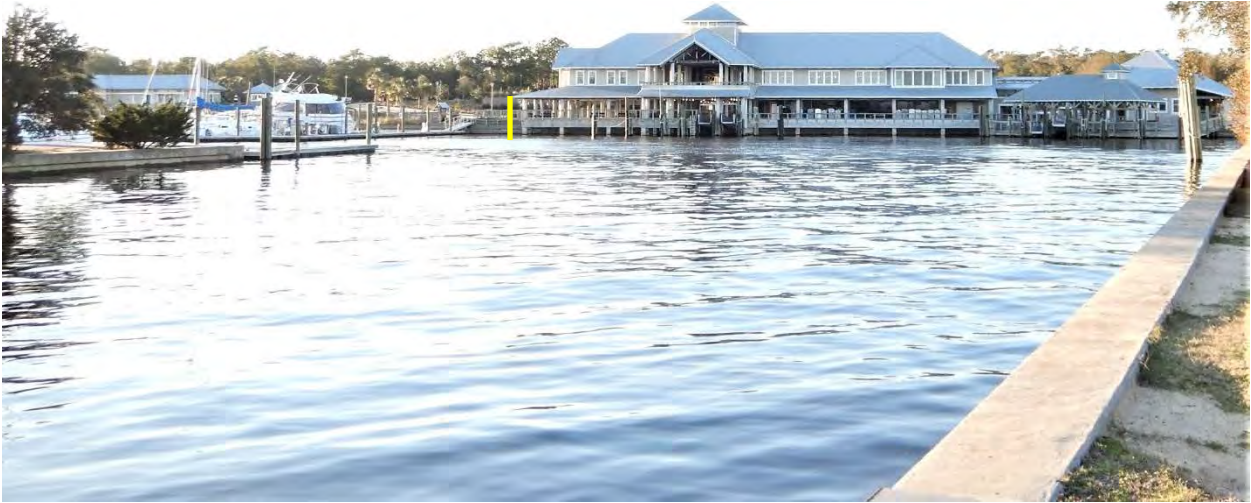
FIGURE 2-11: VIEW OF DPM (LOOKING WEST)

View of DPM bulkhead wall at marina inlet (foreground left and right) and end of scope limits between Ferry Terminal Building and A Dock (yellow, background center-left)

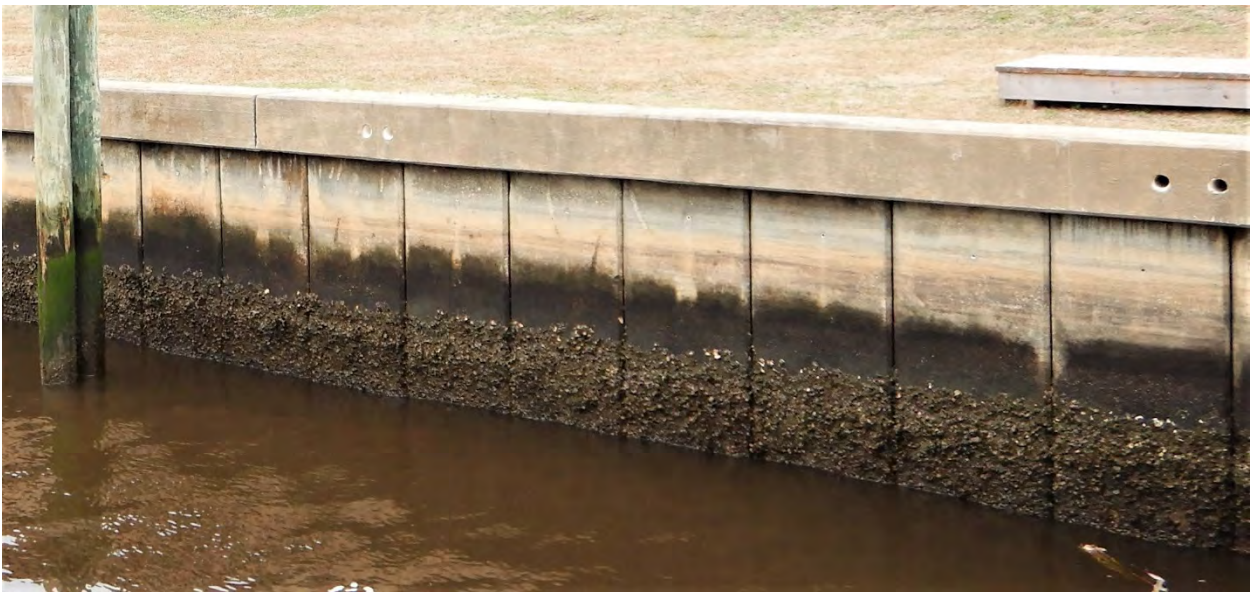
FIGURE 2-12: TYPICAL BULKHEAD WALL ELEVATION AT LOW TIDE

Location adjacent to "H" Berth and Maintenance Docks, looking West

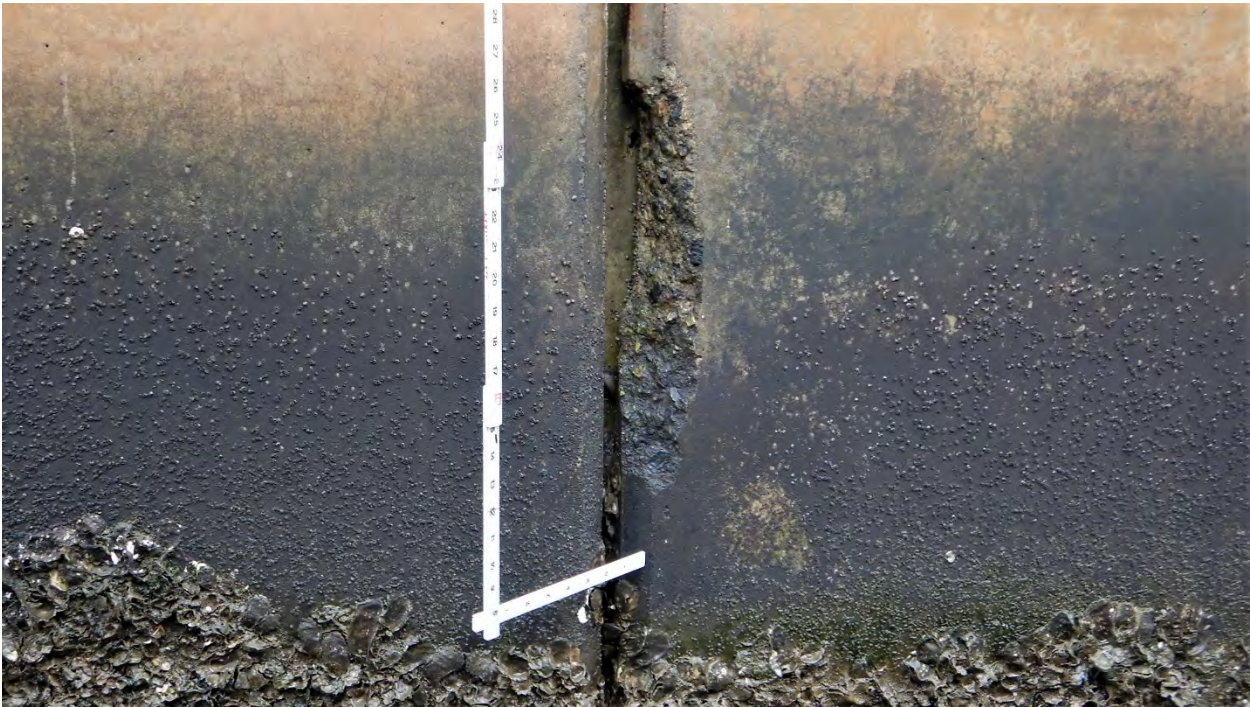
FIGURE 2-13: TYPICAL CONCRETE SHEET PILE SPALL

Note tongue-and-groove fit between the sheets, visible inside the spall

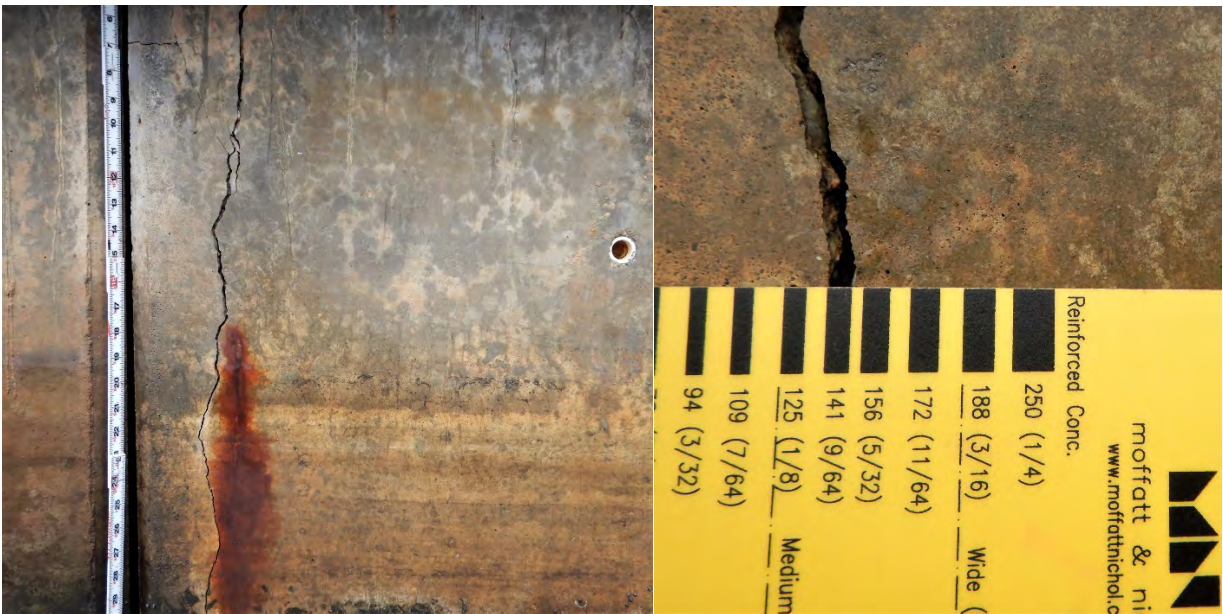
FIGURE 2-14: CONCRETE SHEET PILE CRACKING

Overall and close up view shown of medium-width “worst case” cracking observed in the bulkhead wall at intermittent locations

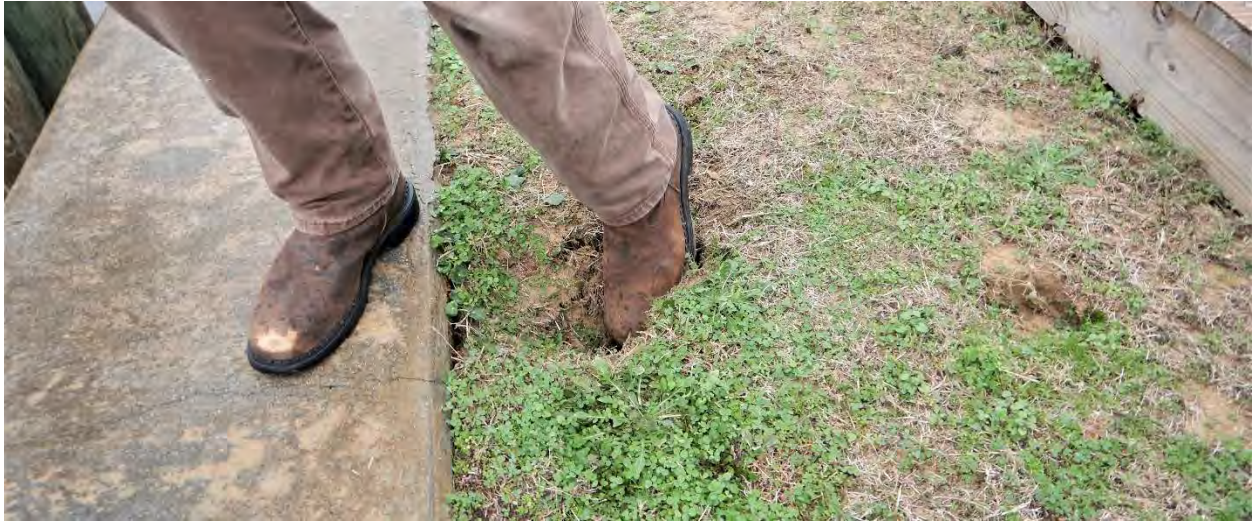
FIGURE 2-15: TYPICAL SINKHOLES BEHIND WALL

Sinkholes in sand fill behind interlocking concrete sheet pile construction of this type is typically caused by migration of the sand backfill through the joint. This may be mitigated by varying the size and gradation of repair materials, i.e. backfilling with larger size gravel or stone. More robust repairs including the installation of filter fabric and/or the use of grout or flowable fill could be considered in the future if sinkholes become larger or more prevalent. Fill loss should be monitored during routine inspections to determine if more substantial repair methods are recommended.

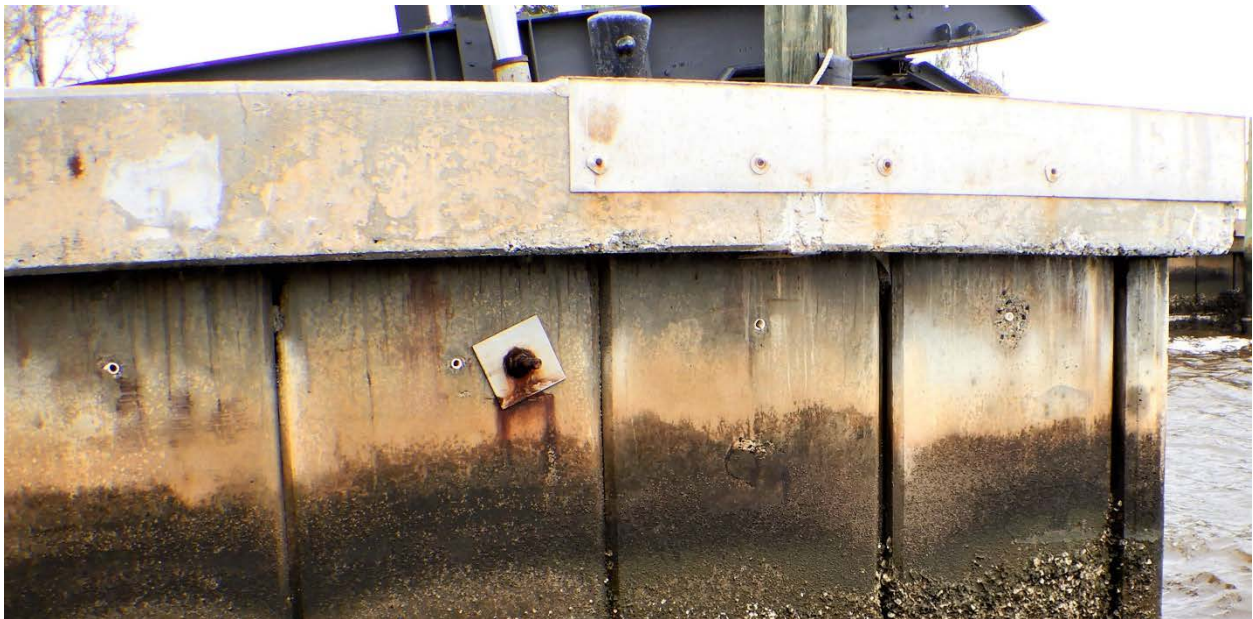
FIGURE 2-16: BULKHEAD REPAIR SECTION ELEVATION VIEW (LOOKING NORTH)

Photo taken from inlet channel showing affected concrete panels, steel tie rod with square plate washer, and steel repair plate on the concrete cap

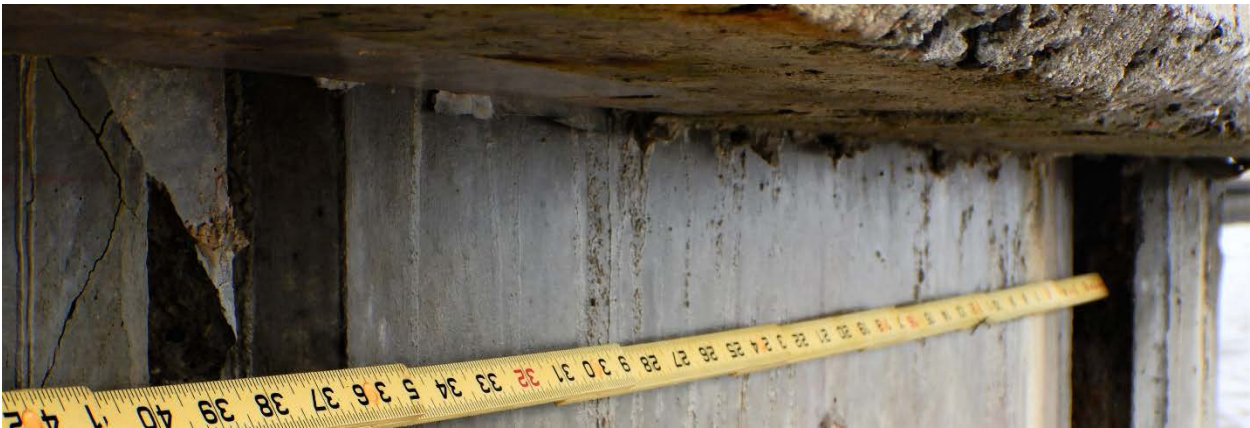
FIGURE 2-17: DISPLACED CONCRETE SHEET PILES AT BULKHEAD REPAIR SECTION

The bulkhead repair section was inspected above and below water and found to be in satisfactory condition. The sheets were found to be intact with no voids or signs of recent movement.

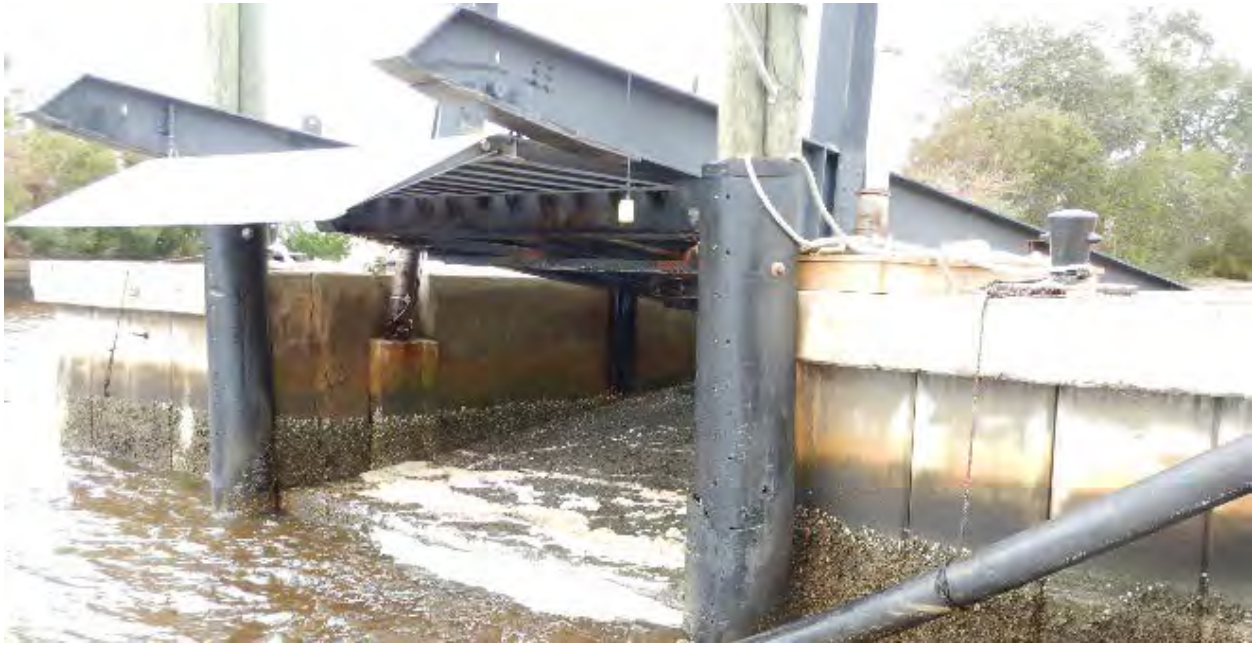
FIGURE 2-18: DPM BARGE RAMP ELEVATION VIEW (LOOKING SOUTHWEST)

Summary	
Construction	Steel Ramp with Concrete Substructure
Overall Condition	Satisfactory
Repair Priority	Medium
Significant Defects	Moderate corrosion of steel elements Crack in concrete substructure
Recommendations	<ol style="list-style-type: none"> 1. Monitor tension crack associated with bulkhead repair section. 2. Monitor steel corrosion and plan refurbishment during the next major CAPEX cycle.
Recommended Repairs Estimate	\$154,000

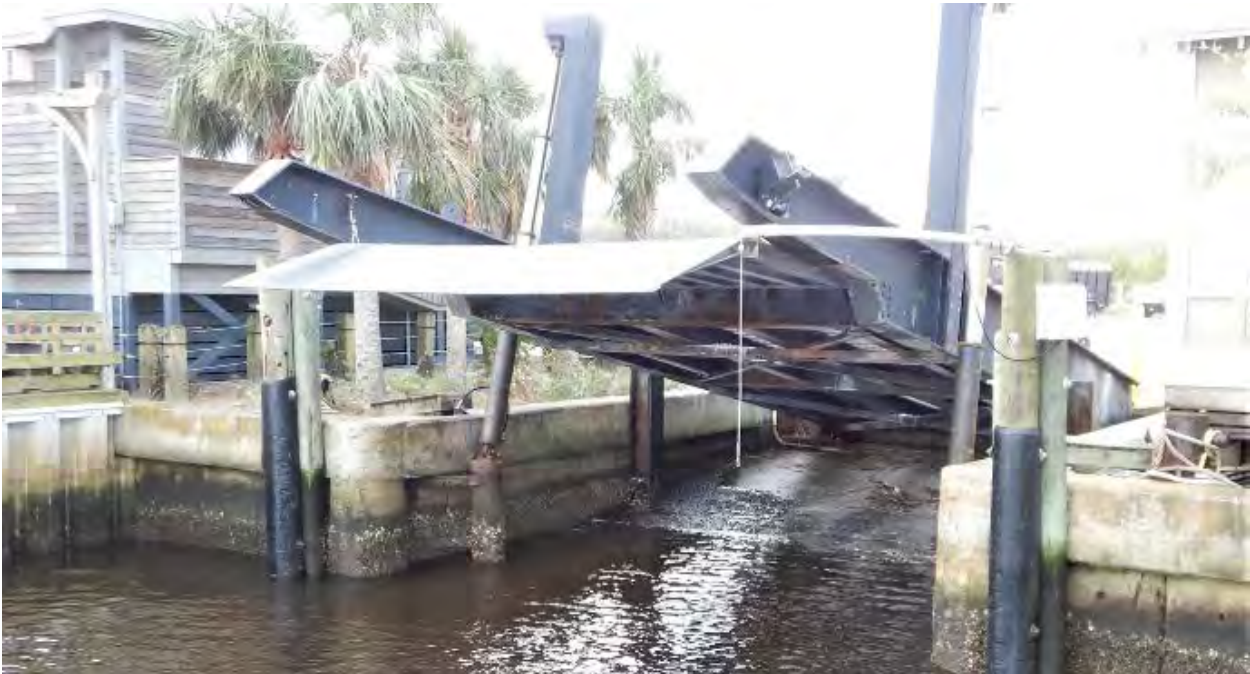
FIGURE 2-20: BHI BARGE RAMP ELEVATION VIEW (LOOKING SOUTHEAST)

Summary	
Construction	Steel Ramp with Concrete Substructure
Overall Condition	Satisfactory
Repair Priority	Medium
Significant Defects	Moderate corrosion of steel elements
Recommendations	Monitor steel corrosion and plan refurbishment during the next major CAPEX cycle.
Recommended Repairs Estimate	\$130,000

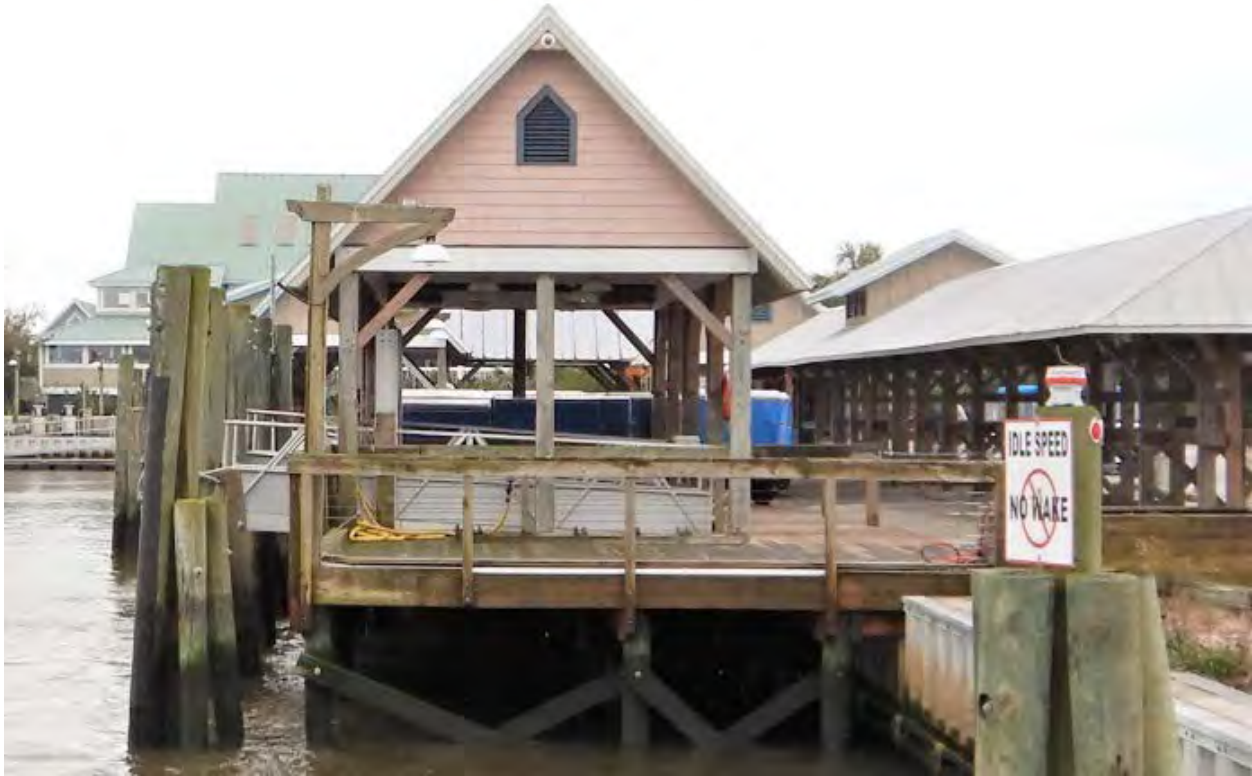
FIGURE 2-22: BHI CONTRACTOR LANDING END VIEW (LOOKING SOUTH)

Summary	
Construction	Timber
Overall Condition	Good
Repair Priority	Low
Significant Defects	Minor decay on 3 piles Open bolt holes and minor timber defects (abrasion/ check/ shake)
Recommendations	Routine Inspection & Maintenance Cover open bolt holes with epoxy
Recommended Repairs Estimate	\$10,000

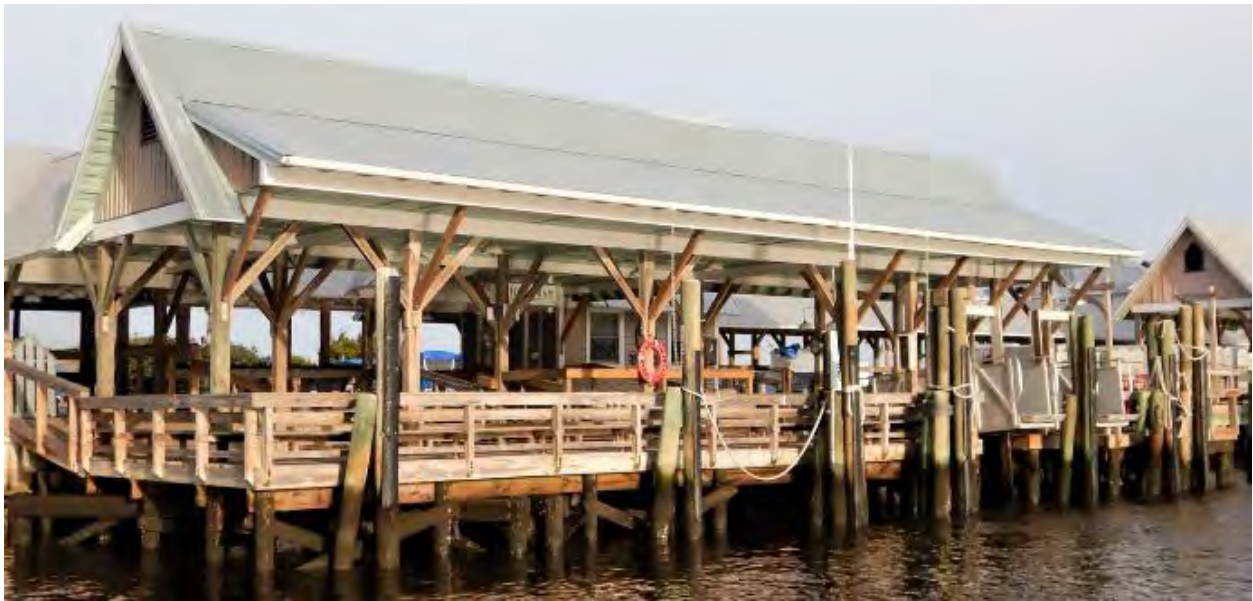
FIGURE 2-24: BHI PASSENGER LANDING ELEVATION VIEW (LOOKING WEST)

The BHI Passenger Landing is a timber structure supported by various types of piles/columns and timber substructure elements, either from the original construction or installed during its repair history. The original round timber piles (installed by pile-driving them into the subsurface) have been augmented by additional timber piles driven where access was available or by square columns jetted into the subsurface. These have been connected directly to the original timber framing stringers or with additional structural members to create “crutch bents” in order to support the loads from the deck and structure above. There are a series of timber pile dolphins along the berth face for vessel breasting and mooring.

Summary	
Construction	Timber
Overall Condition	Fair
Repair Priority	Medium
Significant Defects	Multiple repairs & retrofits; load path may not be adequate for current conditions (multiple piles are no longer bearing; repair history is unknown) Cargo Ramp is bearing on bulkhead Crutch bents are bowed
Recommendations	1. Monitor piles and framing for deterioration 2. Plan replacement of the substructure
Recommended Repairs Estimate	\$900,000

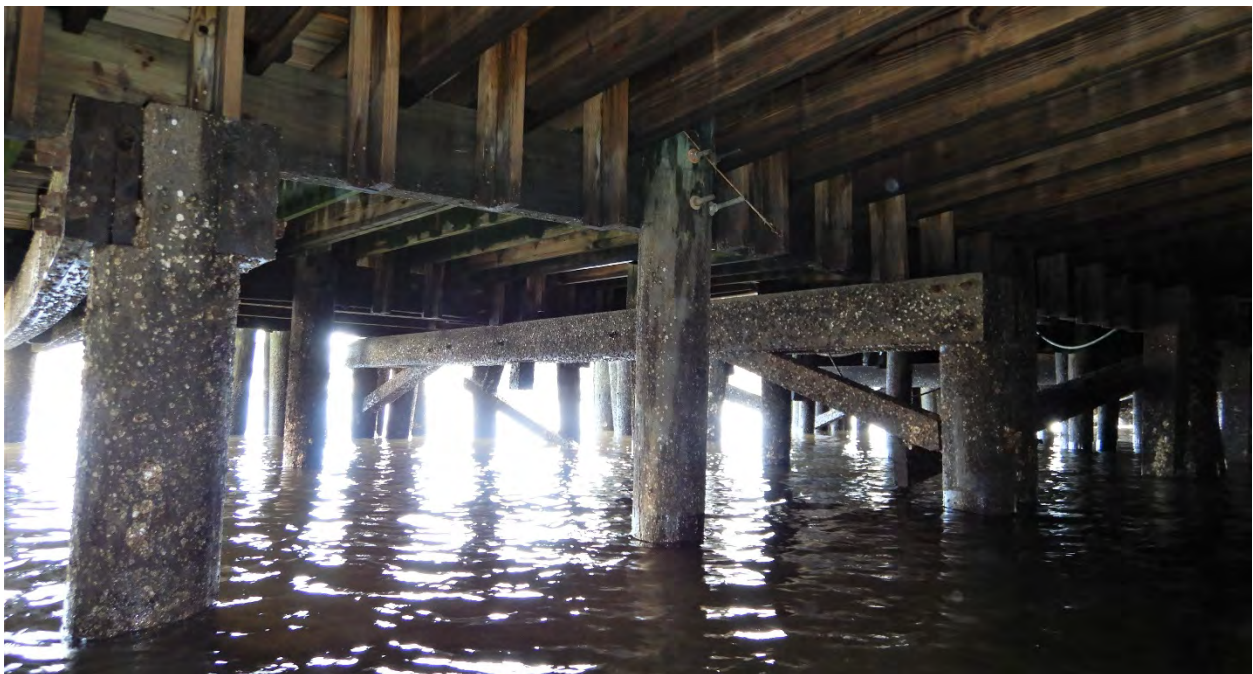
FIGURE 2-25: BHI PASSENGER LANDING UNDERDECK VIEW (LOOKING EAST)

Two long-span crutch bents are visible at left and center of the photo. Bowing of timber crutch bent cap visible to the left (others similar).

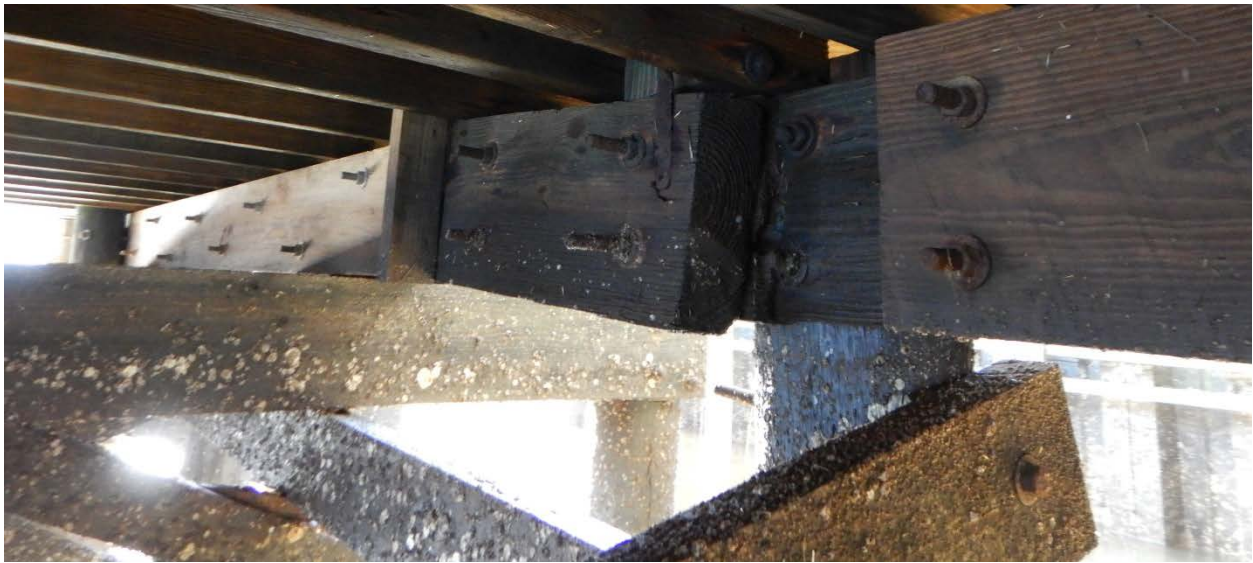
FIGURE 2-26: UNDERDECK VIEW OF TIMBER STRINGER

Stringer has been repaired with thru-bolted "sistered" boards. Note the various repairs do not form a continuous member and are out of alignment.

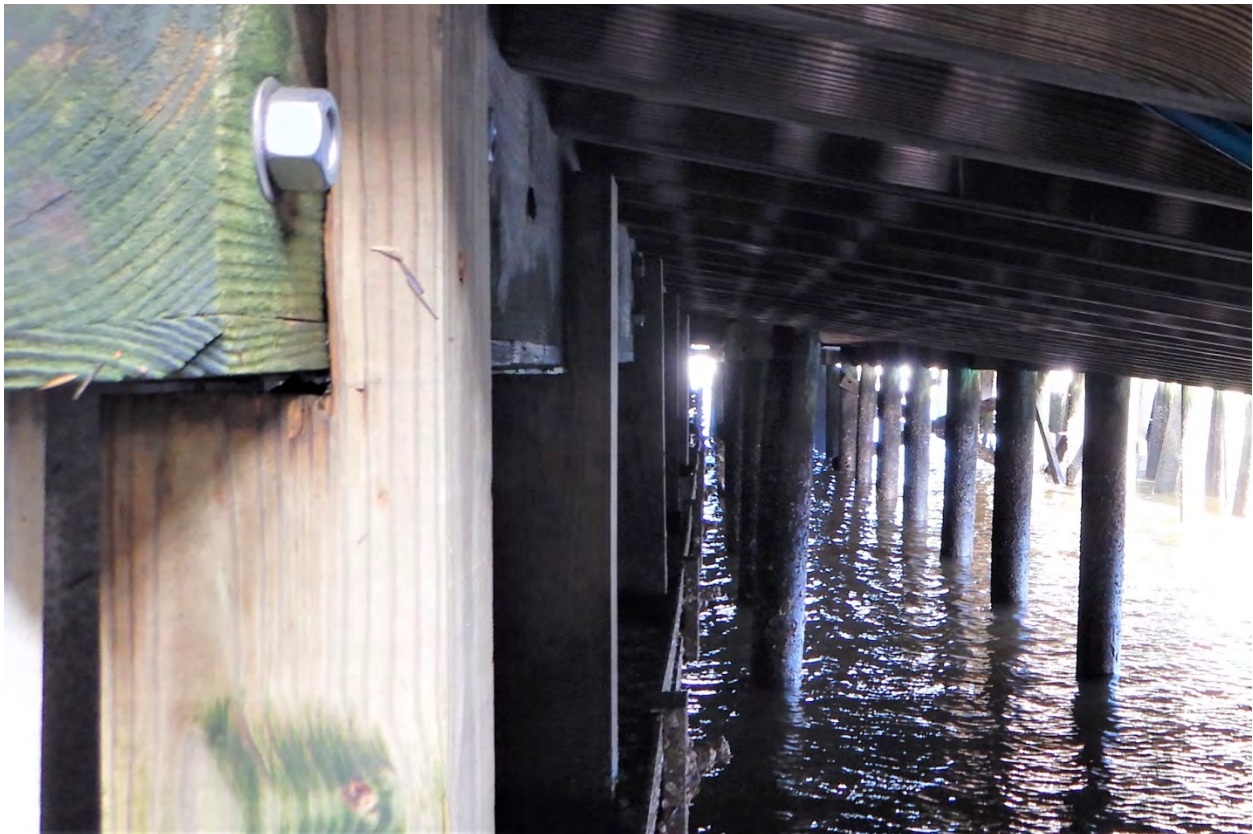
FIGURE 2-27: UNDERDECK VIEW OF CARGO RAMP

Cargo ramp at Passenger Landing is supported by the marina bulkhead wall (foreground). For comparison, the adjacent Contractor Landing is fully supported with a row of timber piles (center background).
