Phase I Environmental Site Assessment
Deep Point Ferry Terminal
Southport, Brunswick County, North Carolina
S&ME Project No. 4305-19-003

Reference: **Phase I Environmental Site Assessment**
Deep Point Ferry Terminal
Southport, Brunswick County, North Carolina
S&ME Project No. 4305-19-003

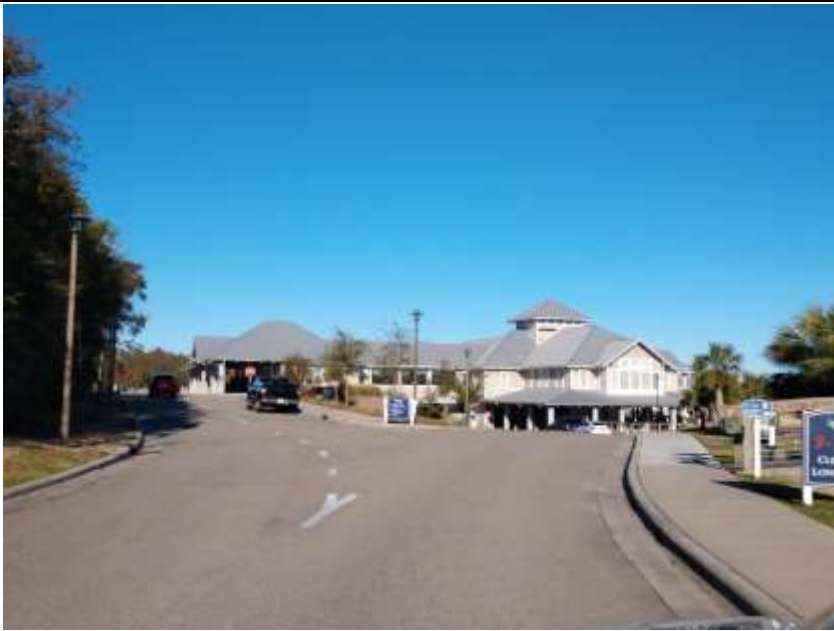
1/9/2019
			Photographer: Claudia Irvin
1	Location / Orientation	View looking northeast from entrance road at ferry terminal.	
	Remarks	View of western side of ferry terminal – upper level baggage drop off on left and lower baggage drop off on right.	
		 	1/9/2019
			Photographer: Claudia Irvin
2	Location / Orientation	View looking east from the passenger ferry outside waiting area.	
	Remarks	View of contractor ferry, ferries not actively being used on this day, and maintenance building.

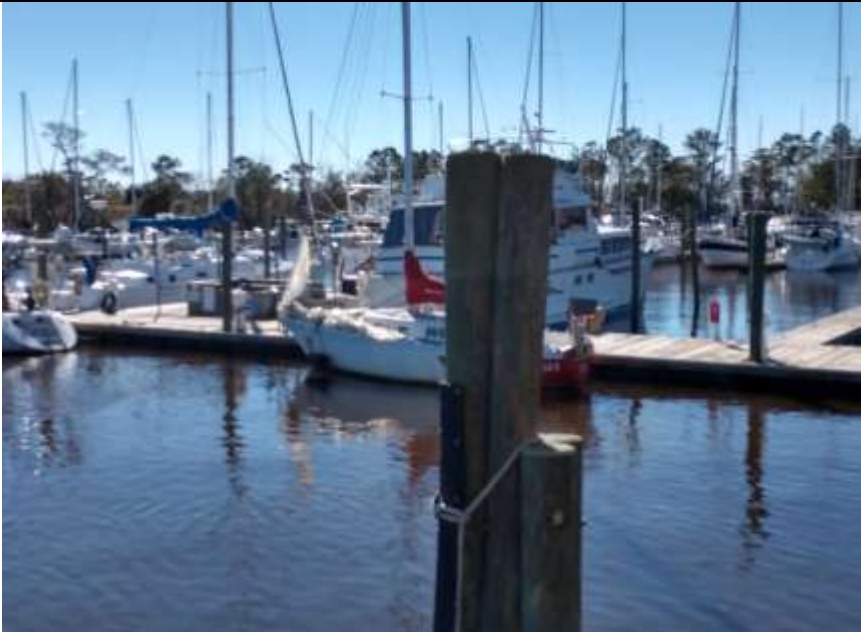
1/9/2019
			Photographer: Claudia Irvin
5	Location / Orientation	View looking south from terminal passenger ferry waiting area.	
	Remarks	Adjacent marina facility.

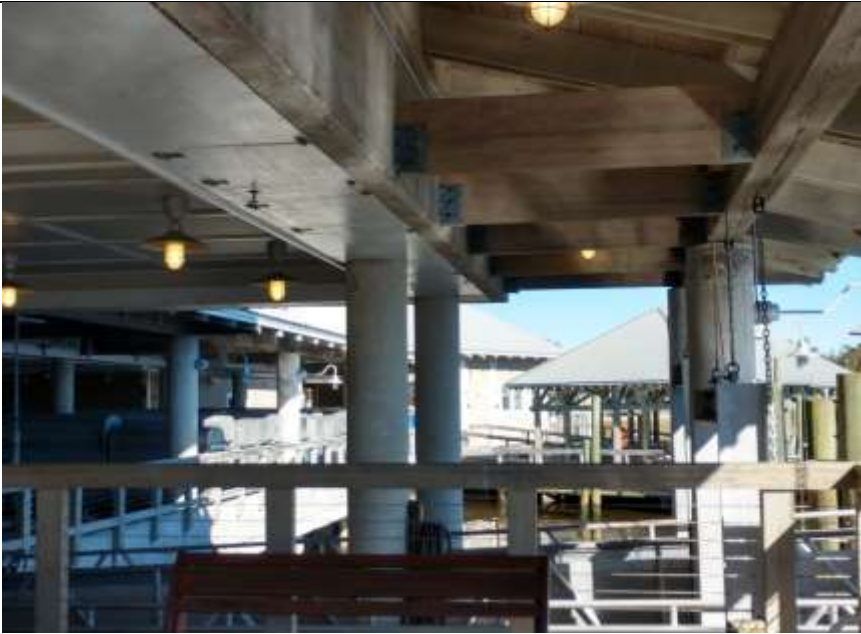
1/9/2019
			Photographer: Claudia Irvin
6	Location / Orientation	View looking east from terminal passenger waiting area.	
	Remarks	View looking at contractor ferry and the interior of the passenger ferry waiting area.

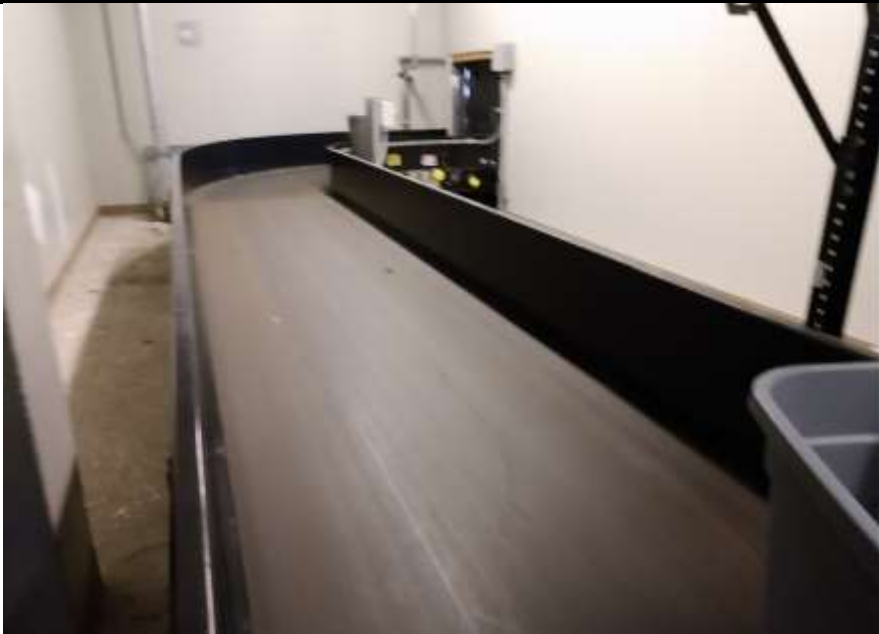
1/9/2019
		Photographer: Claudia Irvin
8	Location / Orientation	Interior view of baggage conveyor belt.
	Remarks	Baggage transfer conveyer belt from upper to lower baggage drop off area at terminal.

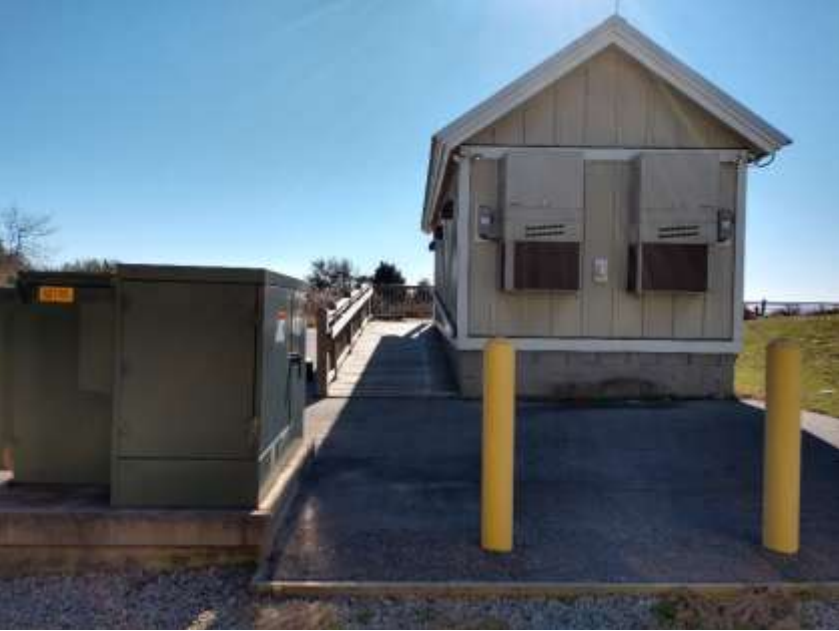
1/9/2019
		Photographer: Claudia Irvin
10	Location / Orientation	View looking southeast near barge landing.
	Remarks	Barge landing hydraulics building. Typical onsite transformer.

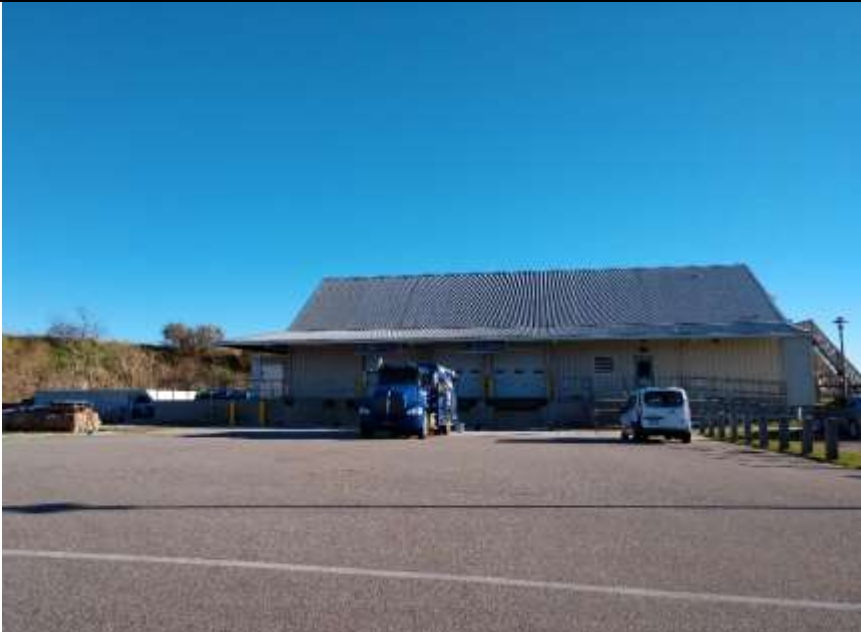
1/9/2019
			Photographer: Claudia Irvin
11	Location / Orientation	View looking south at Shipping and Receiving Building.	
	Remarks	Northern side of Shipping and Receiving building.

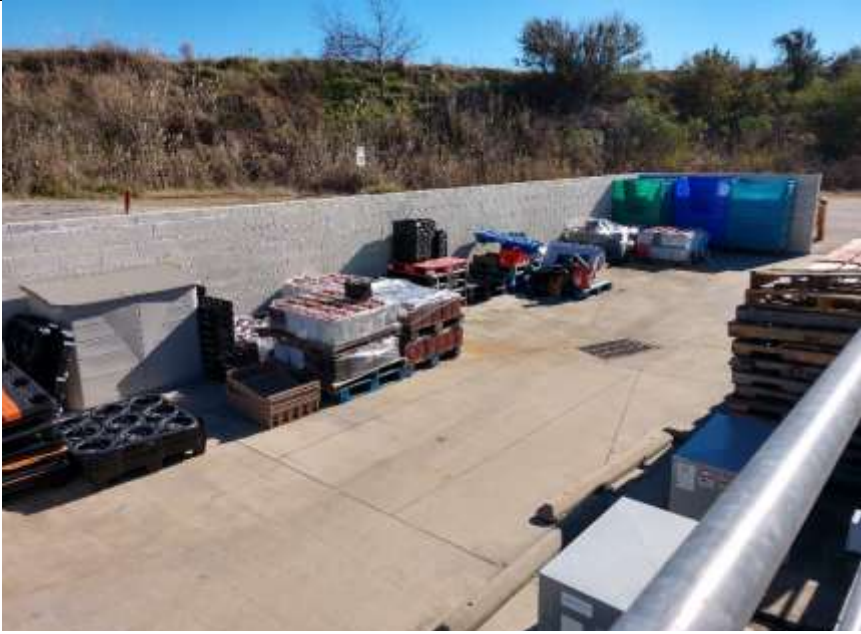
1/9/2019
			Photographer: Claudia Irvin
12	Location / Orientation	View of eastern side of Shipping and Receiving building.	
	Remarks	Outside eastern storage area of Shipping and Receiving building.

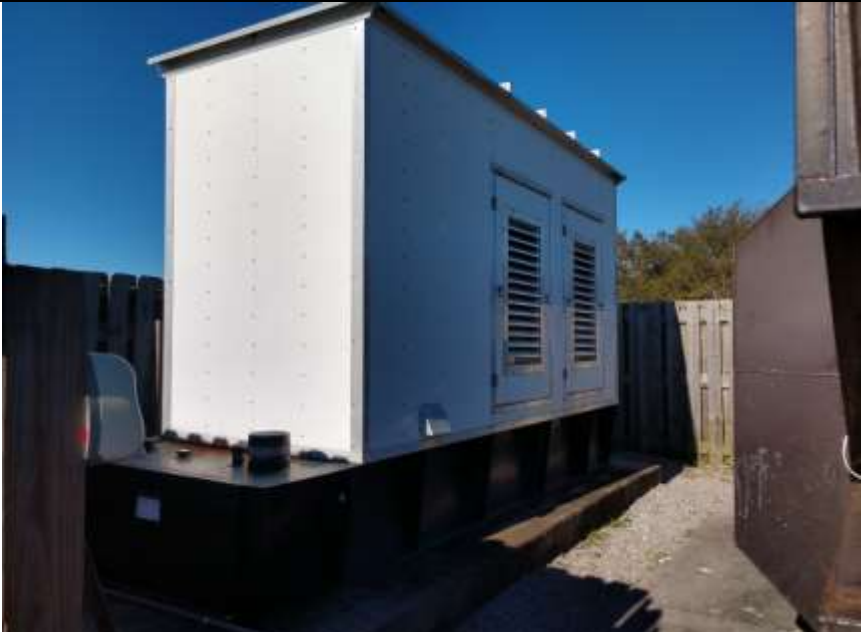
1/9/2019
			Photographer: Claudia Irvin
17	Location / Orientation	View looking north inside fenced in area north of Maintenance Facility.	
	Remarks	Onsite backup generator for terminal facility.

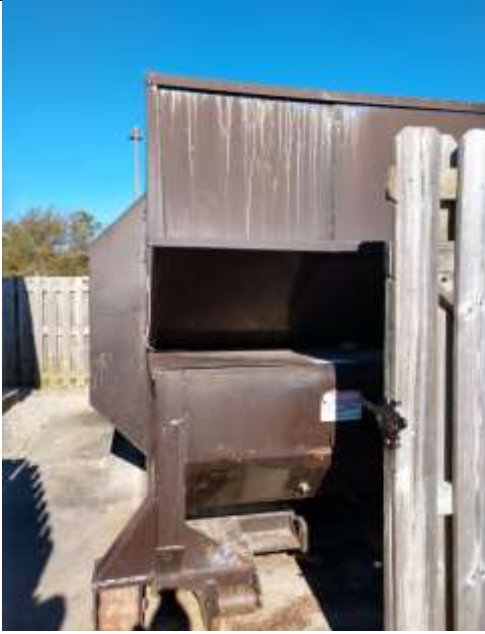
1/9/2019
			Photographer: Claudia Irvin
18	Location / Orientation	View looking north inside fenced in area north of Maintenance Facility.	
	Remarks	Trash compactor for onsite solid waste.

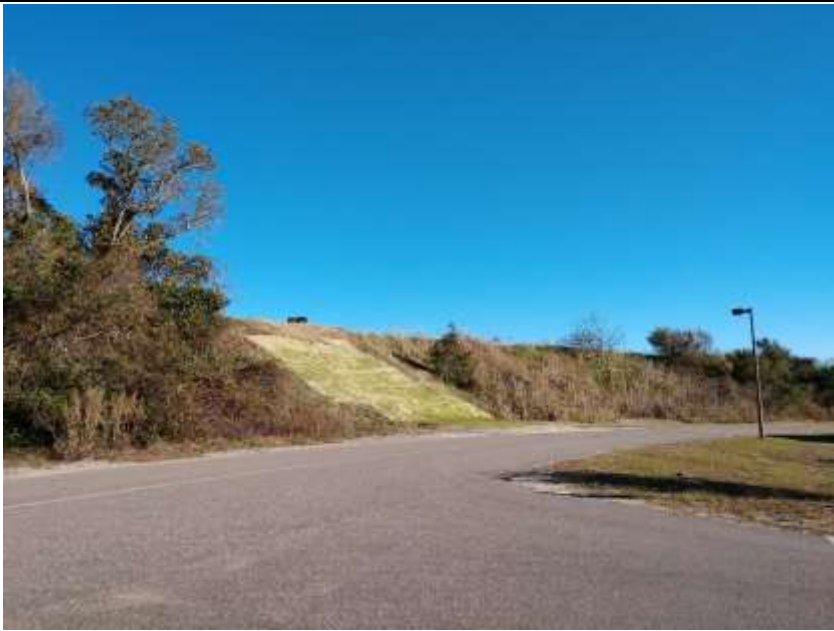
1/9/2019
			Photographer: Claudia Irvin
19	Location / Orientation	View looking east from Shipping and Receiving building.	
	Remarks	View of western side of onsite dredge spoil basin.

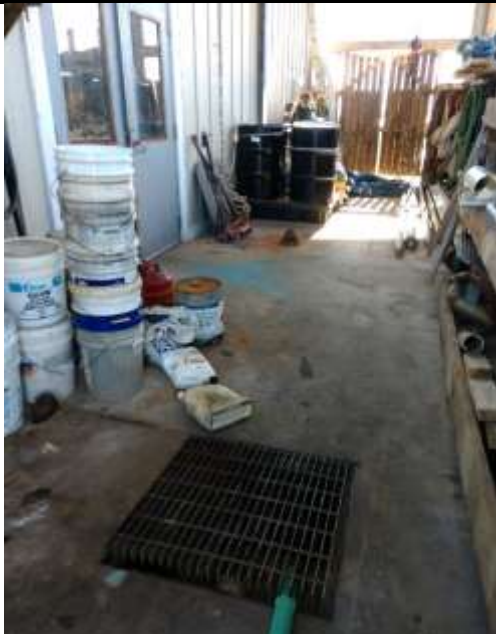
1/9/2019
			Photographer: Claudia Irvin
20	Location / Orientation	View looking south inside the western storage area of the onsite Maintenance building.	
	Remarks	Drums of hydraulic oil and sump that drains to oil water separator.

Hydraulic equipment was observed in the southeastern portion of the subject property and in the ferry terminal. Three above ground storage tanks (ASTs): one approximate 250-gallon containing used oil, one 300-gallon containing bilge slops from the ferries, and one approximate 250-gallon containing used oil filters and drained oil, are located on the north side of the Maintenance Building. One 300-gallon AST containing new oil is located inside the Maintenance Building. Two diesel generators were observed in the eastern portion of the subject property. Drums containing petroleum were observed inside and adjacent to the Maintenance Building. An oil/water separator is located on the north side of the Maintenance Building. Golf cart batteries and propane tanks were observed stored adjacent to the Shipping and Receiving Building. An area of fill was observed in the northeastern portion of the subject property. Two waste dumpsters were observed: a solid waste dumpster adjacent to the Shipping and Receiving Building and a trash compactor north of the Maintenance Building. One sump is located on the subject property, adjacent to the maintenance facility. No visual evidence of contamination or incident have been recorded with these observed findings.

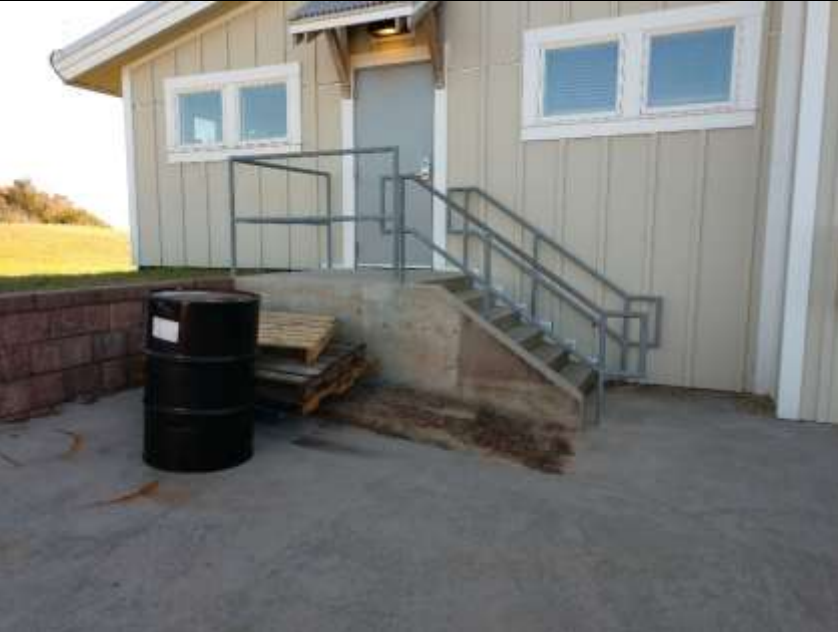
1/9/2019
			Photographer: Claudia Irvin
22	Location / Orientation	North side of Maintenance building.	
	Remarks	View of drum of unknown contents located on north side of Maintenance building.

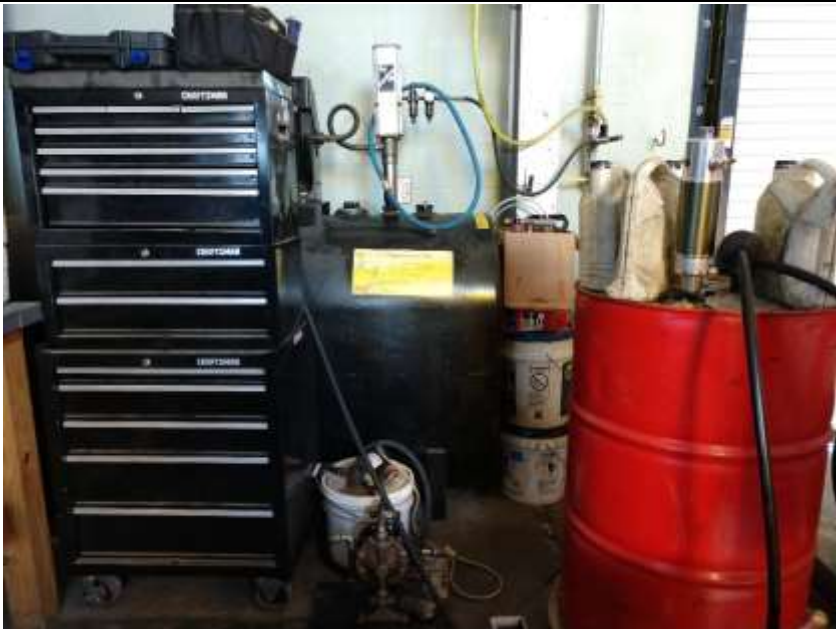
1/9/2019
		Photographer: Claudia Irvin
25	Location / Orientation	North wall of interior of Maintenance Building.
	Remarks	View of 300-gallon aboveground storage tank of new oil.

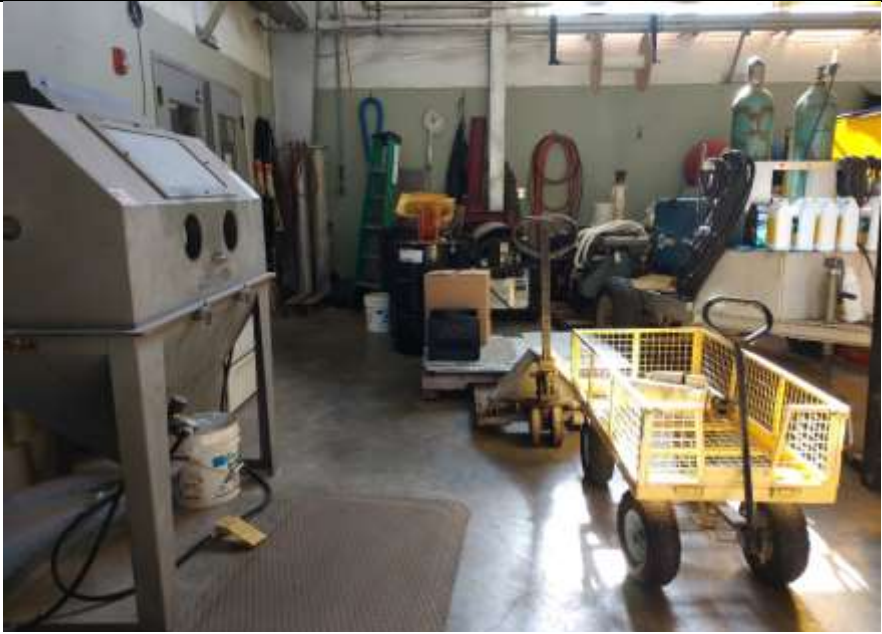
1/9/2019
		Photographer: Claudia Irvin
26	Location / Orientation	View looking south along western wall of interior of Maintenance Building.
	Remarks	Typical view of equipment and new oil drums storage inside Maintenance building.

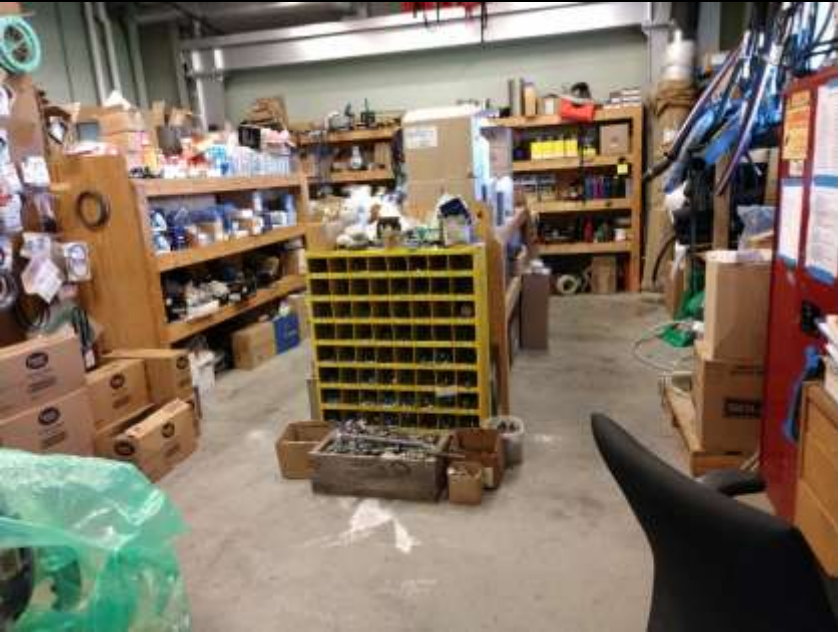
1/9/2019
28	Location / Orientation	View looking east inside Shipping and Receiving building.	Photographer: Claudia Irvin	
	Remarks	View of interior of Shipping and Receiving building.

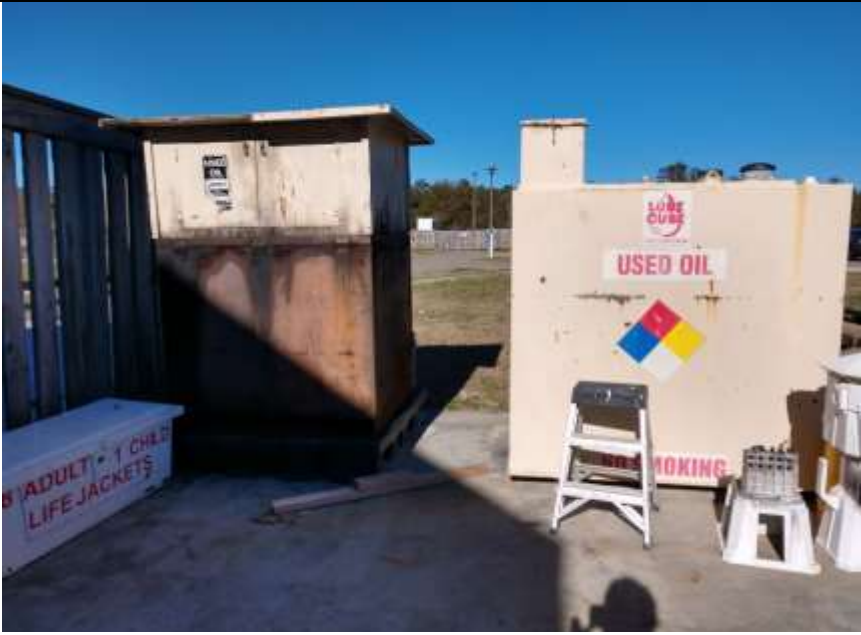
1/9/2019
				Photographer: Claudia Irvin
29	Location / Orientation	View looking north on north side of Maintenance building.		
	Remarks	Used oil tank and used oil filter container located on the north side of the Maintenance building.

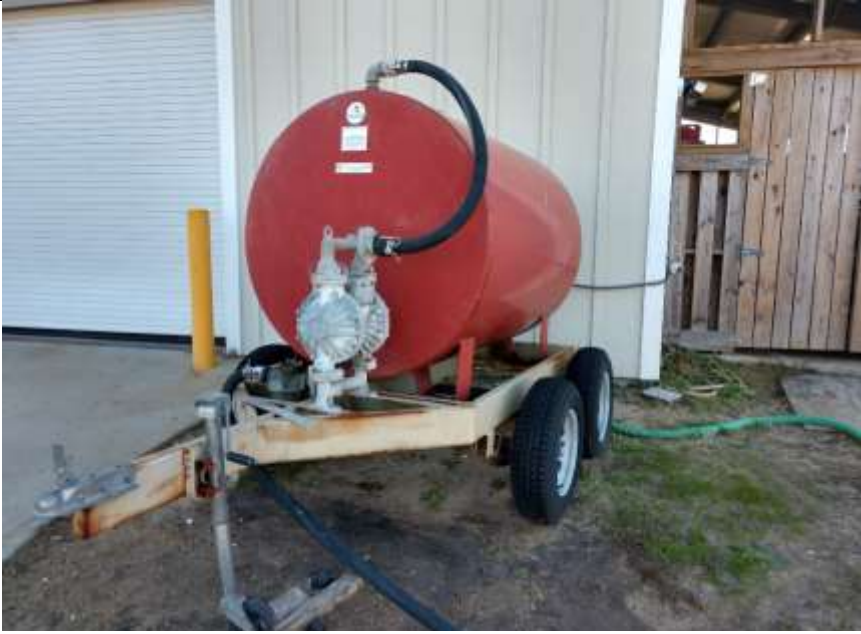
1/9/2019
				Photographer: Claudia Irvin
30	Location / Orientation	View looking south on the north side of Maintenance building.		
	Remarks	View of mobile tank used for the collection of bilge water from ferries.
