CONDITION & VALUATION SURVEY REPORT

**76 GRT / 61 NRT
Passenger Vessel**

ADVENTURE

November 26, 2018

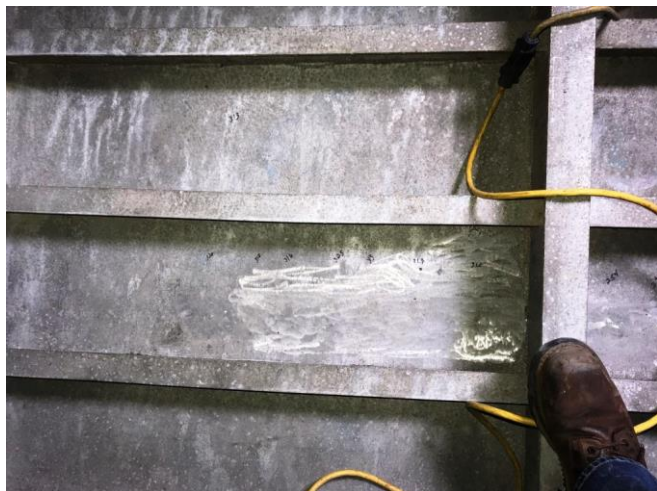
The underwater hull was fully inspected while in dry-dock at Wilmington Marine Center. The vessel was also in the process of completing the 2-year intermediate USCG inspection for dry docking credit and annual COI endorsement. The USCG inspectors had taken a series of bottom shell UT measurement readings from the inside of compartment # 3 which substantiated that the bottom hull plate thickness was satisfactory. From observation of the UT readings taken, the bottom hull plate diminution appears to average around 15% from the original 3/8". (See photo # 1 & # 2).

Photo # 1 – Port side bottom hull insert

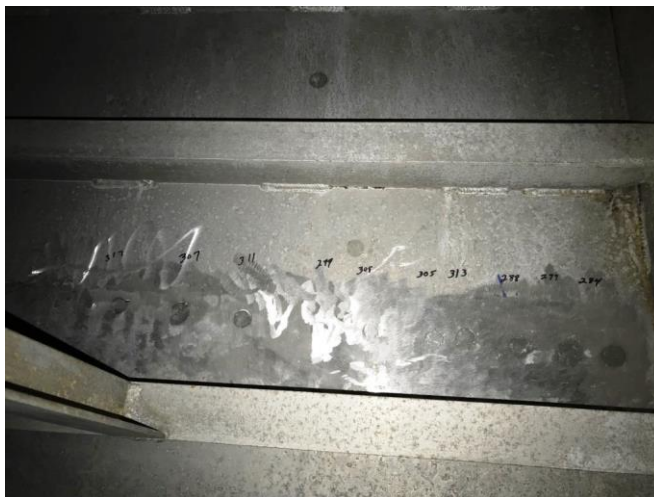
Photo # 2 – P&S bottom insert at keel

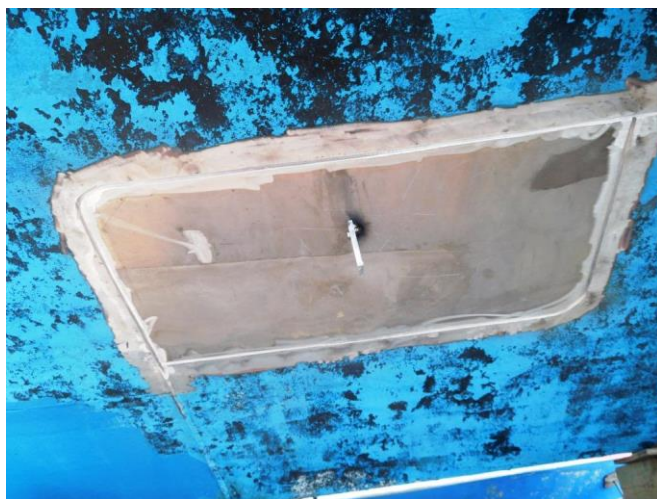
During the inspection by the USCG, three (3) areas of hull plate pitting were discovered and were cropped out and inserted with new 3/8" plate. (See photos # 3 & # 4).

Photo # 3 – Port side bottom hull insert

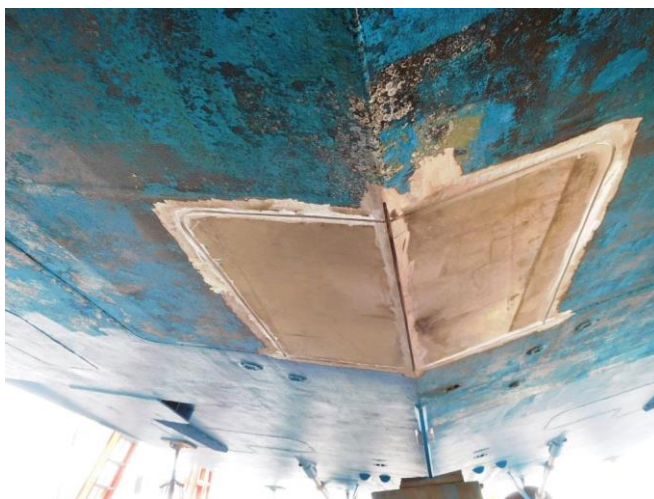
Photo # 4 – P&S bottom insert at keel

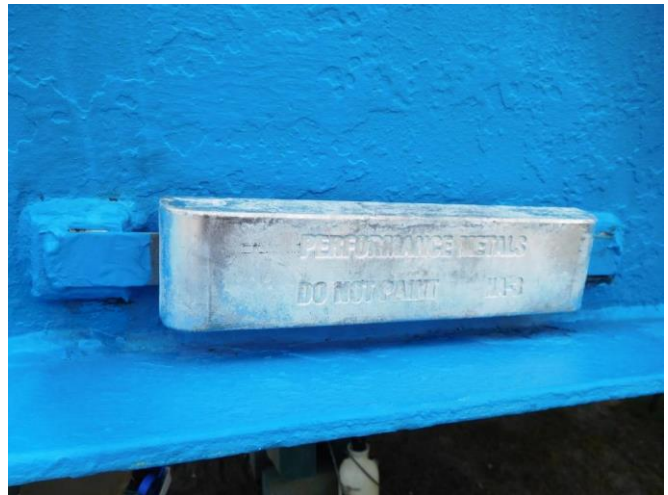
Photo # 12 – New anodes at the transom

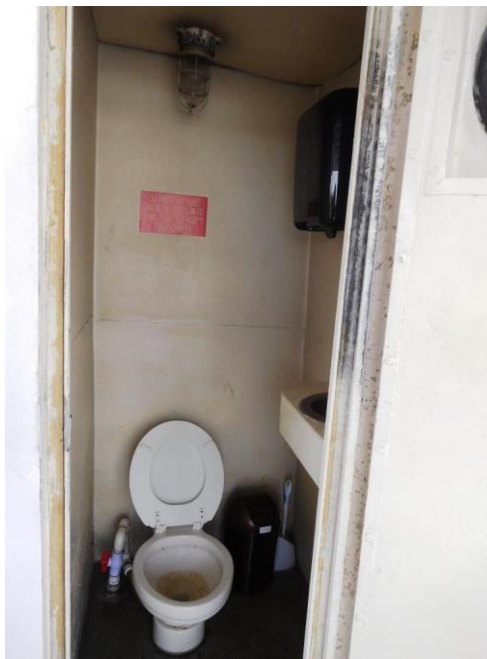
The men's and women's toilet spaces were notice to have loose ceiling panels with no batten strips to secure them around the perimeter. Also noted was that the wash basins in both spaces are only provided with cold water connections and no "P-traps" to prevent the passage of odors.

Photo # 16 – Men's toilet space

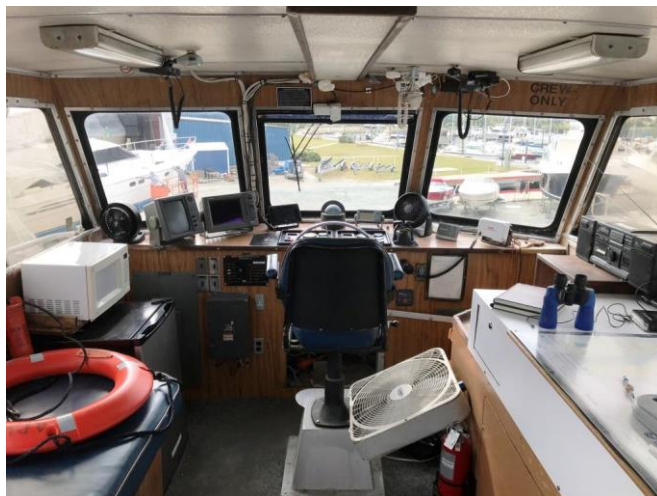
The pilot house was observed to have a significant amount of deterioration to the joiner paneling throughout, the trim around the windows, and in some areas of the console top.

There are several areas around the ceiling linings (above the steering console) which have towels stuffed around cables, or other penetrations which is indicative of some water ingress from the roof. The exact issue was not cited during this inspection.

Photo # 23- Pilot house – forward view

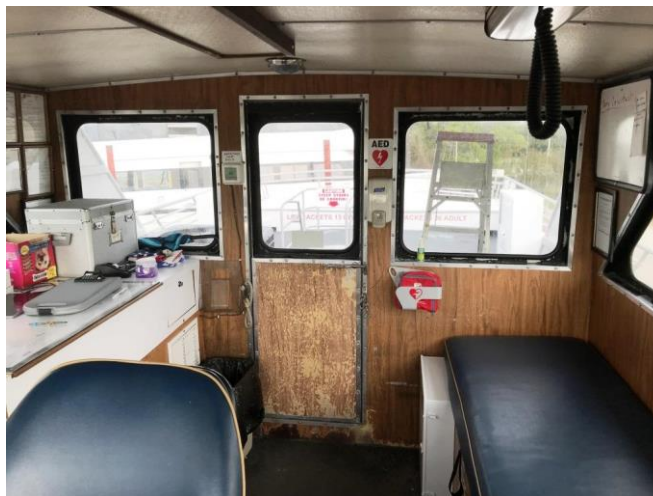
Photo # 24 – Pilot house – aft view

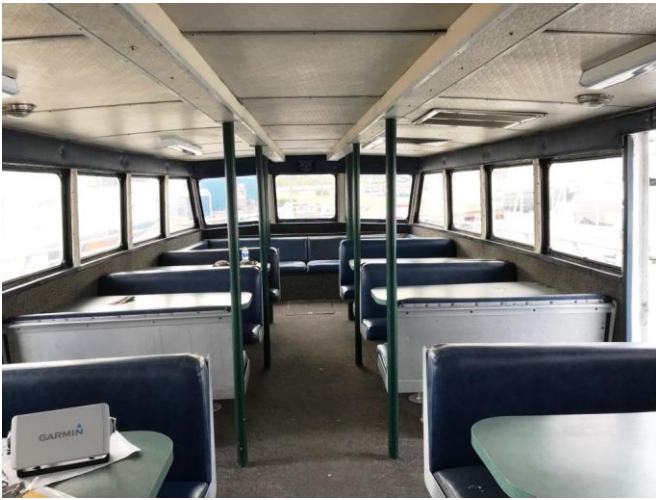
It was noted during this inspection that the overall appearance of the deckhouse interior furnishings show wear and tear, such as to the carpets, the Formica laminates, and the padded upholstery.

Photo # 25 – Main deck house – forward view

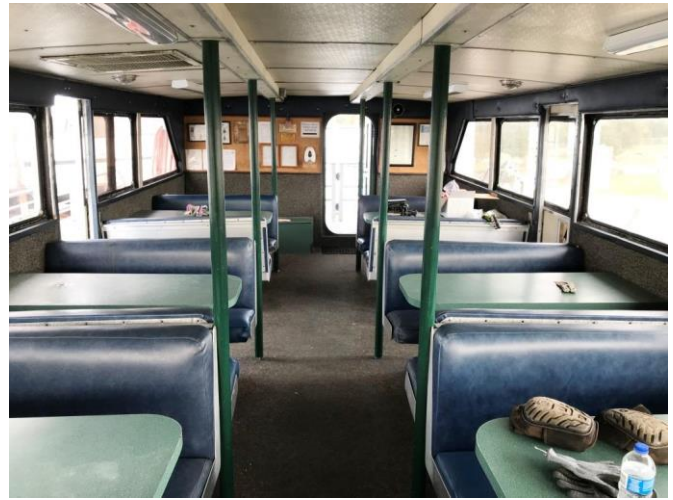
Photo # 26 – Main deck house – aft view

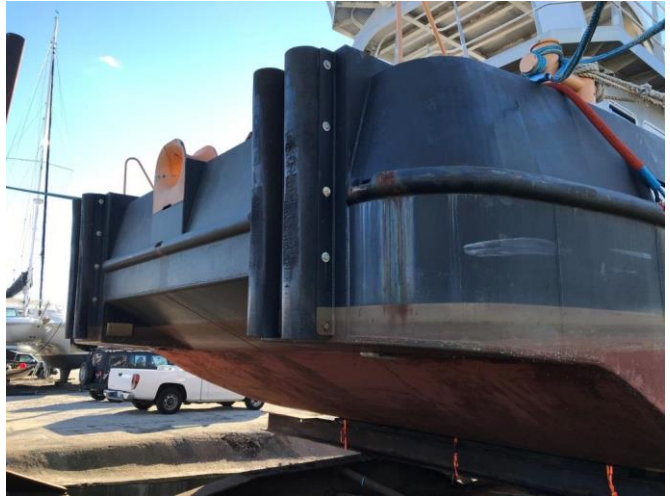
Photo # 2 – Port side elevation

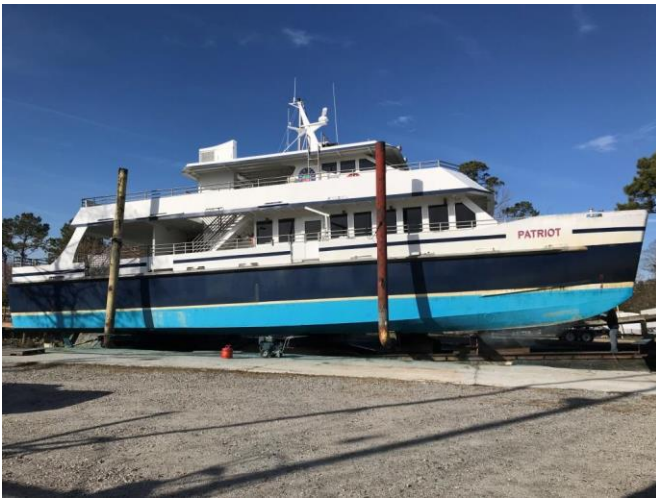
Photo # 3 – Starboard side elevation

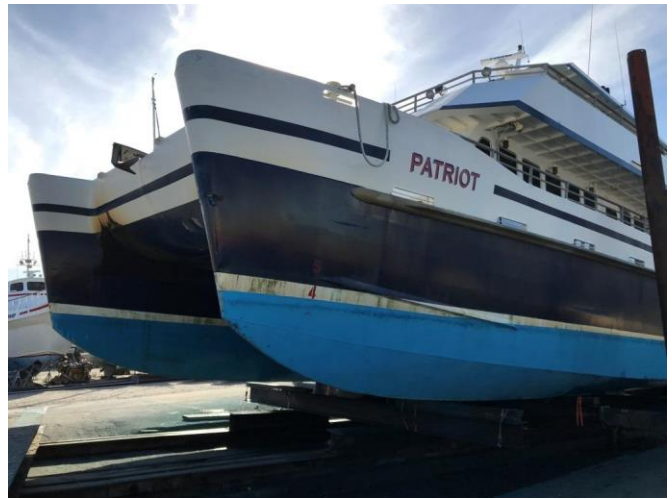
Photo # 4 – Port side elevation

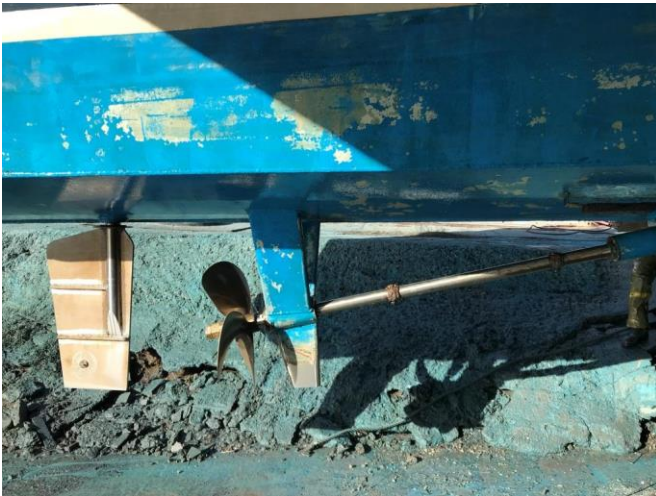
Photo # 5 – Starboard side tail shaft, prop, and rudder

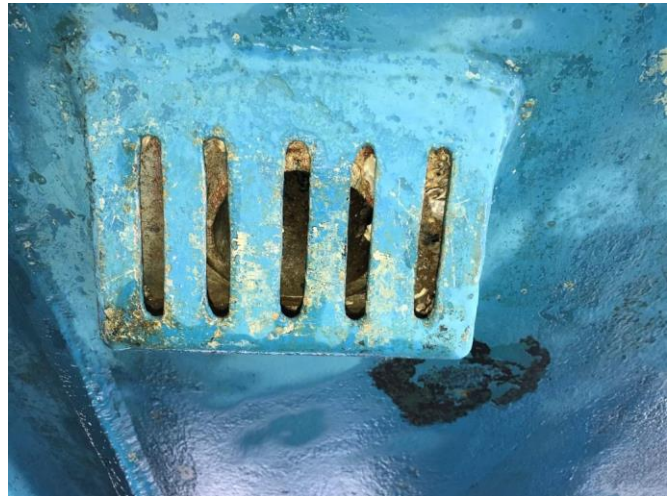
Photo # 6 – Port side main engine sea chest fouling

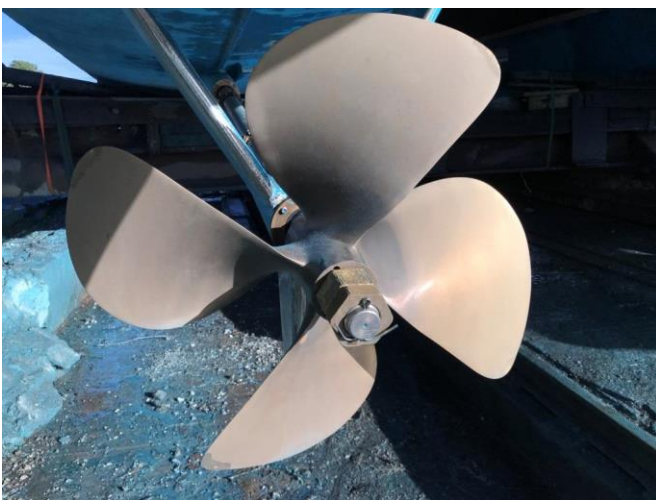
Photo # 7 – Port propeller

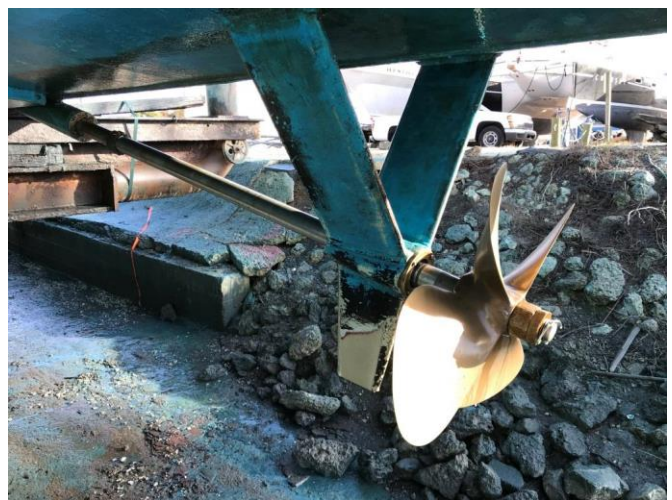
Photo # 8 – Starboard propeller

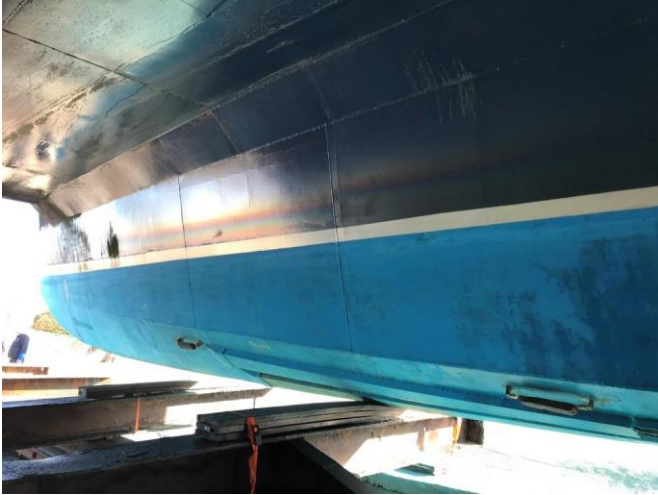
Photo # 9 – Port hull inboard side

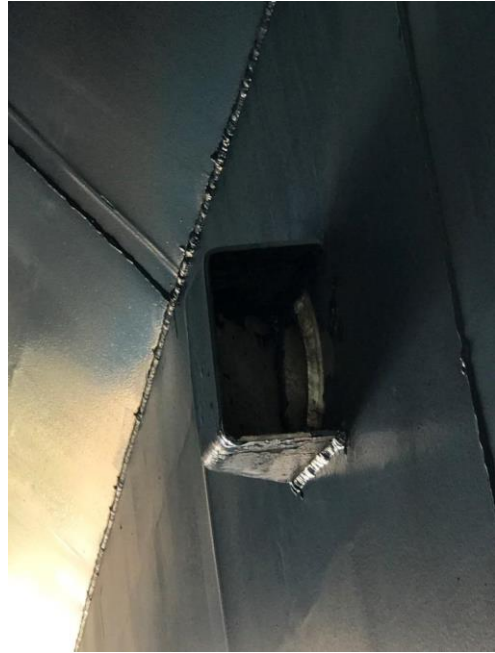
Photo # 10 – Starboard side main engine exhaust

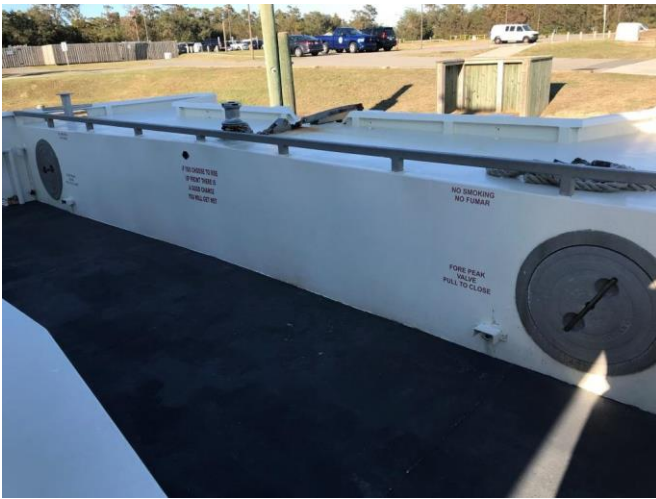
Photo # 17 – Bow view arrangement

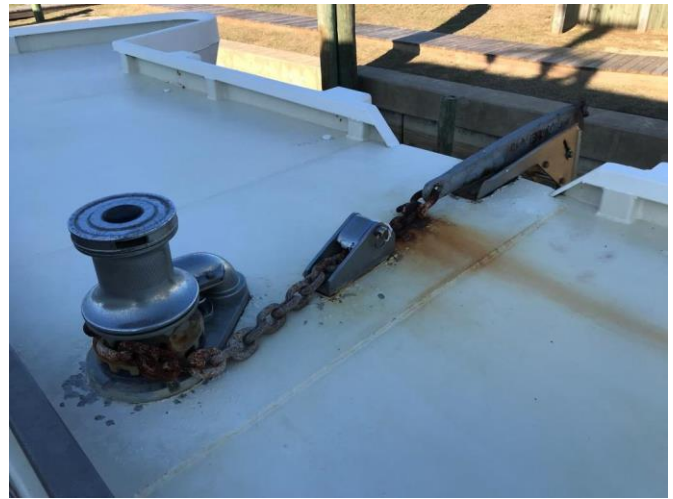
Photo # 18 – Anchoring arrangement at bow

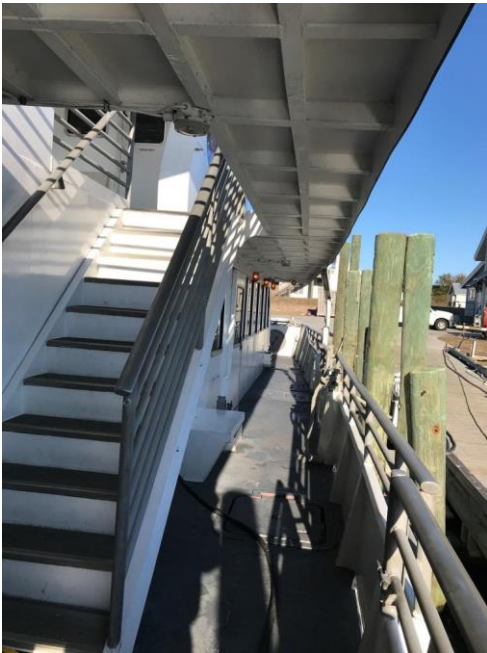
Photo # 19 – Starboard side main deck house

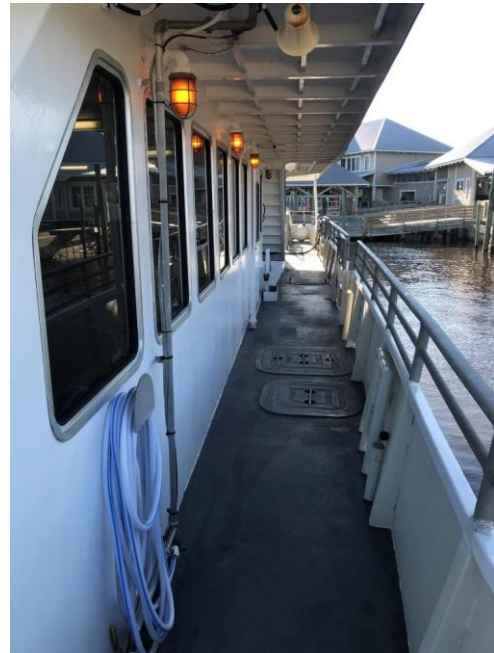
Photo # 20 – Port side main deck house

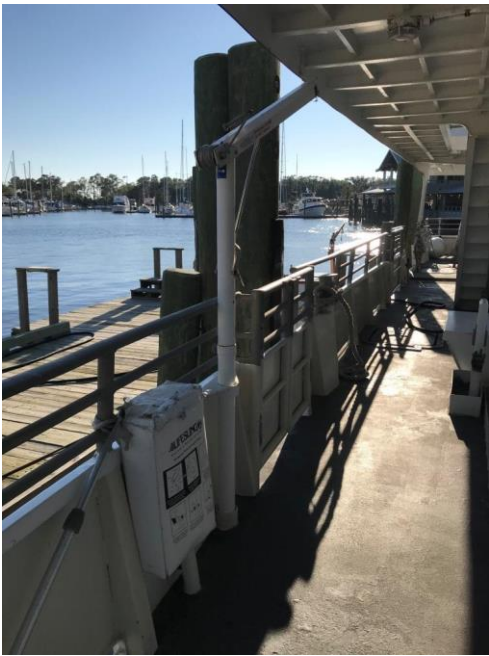
Photo # 21 – Man-over-board rescue gear

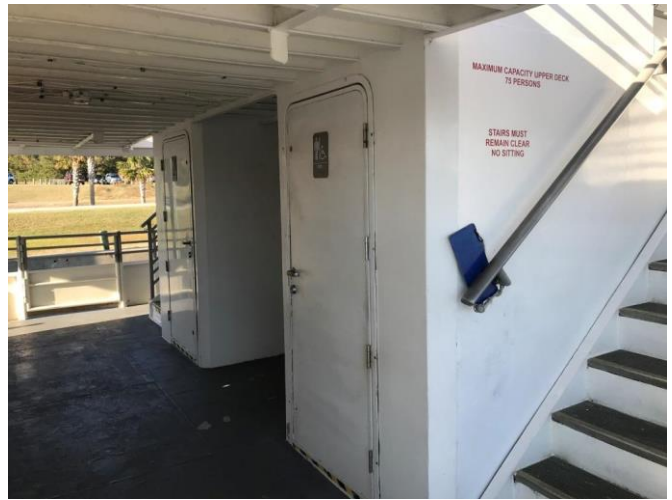
Photo # 22 – Aft end of deck house with restrooms and ladder to the upper (Bridge) deck

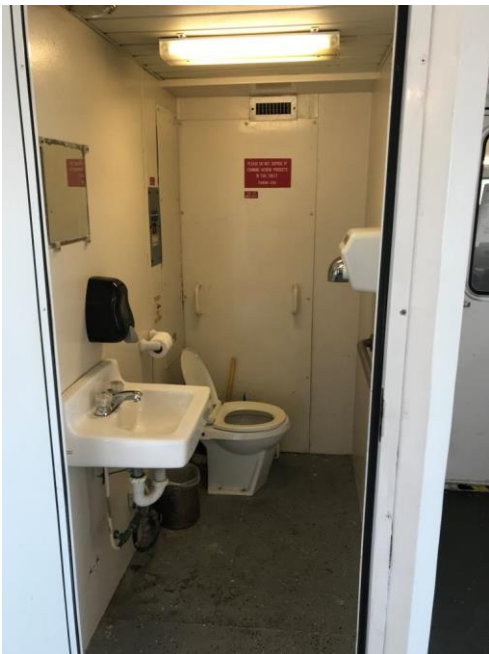
Photo # 23 – Typical restroom

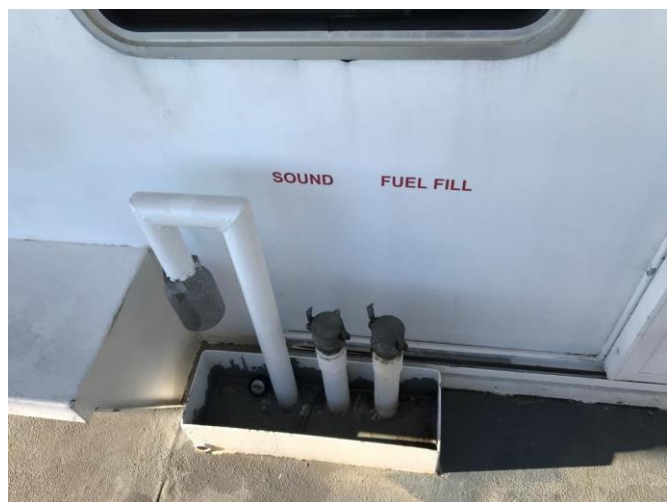
Photo # 24 – Fueling station P&S

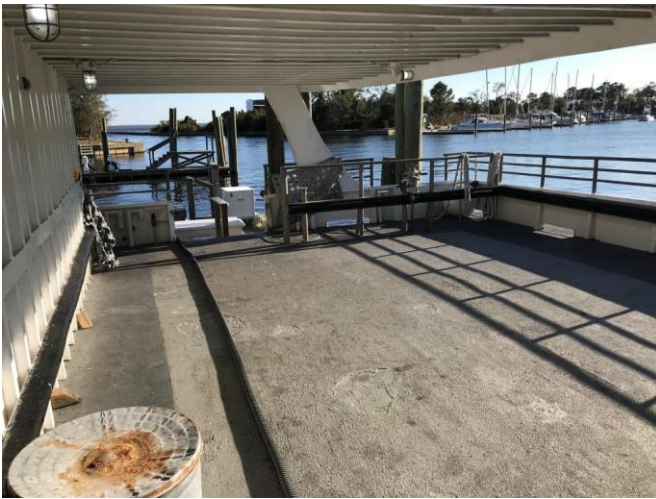
Photo # 25- Aft main deck 'Dollie' storage area looking stbd

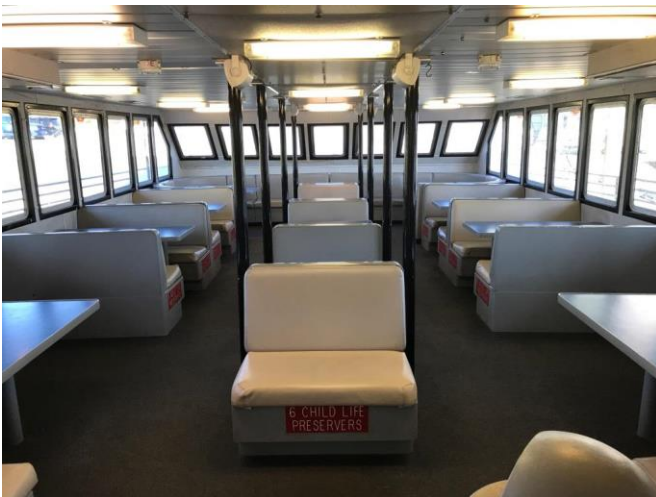
Photo # 27 – Passenger deck house – looking forward

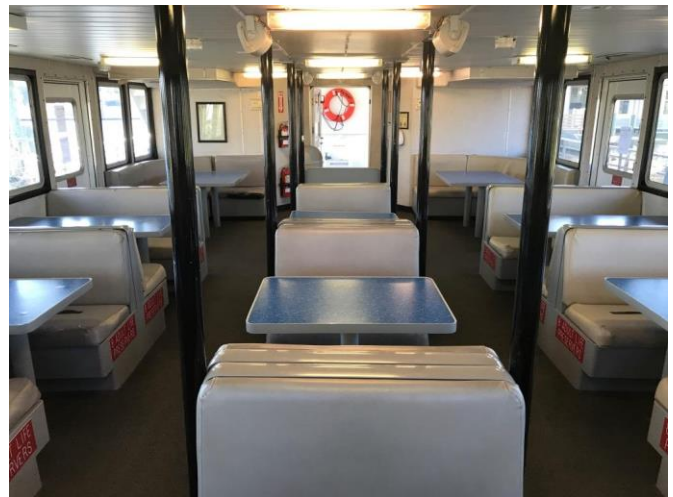
Photo # 28 – Passenger deck house – looking aft

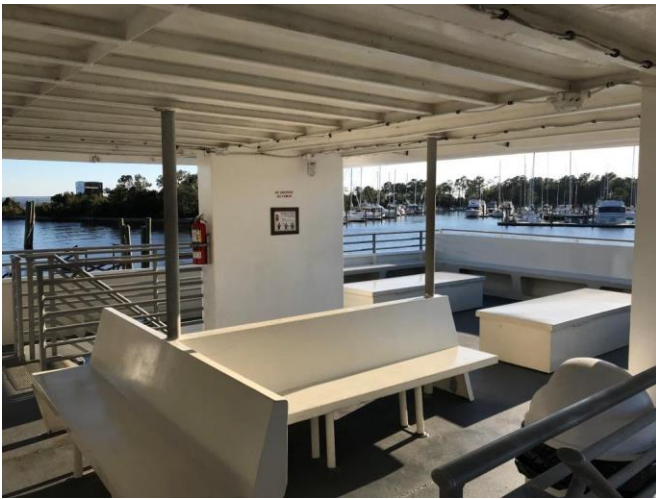
Photo # 31 – Bridge deck seating area – looking aft

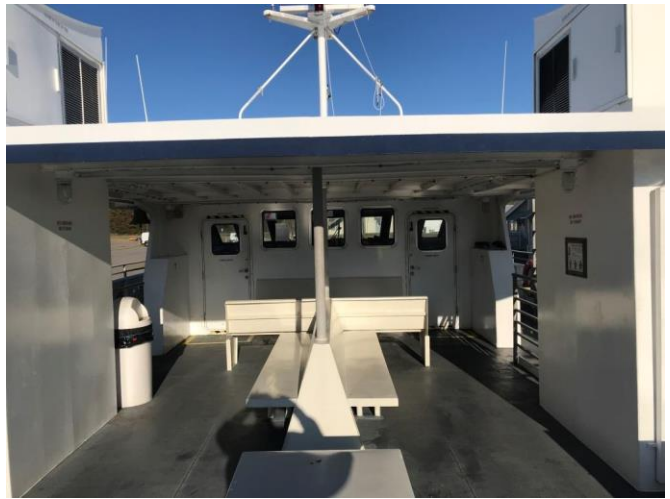
Photo # 32 – Bridge deck – looking forward at pilot house

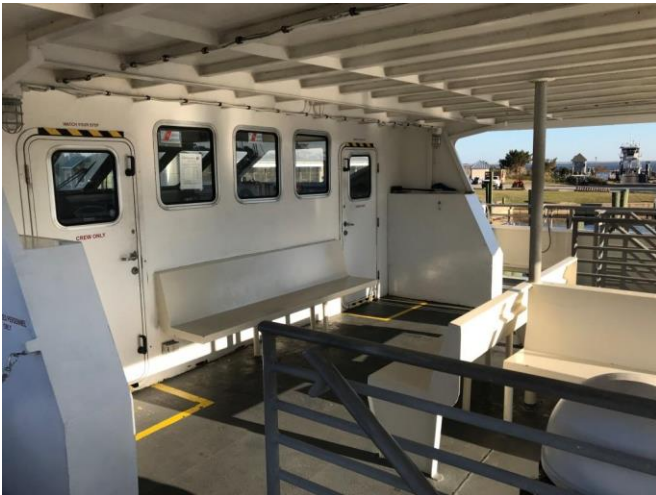
Photo # 33 – Aft bulkhead of pilot house

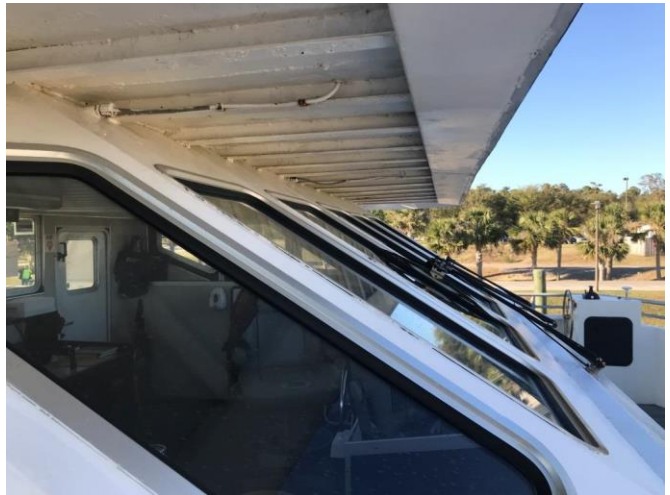
Photo # 34 – Forward bulkhead of pilot house with visor & windshield wipers

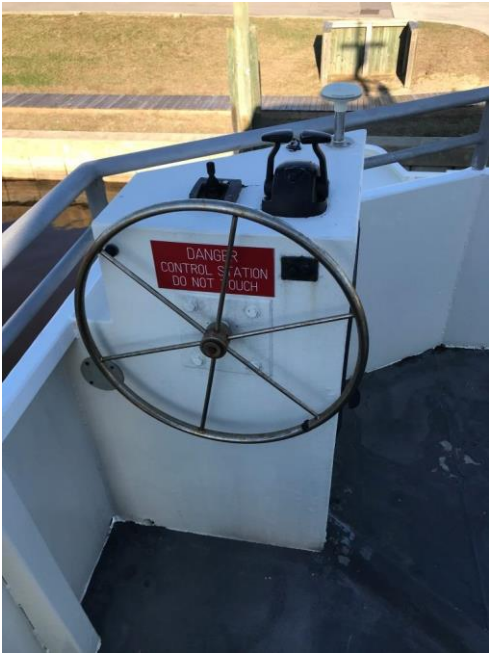
Photo # 35 – Port side bridge deck wing station

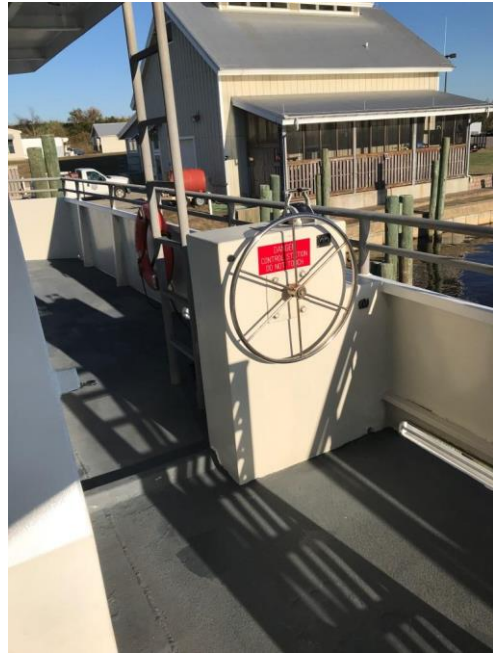
Photo # 36 – Starboard side bridge deck wing station

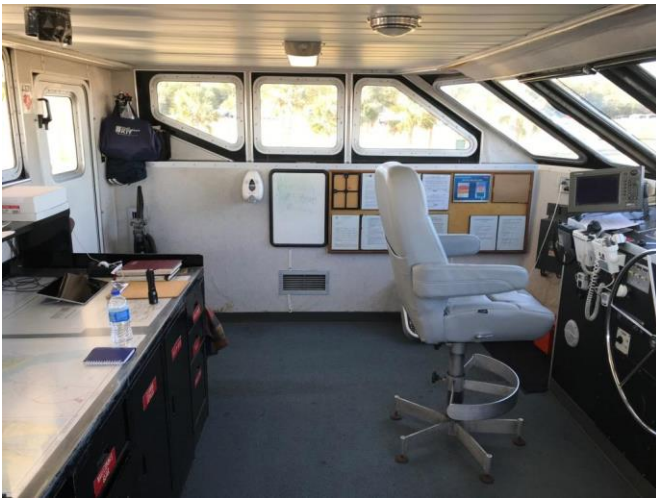
Photo # 37 – Interior pilot house – looking to port

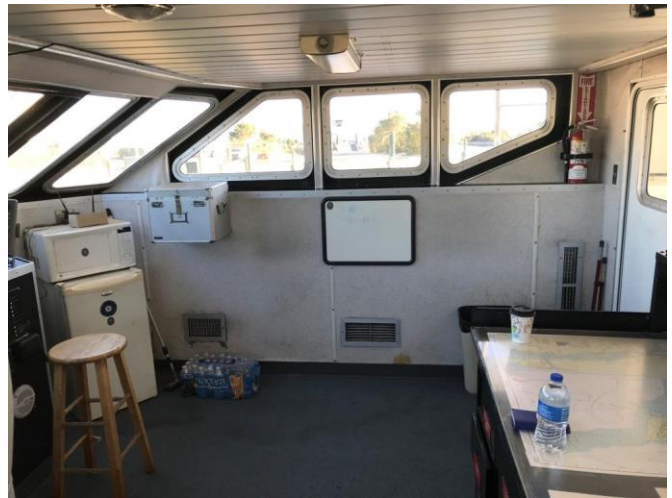
Photo # 38 – Interior pilot house – looking to starboard

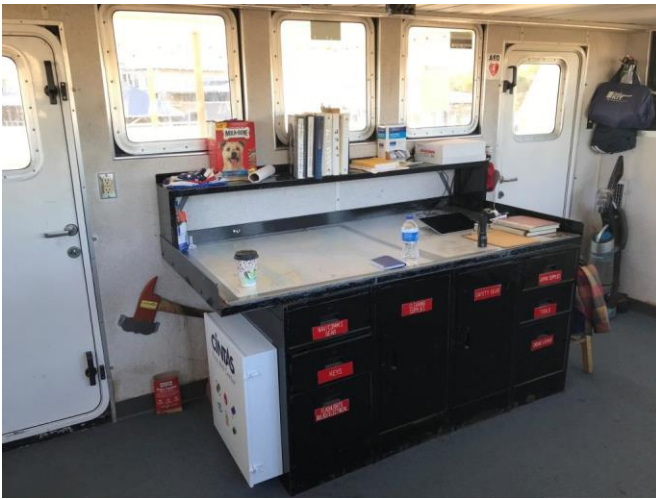
Photo # 39 – Interior pilot house – looking aft

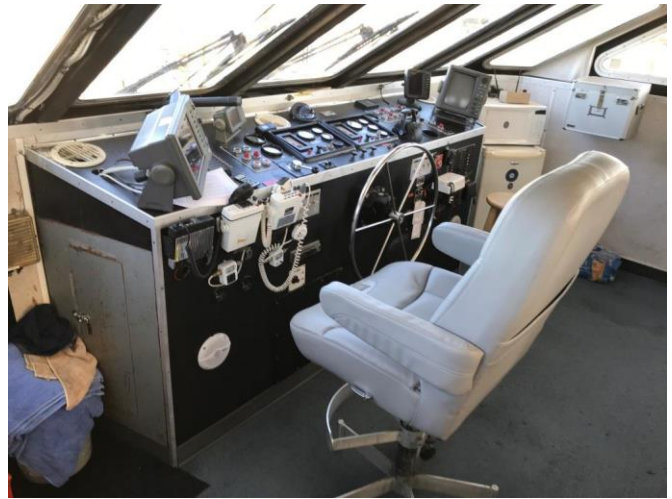
Photo # 40 – Helm and control console

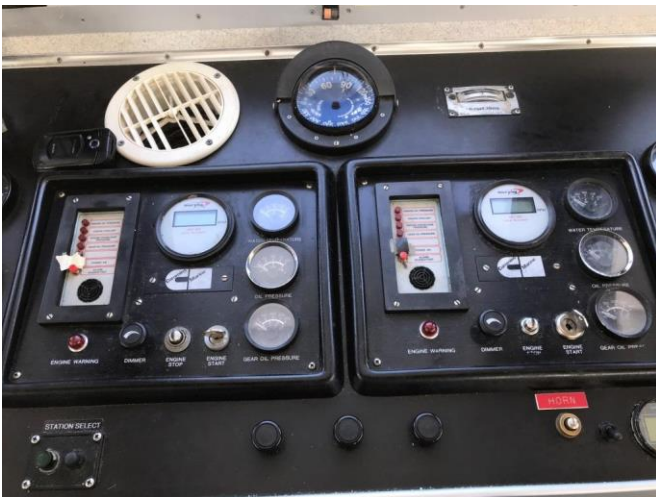
Photo # 41 – Cummins engine control panels at helm

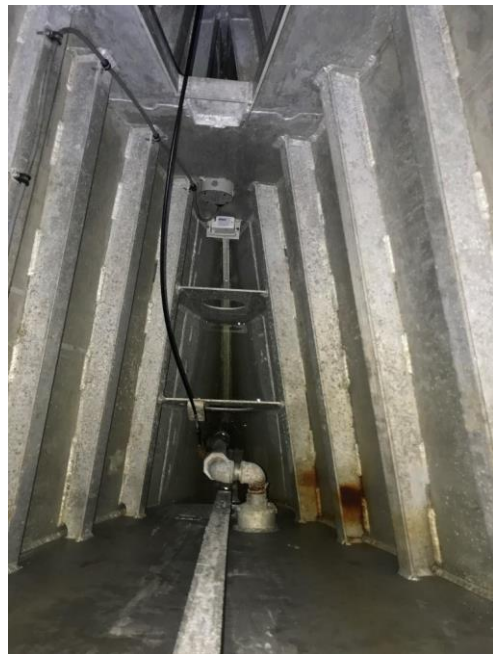
Photo # 42 – Port side fore peak compartment

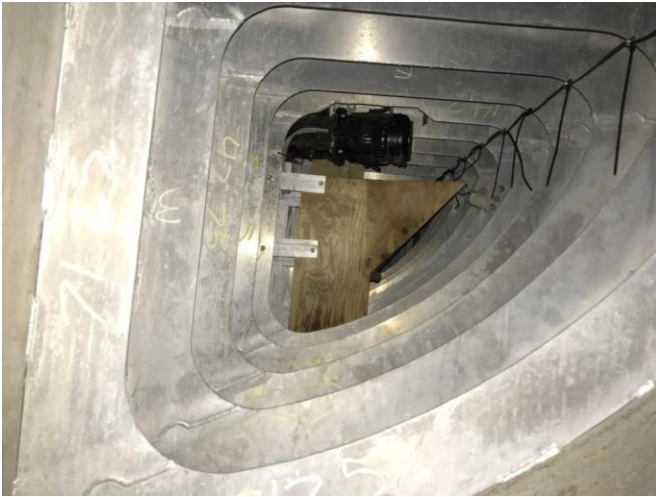
Photo # 43 – View across forepeak to chain locker
& underside of anchor windlass equipment

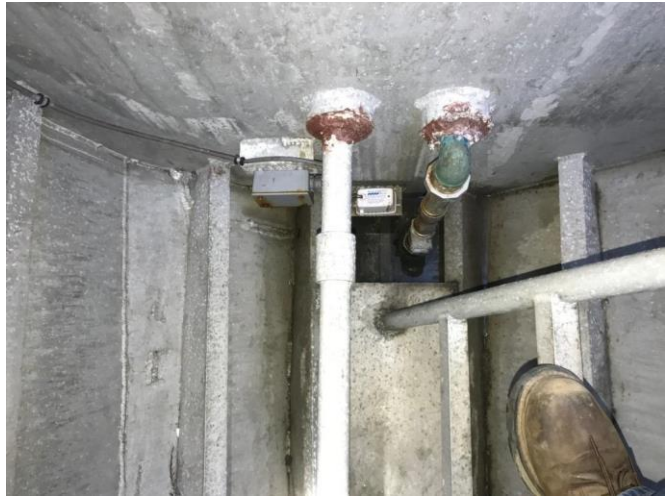
Photo # 44 – Comp. # 2 – Bilge suction piping and bilge alarm

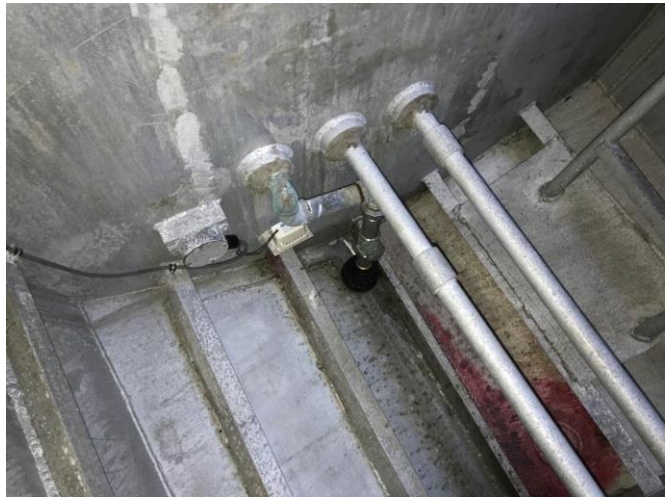
Photo # 46 – Comp. # 3P - Bilge suction piping & bilge alarm

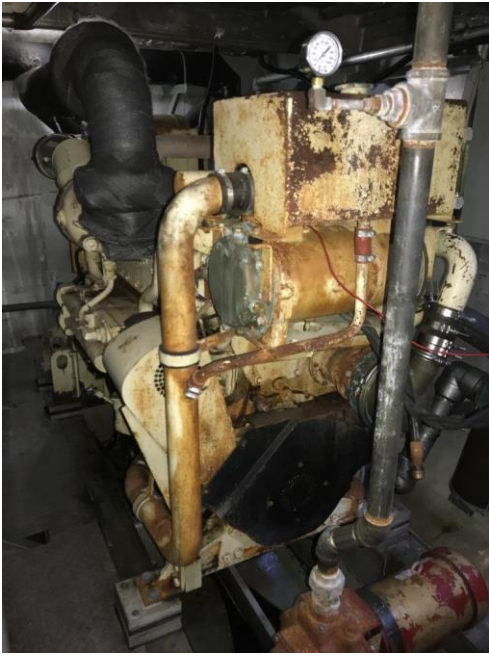
Photo # 47 – Comp. # 5 – Cummins 640 HP Main Engine

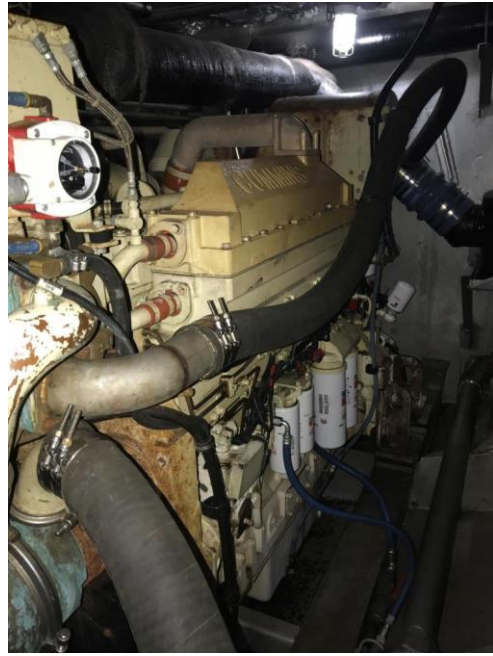
Photo # 48 – Comp. # 5 – Main engine

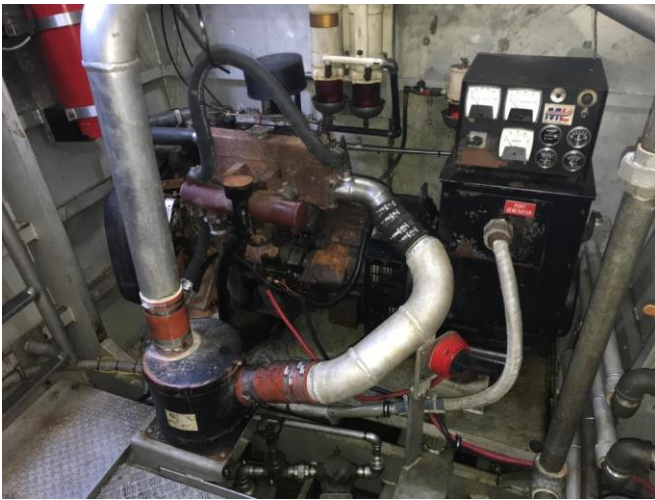
Photo # 49 – Comp. # 5 – 40 kW Generator Set

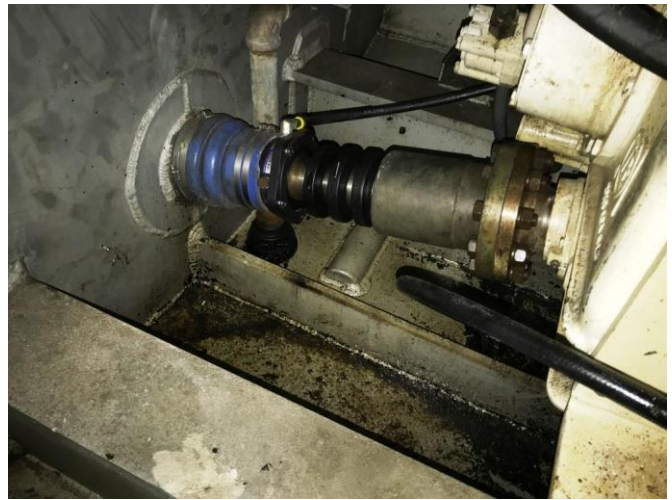
Photo # 50 – Comp. # 5 – Tail shaft

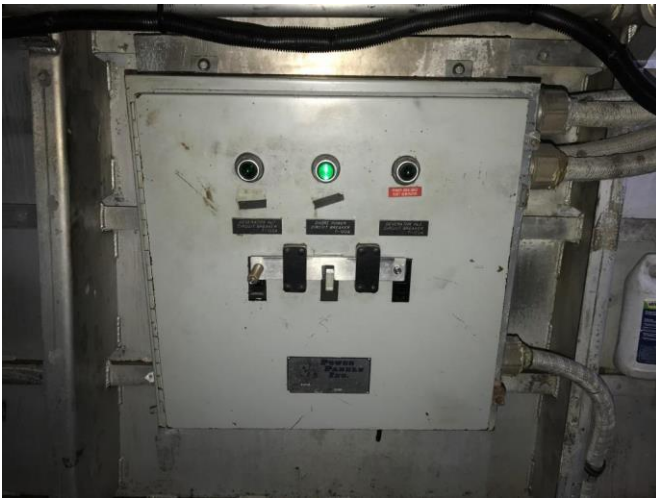
Photo # 51 – Comp. # 5 – Main switchboard – (S)

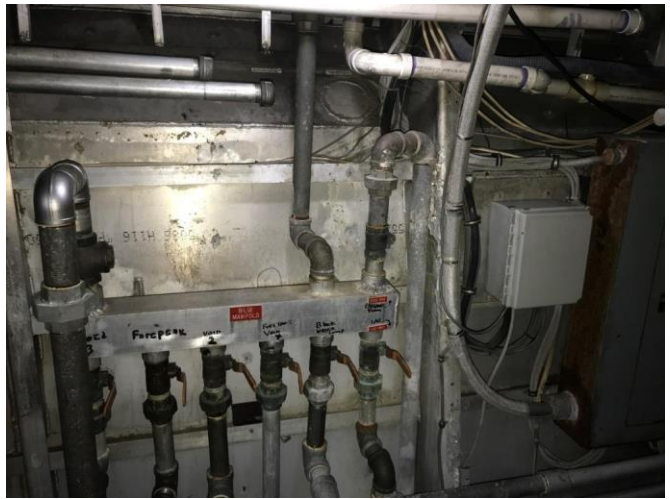
Photo # 52 – Comp. # 5 – Bilge manifold

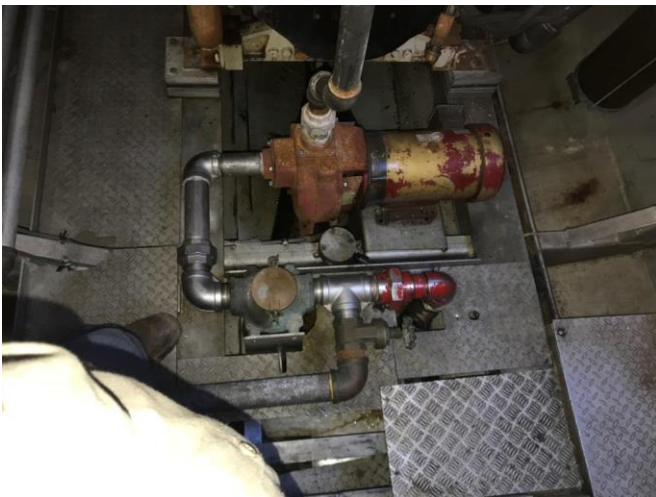
Photo # 53 – Comp. # 54 – 5.0 HP min fire pump

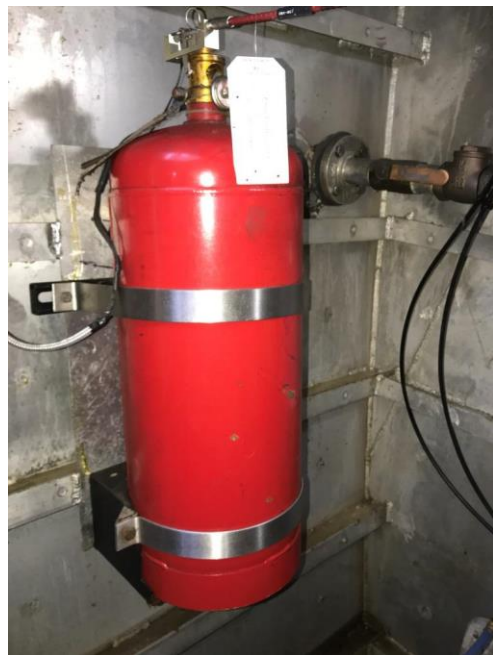
Photo # 54 – Comp. # 5 – Fixed fire system

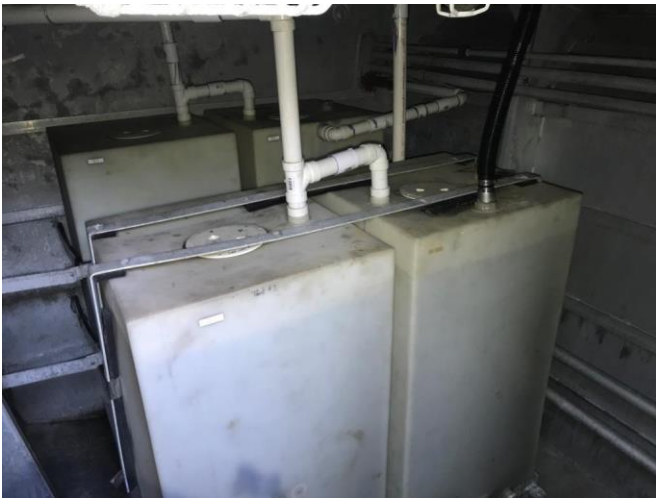
Photo # 55 – Comp. # 6P – 2 x 100-gallon sewage & 2 x 100 gallon fresh water tanks

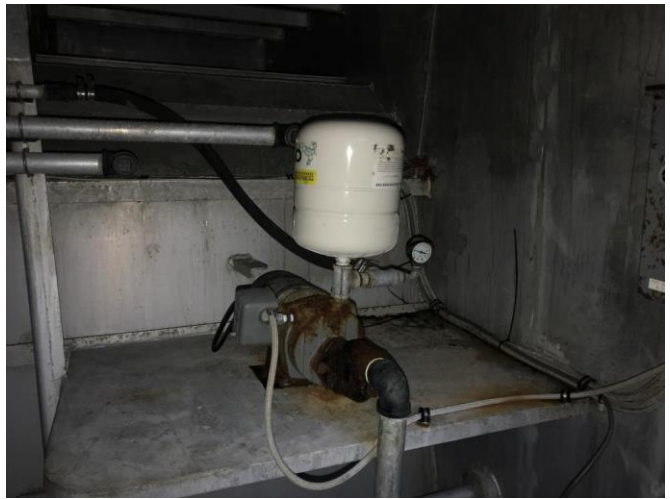
Photo # 56 – Comp. # 6P – Fresh water pressure set

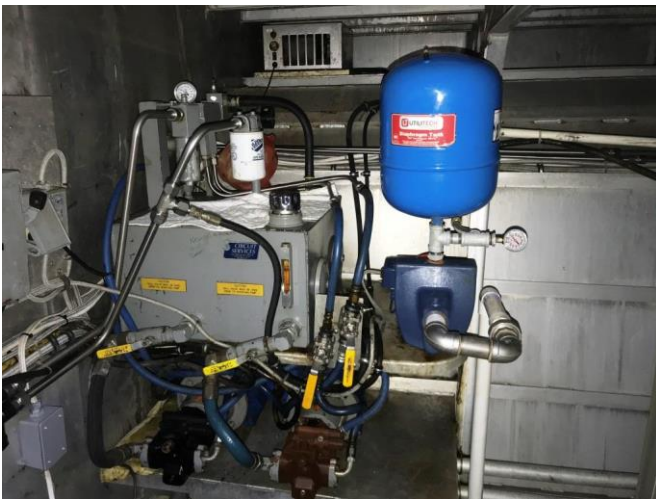
Photo # 57 – Comp. # 6S – Hydraulic steering system & Fresh water pressure set & de-humidifier in the background

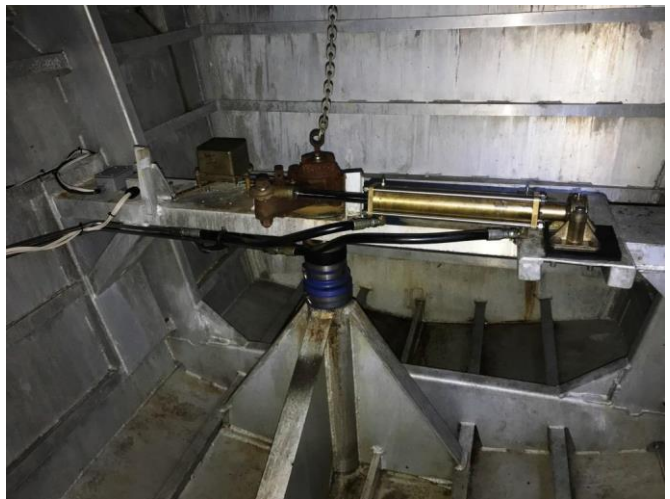
Photo # 58 – Comp. # 7P - Steering arrange. at port tiller-head

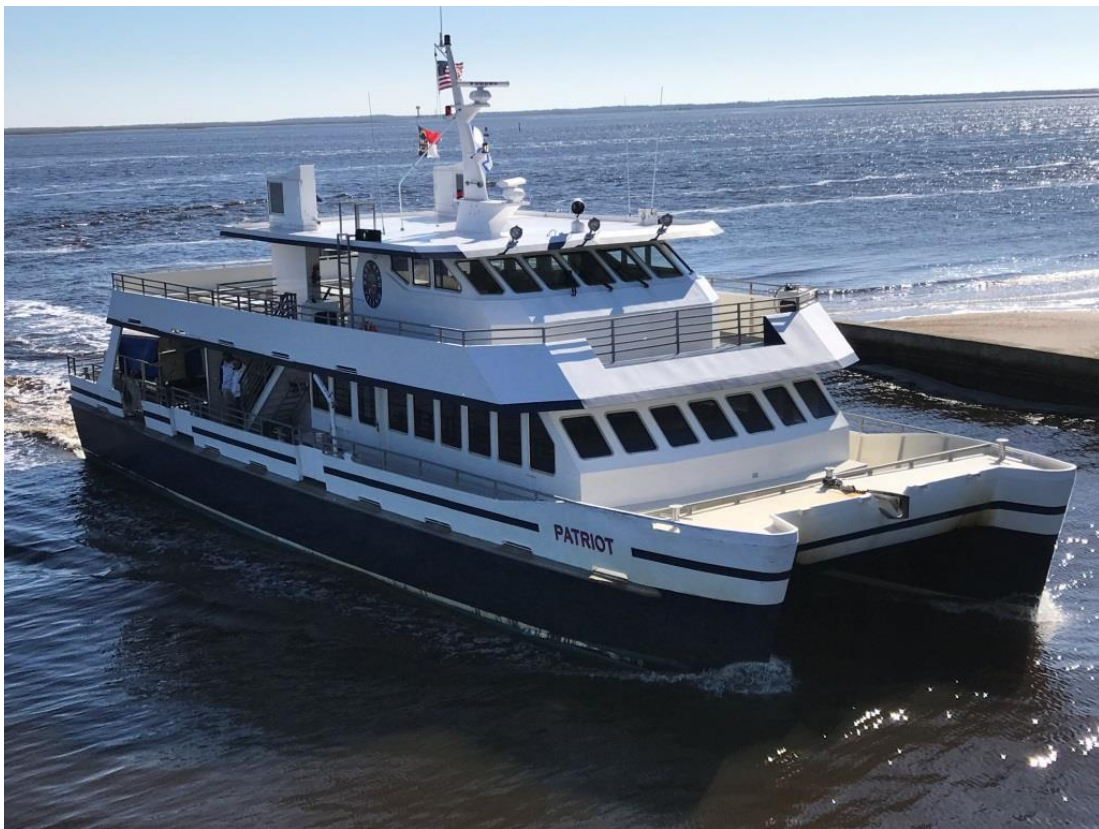
Photo # 61 – Vessel underway – Bow view

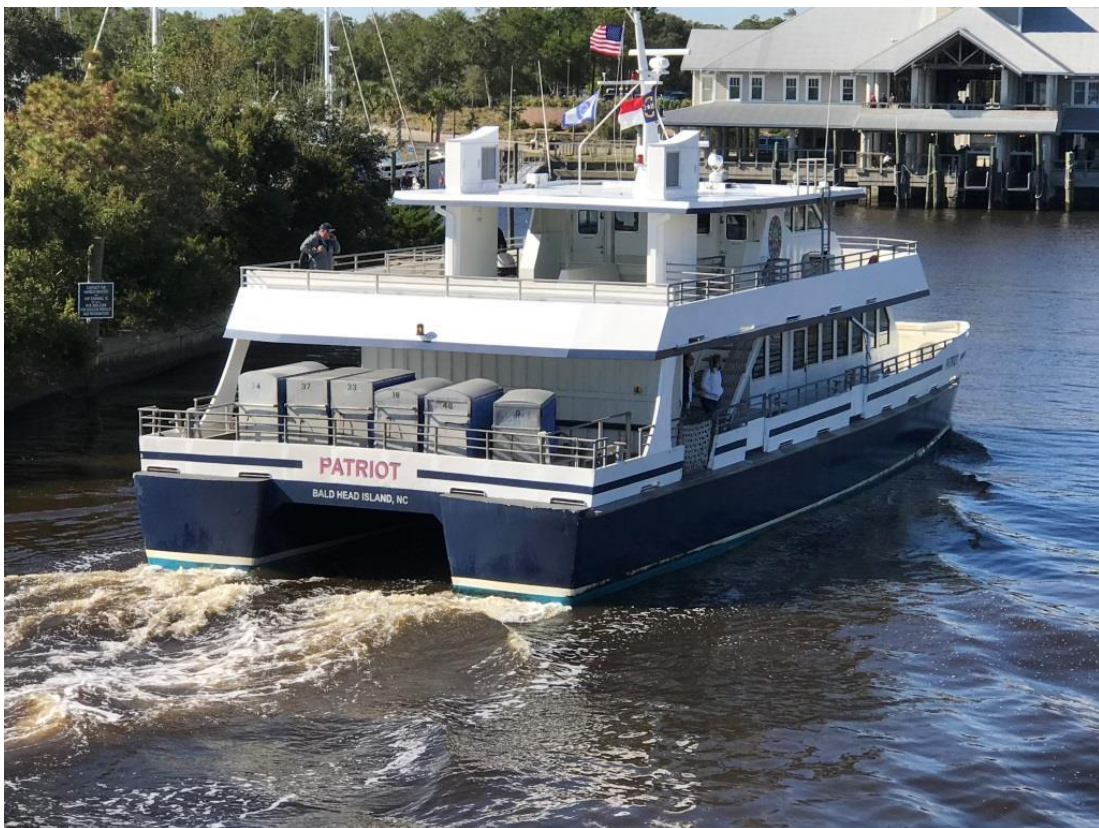
Photo # 62 – Vessel underway – stern view

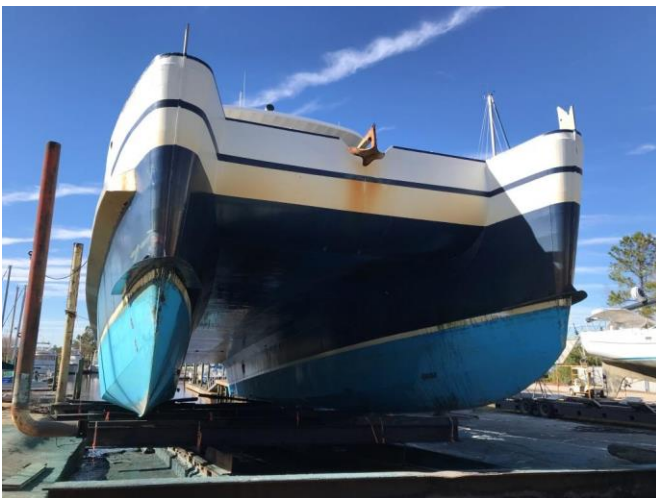
Photo # 1 – Bow View

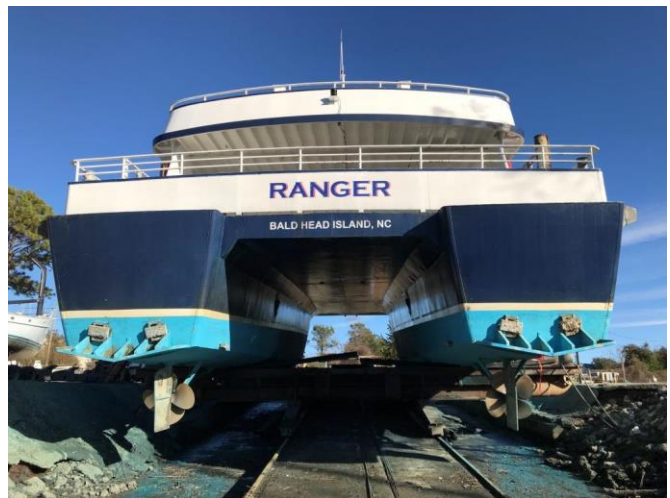
Photo # 2 – Stern View

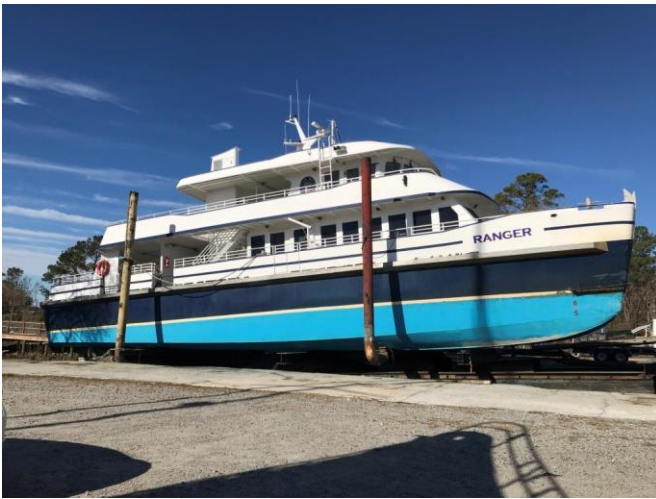
Photo # 3 – Starboard side elevation

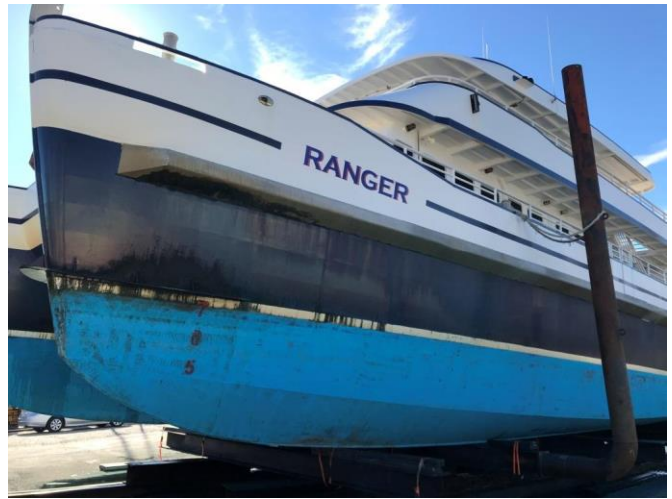
Photo # 4 – Port side elevation
