CONDITION & VALUATION SURVEY REPORT

**76 GRT / 61 NRT
Passenger Vessel**

ADVENTURE

November 26, 2018

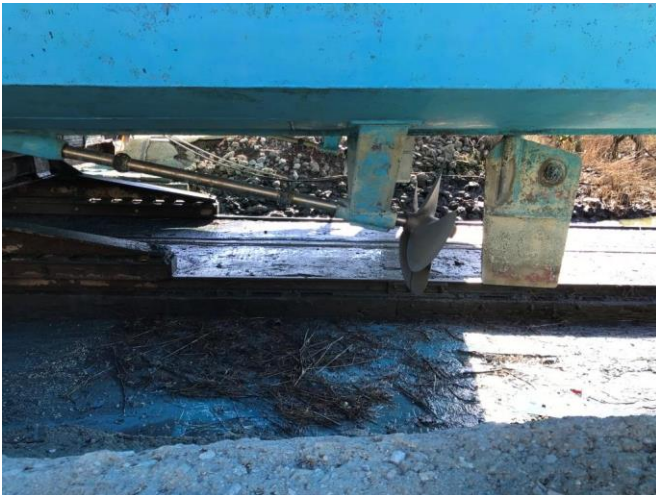
Photo # 5 – Port side tail shaft, prop, and rudder

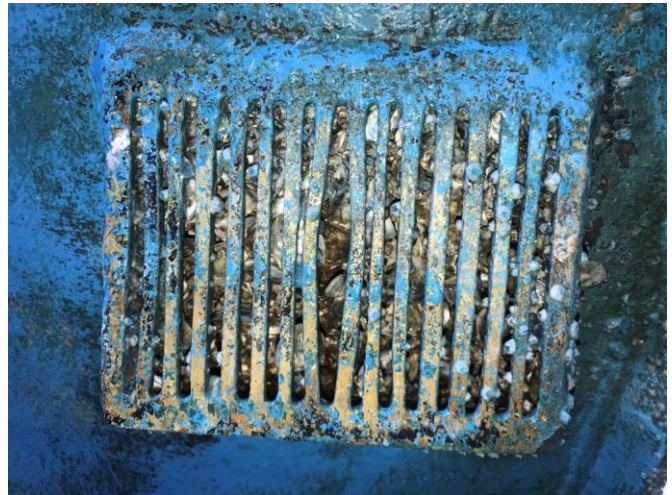
1. The starboard propeller was observed with distortion to the edges of four blades.
2. The P&S rudders visually appear to be at slightly different degrees.
3. The starboard hull bow wrap-around flat bar at the 7’ 8” waterline was damaged and torn.
4. The main engine exhausts appear to have reinforcing plates added to the exterior and interior of the hull.
5. The condition of the remaining sacrificial anodes was about 50% used. The anodes which were attached to the propeller shafts and rudders were in poor condition. Anodes were totally missing in serval other locations.
6. All of the sea chest grills and sea suction pipes were heavily fouled.
7. The underwater A/F coating was with deterioration.

Photo # 6 – Port side main engine sea chest heavy fouling

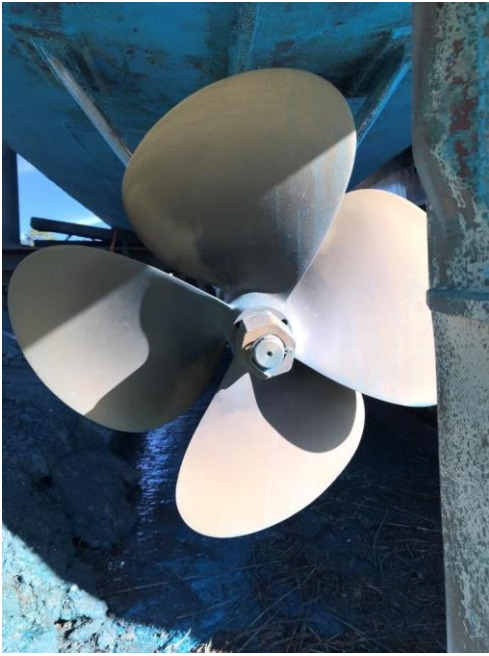
Photo # 7 – Port propeller

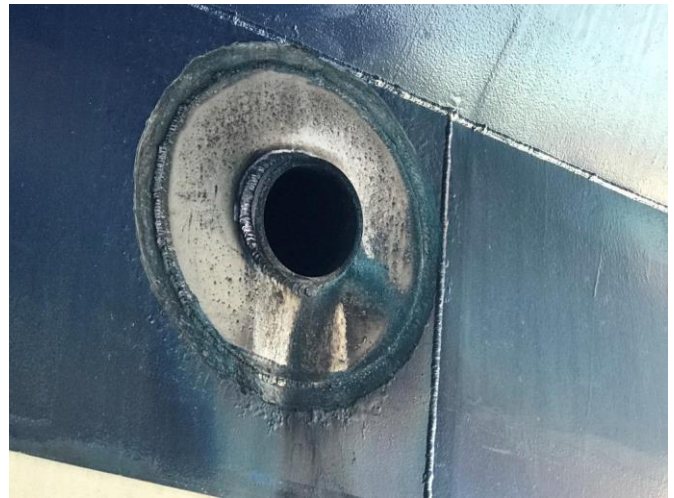
Photo # 10 – Starboard side main engine exhaust w/
reinforcement ring

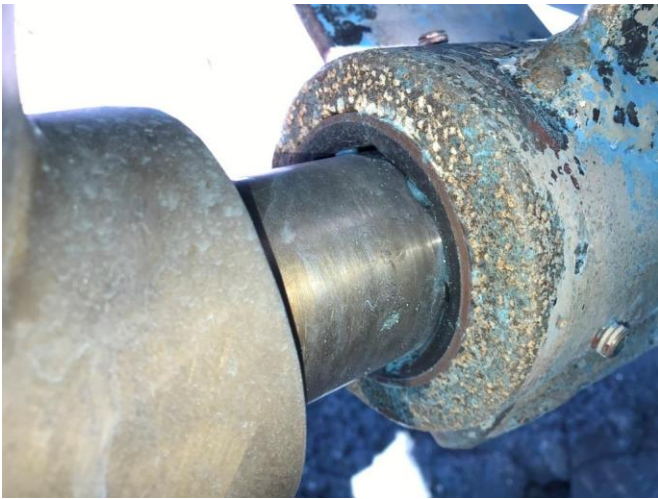
Photo # 11 – Typical condition of cutlass bearing at ‘V-strut’

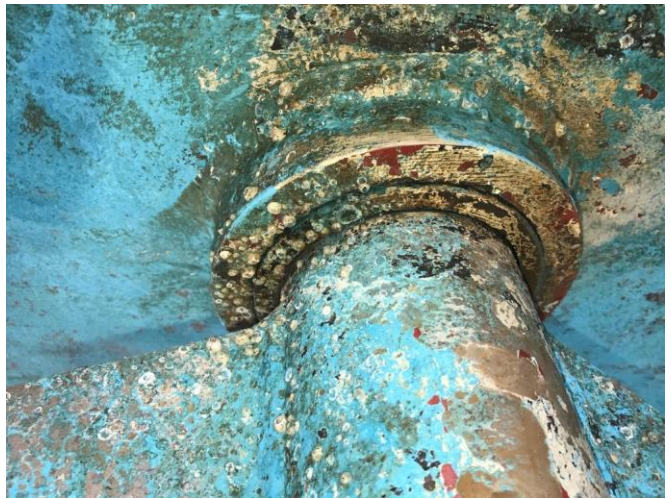
Photo # 12 – Typical condition of rudder bushing

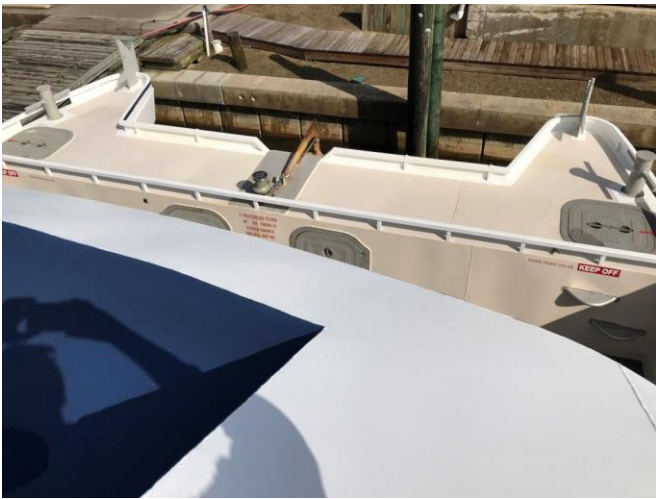
Photo # 15 – View of bow arrangement

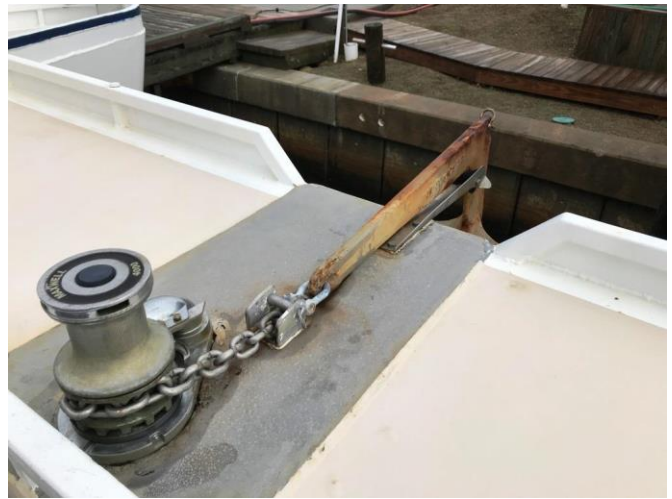
Photo # 16 – Bow anchor arrangement

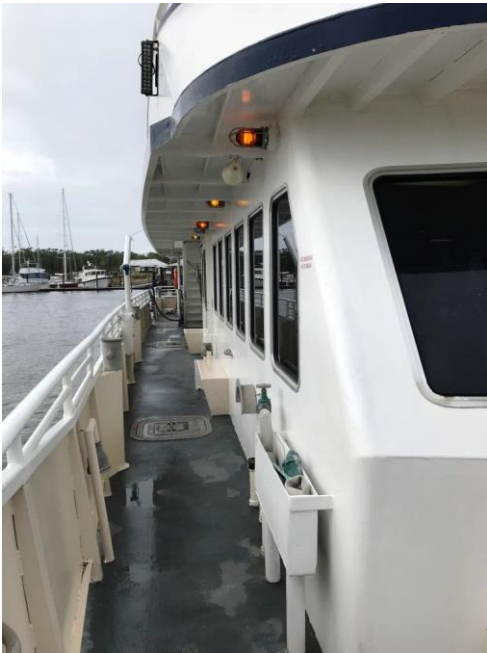
Photo # 17 – Starboard side main deck house

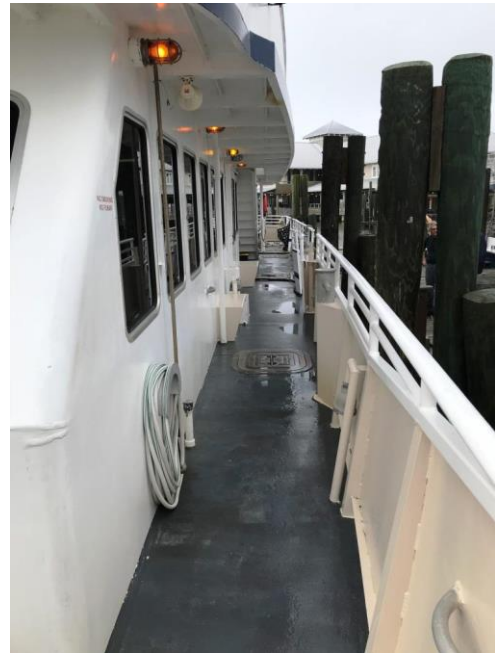
Photo # 18 – Port side main deck house

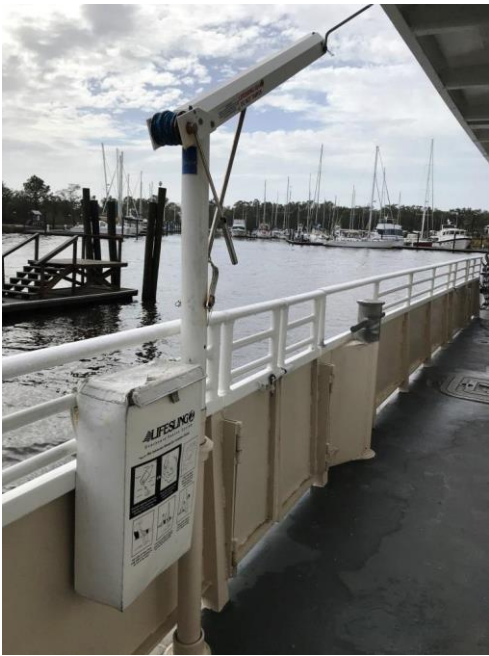
Photo # 19 – Man-over-board rescue gear

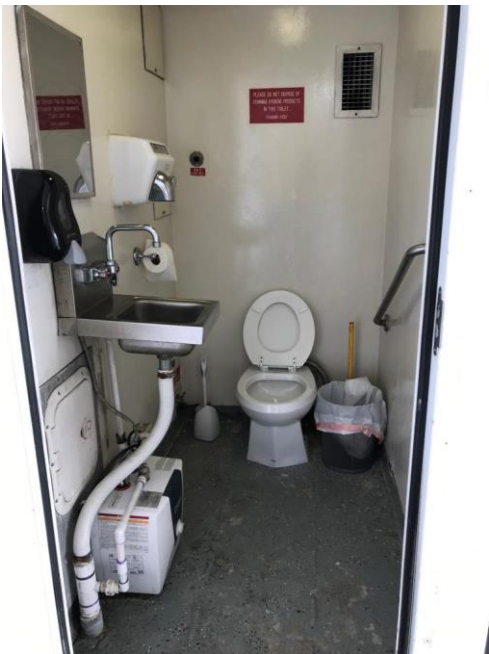
Photo # 21 – Typical restroom

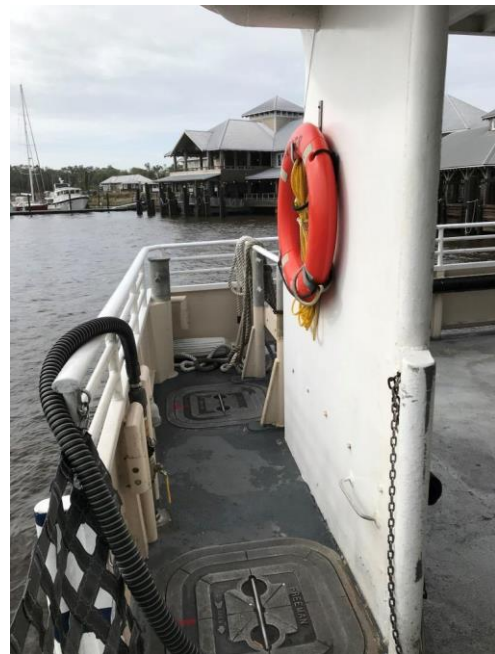
Photo # 22 – Sewage pump-out station

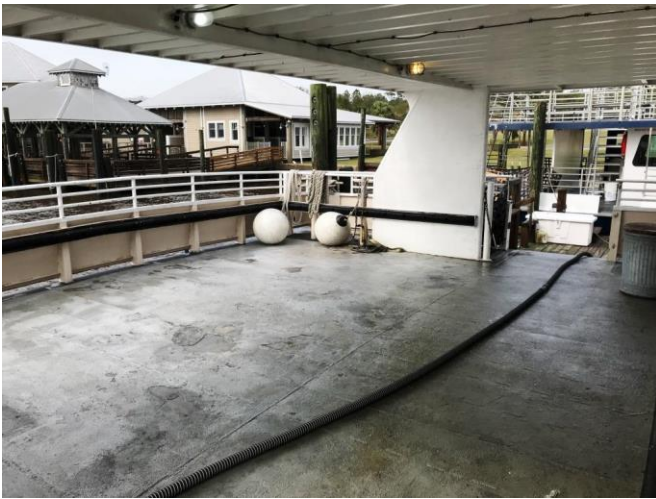
Photo # 23- Aft main deck 'Dollie' storage area looking port

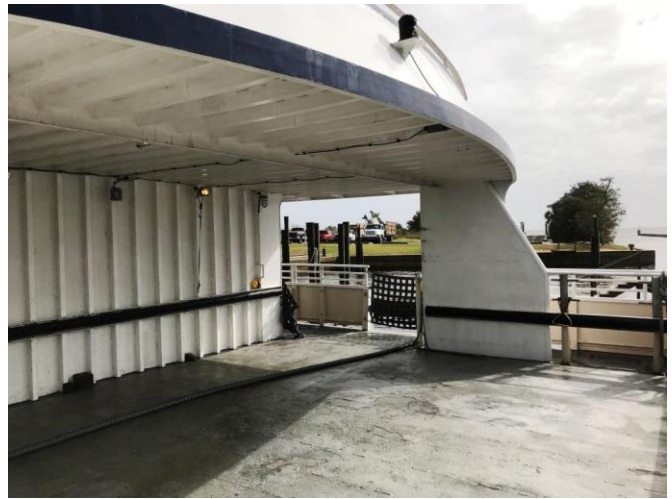
Photo # 24 – Aft main deck 'Dollie' storage area looking stbd.

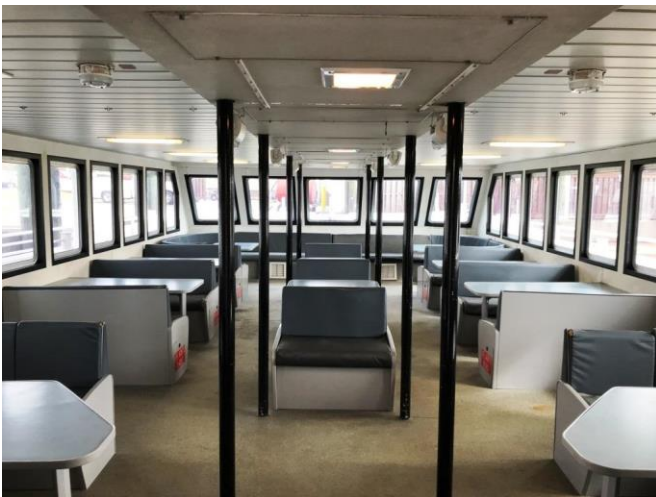
Photo # 25 – Passenger deck house – looking forward

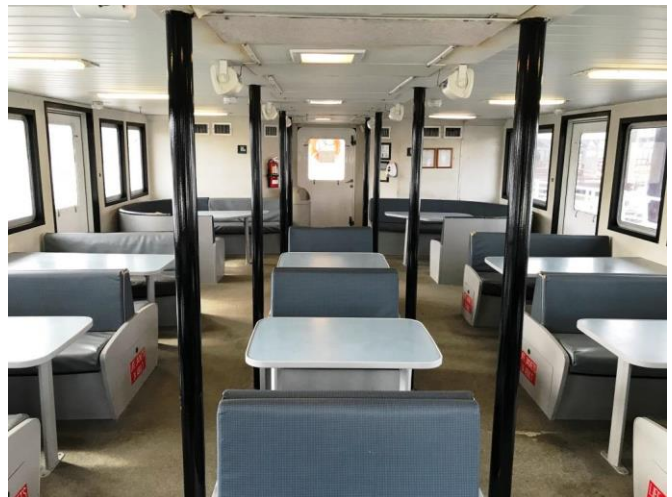
Photo # 26 – Passenger deck house – looking aft

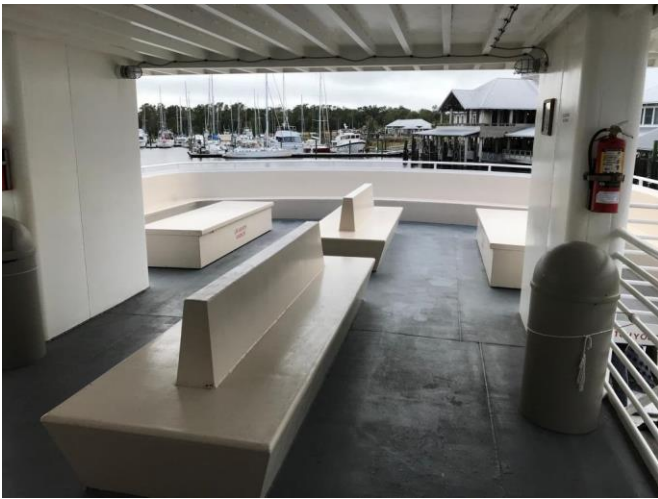
Photo # 29 – Bridge deck seating area – looking aft

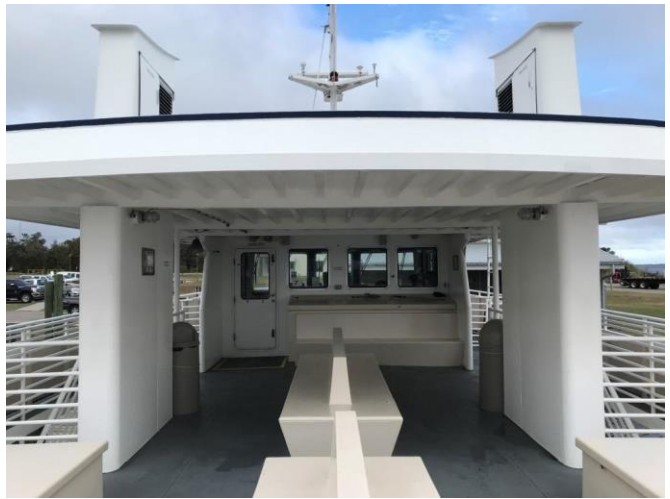
Photo # 30 – Bridge deck – looking forward

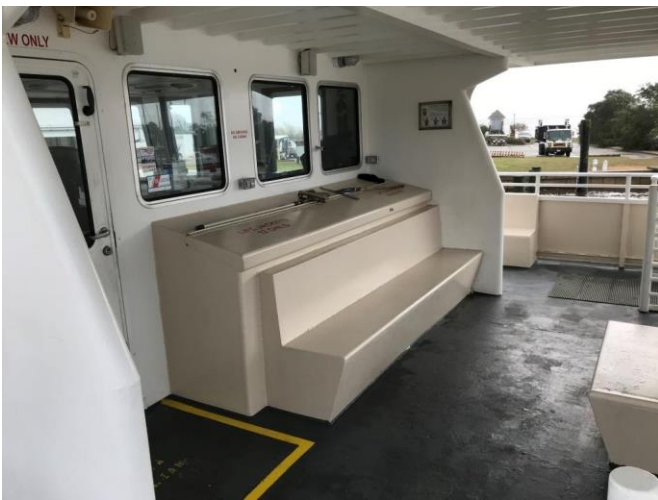
Photo # 31 – Aft bulkhead of pilot house

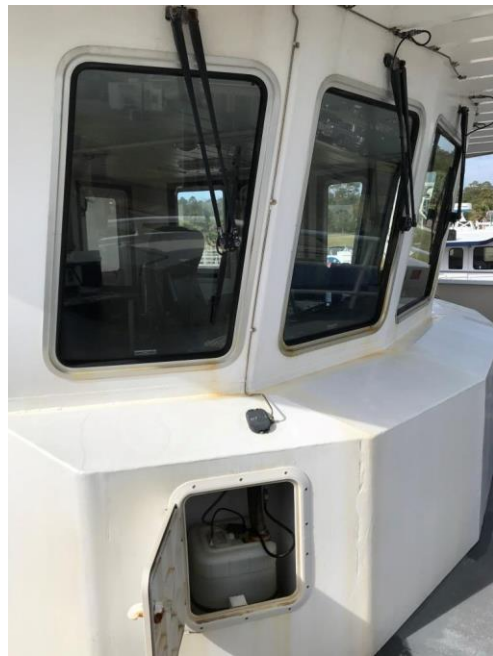
Photo # 32 – Forward bulkhead of pilot house with windshield wipers and wash system

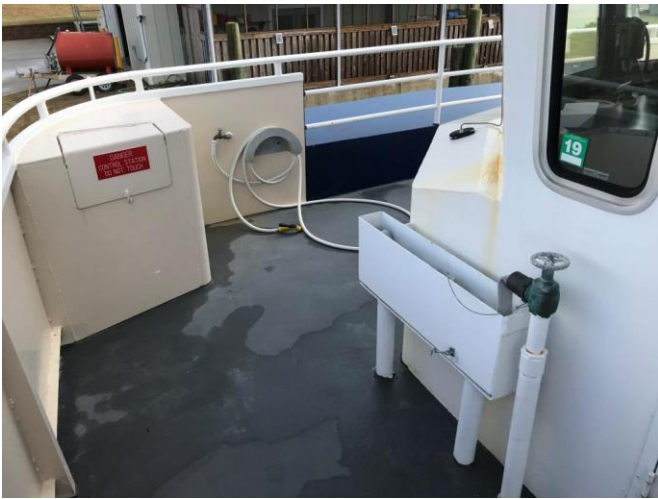
Photo # 33 – Port side bridge deck with wing station and bridge deck fire station

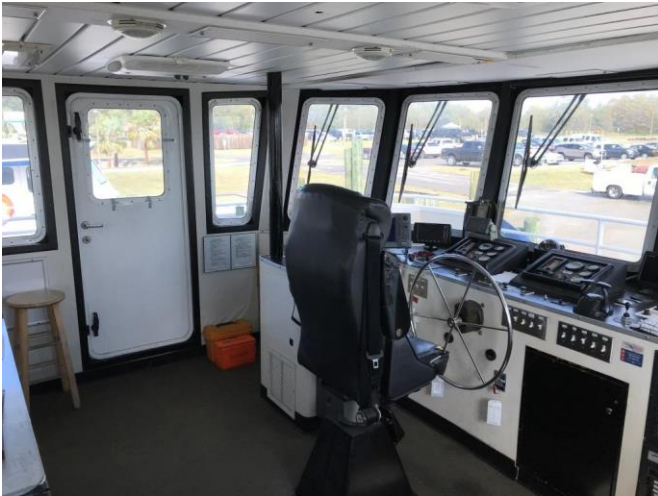
Photo # 35 – Interior pilot house – looking to port

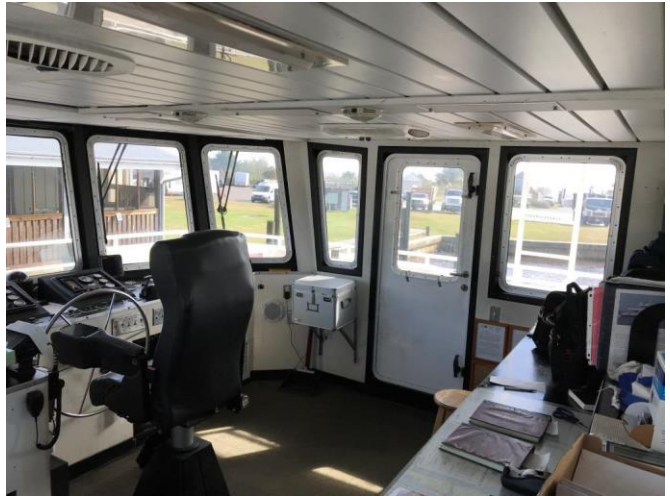
Photo # 36 – Interior pilot house – looking to starboard

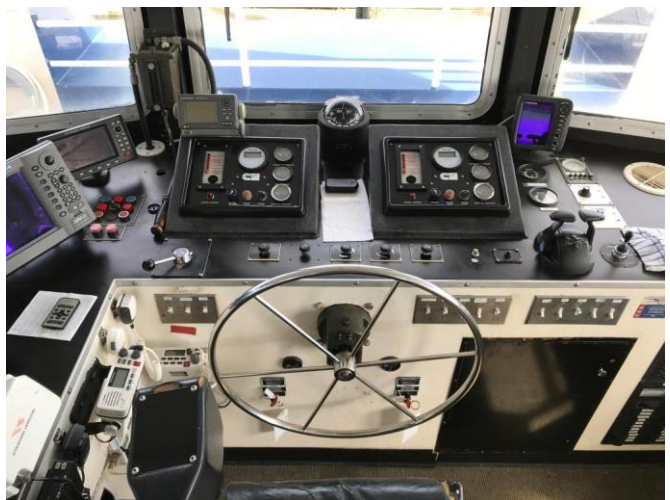
Photo # 38 – Helm and control console

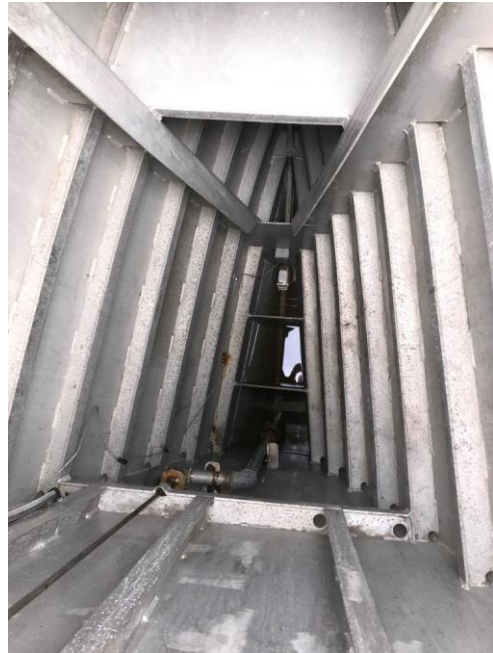
Photo # 40 – Starboard fore peak compartment

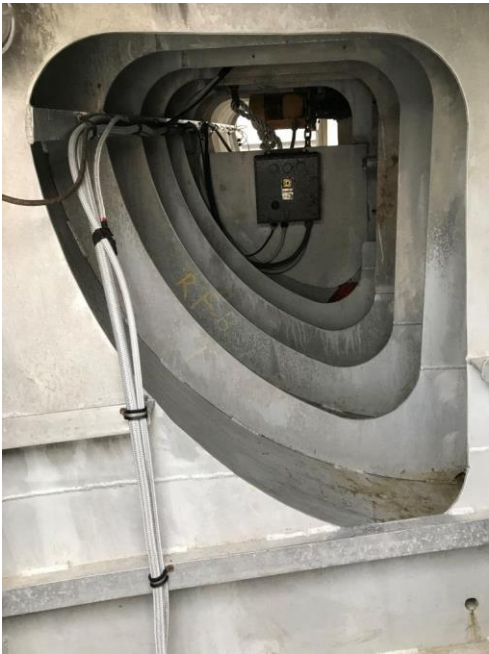
Photo # 41 – View across forepeak to chain locker and underside of anchor windlass equipment

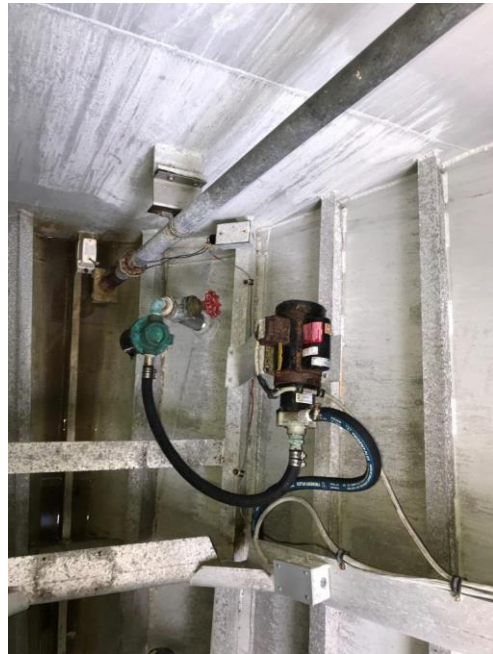
Photo # 42 – Comp. # 2 – Cooling pump sea chest & pump for fwd. HVAC, bilge suction, and level alarm

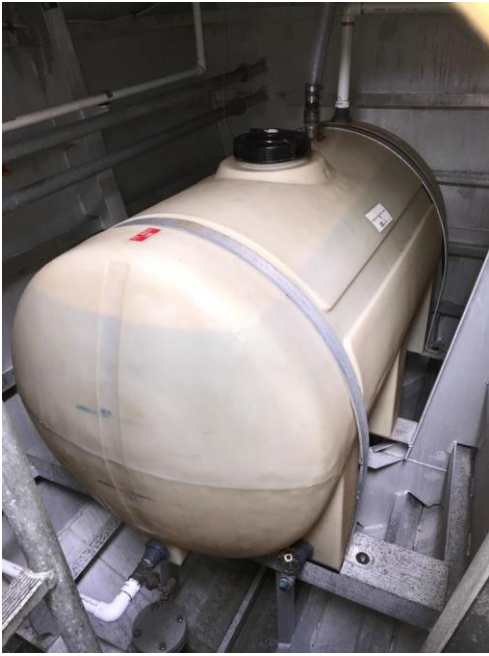
Photo # 43 – Comp. # 3 – 300-gallon fresh water tank

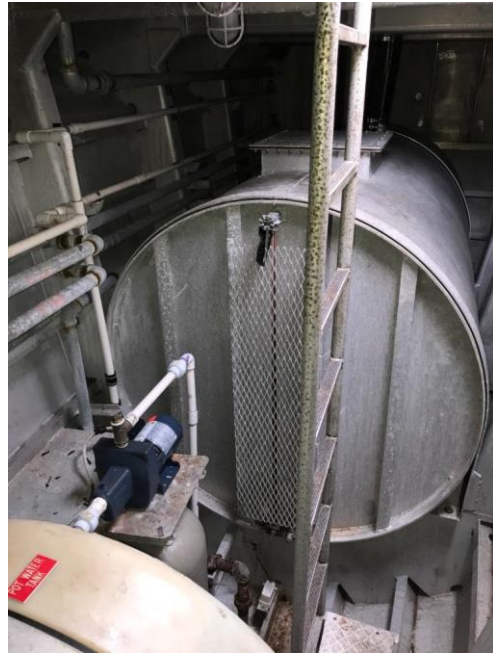
Photo # 44 – Comp. # 3 - Main fuel oil storage tank

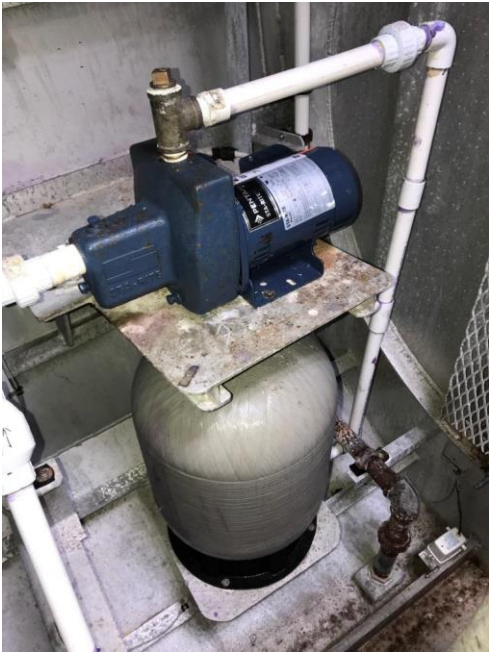
Photo # 45 – Comp. # 3 – 8.5-gallon fresh water pressure set

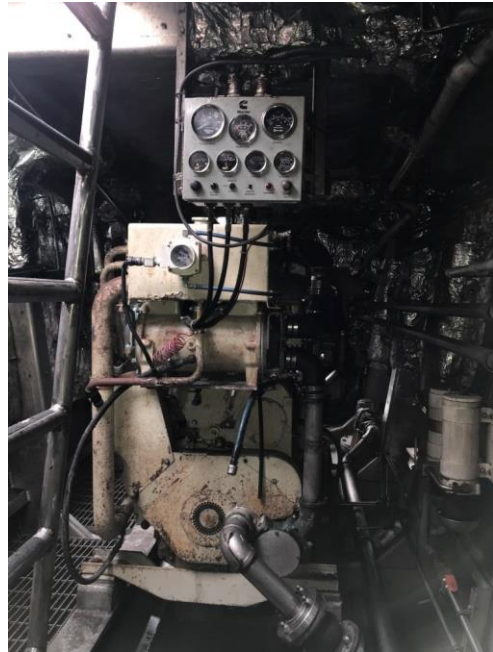
Photo # 46 – Comp. # 4 – 700 HP Main engine

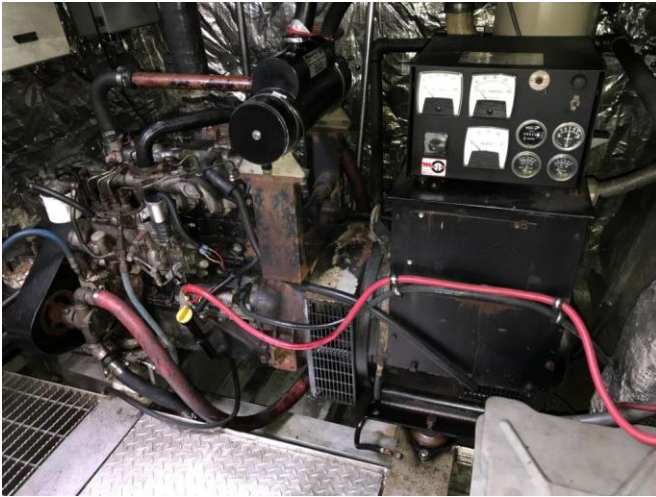
Photo # 47 – Comp. # 4 – 40 kW Generator Set

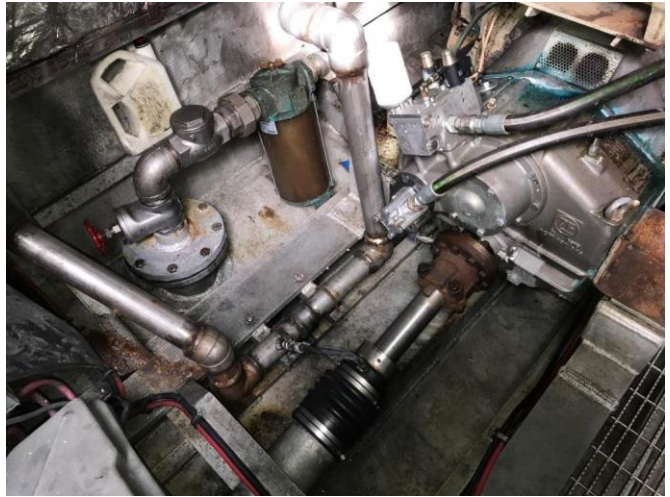
Photo # 48 – Comp. # 4 – Tail shaft and sea chest

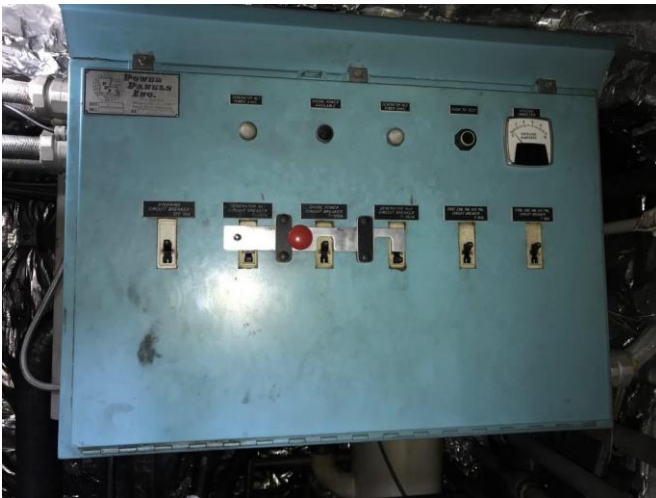
Photo # 49 – Comp. # 4 – Main switchboard – (P)

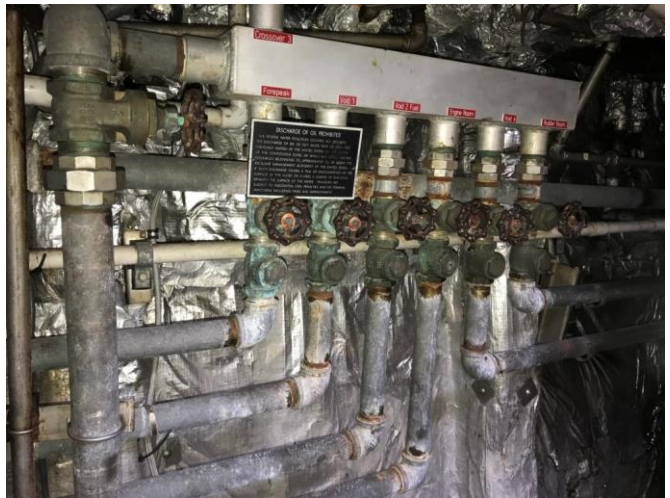
Photo # 50 – Comp. # 4 – Bilge manifold

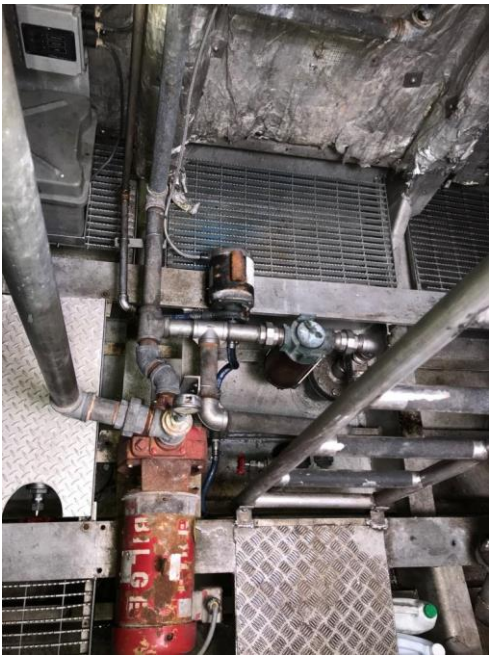
Photo # 51 – Comp. # 4 – 7.5 HP min fire pump

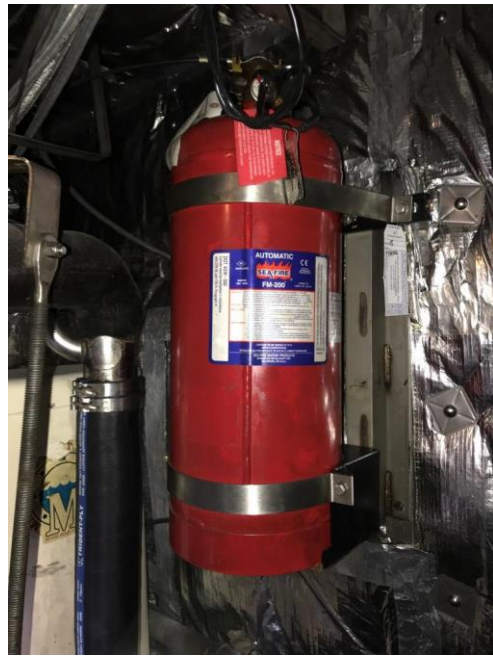
Photo # 52 – Comp. # 4 – Fixed fire system

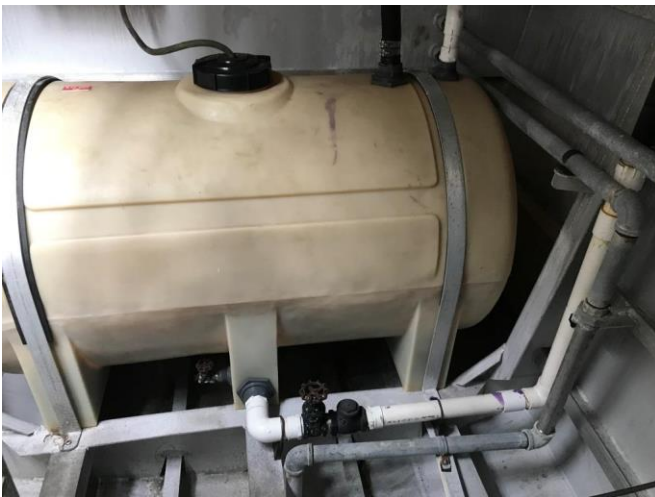
Photo # 53 – Comp. # 5 – 300-gallon sewage holding tank

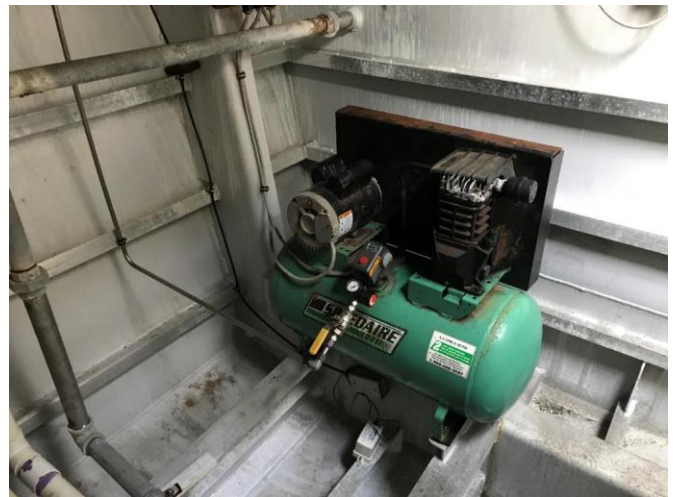
Photo # 54 – Comp. # 5 – Air compressor

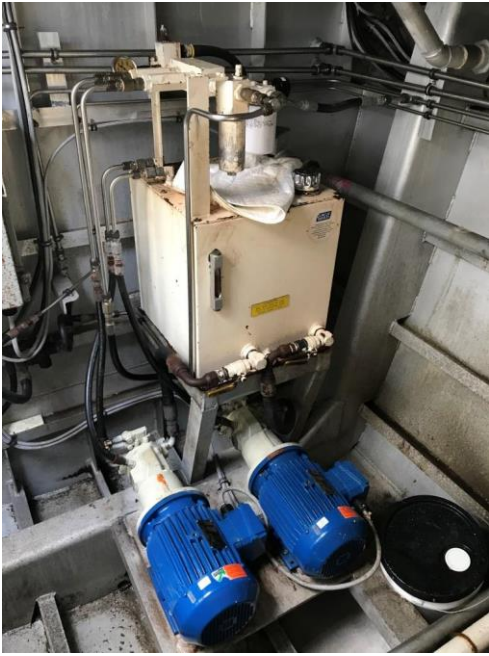
Photo # 55 – Comp. # 5 – Hydraulic steering system

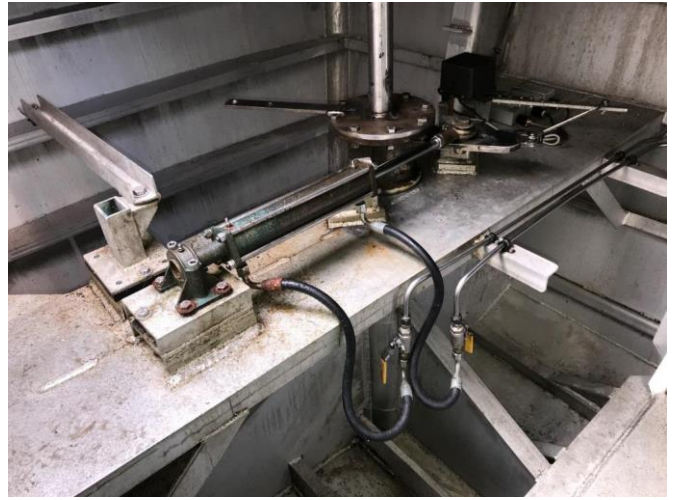
Photo # 56 – Comp. # 6 - Steering arrange. at port tiller-head

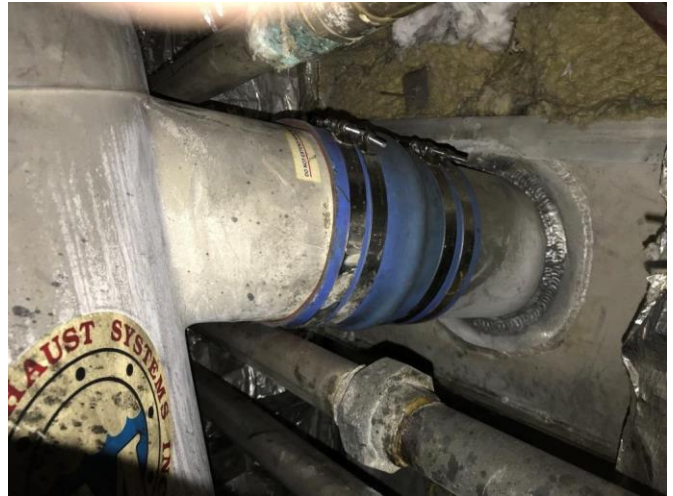
Photo # 58 – Comp. # 4 – Main engine thru-hull exhaust w/
new welding at hull

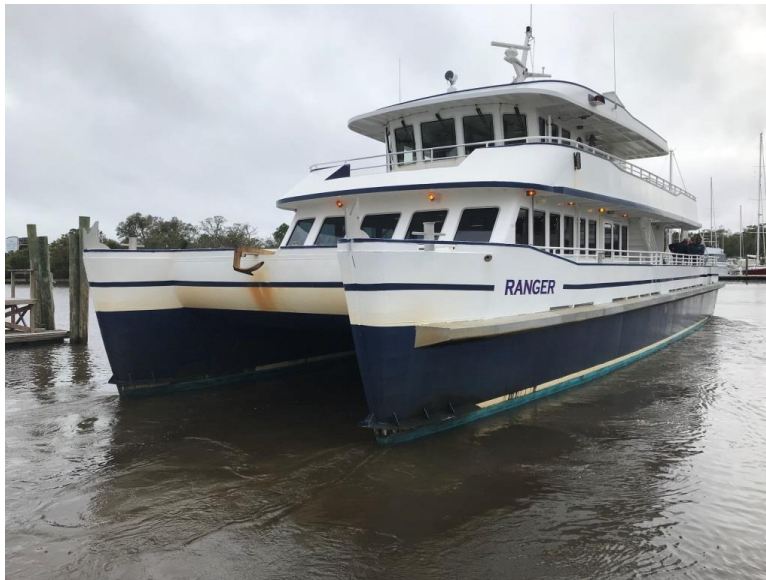
Photo # 59 – Vessel underway – Bow view

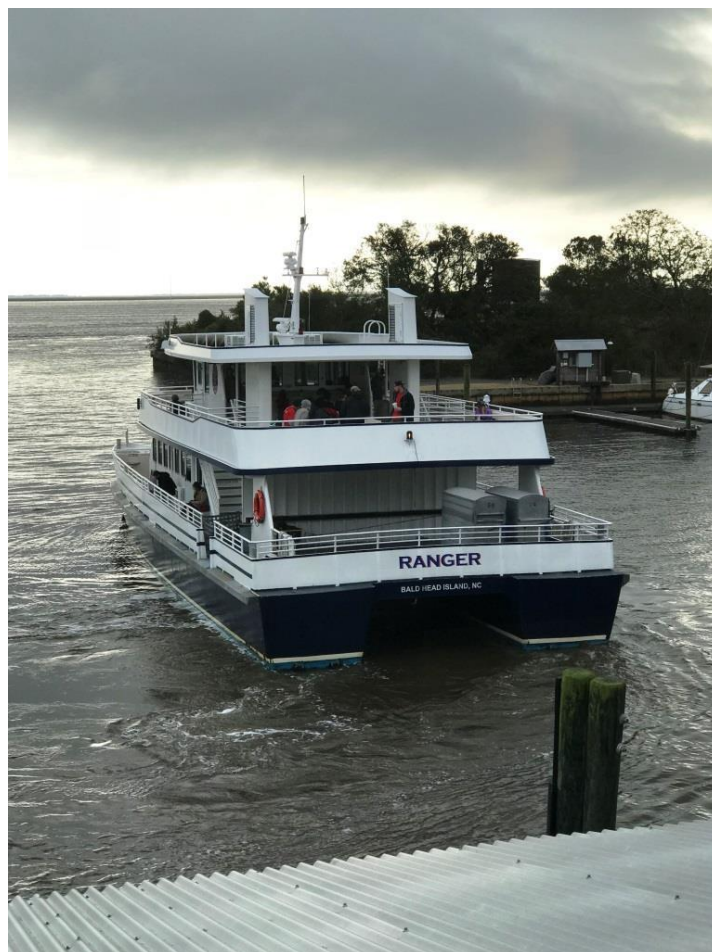
Photo # 60 – Vessel underway – stern view

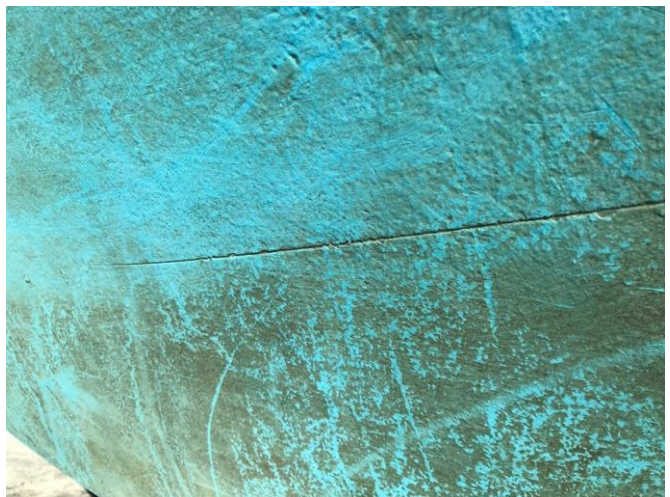
1. A deep scrape in the paint coatings and apparent scrape into the bottom hull plate was observed along the port bow approximately 3 feet above the line of the keel and about 8 feet long, in way of the Fore Peak and adjacent Void Compartments.
2. Various areas of paint coating failures on the underwater hull.
3. Heavy marine growth and fouling on the intake for the main engine sea-chest and other sea-chests.
4. Marine growth on the prop-shafts and significant deterioration of the shaft anodes.
5. Fish line entanglement on the starboard shaft at the stern tube bearing.
6. Looseness in the rudder linkage as noticed by hand moving the rudders.
7. A very slight 'ding' in the tip of the starboard propeller blades.
8. 'Pitting' on the port side rudder shaft and the inboard side of the rudder blade w/ deterioration of the rudder anodes.

Photo # 2 – Bow hull (port side) with scrape indentation

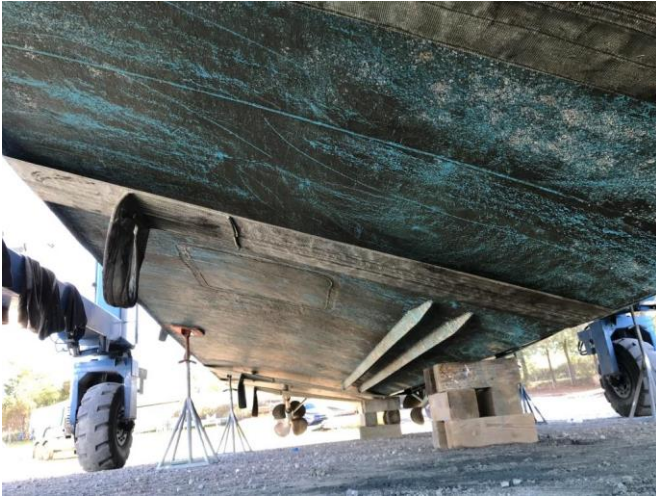
Photo # 3 – Starboard side bottom hull looking aft

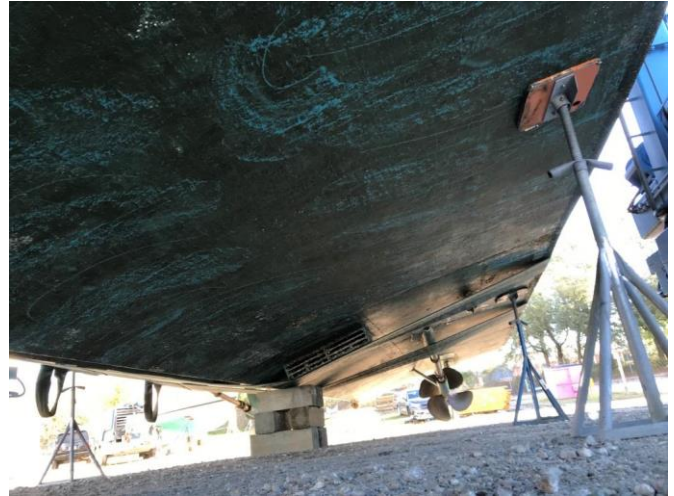
Photo # 4 – Port side bottom hull looking aft

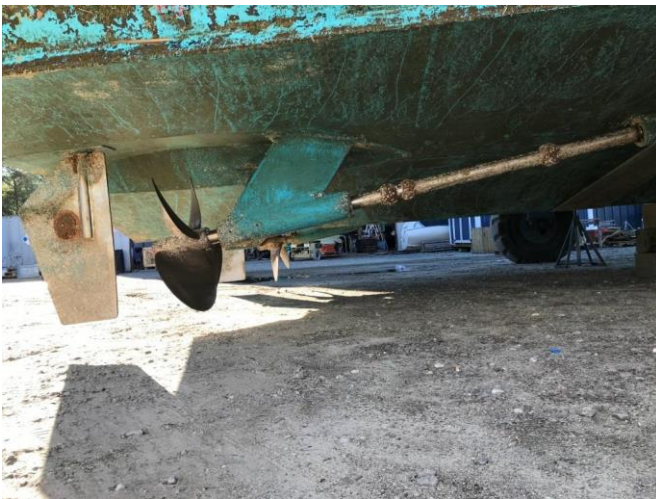
Photo # 5 – Starboard tail shaft, prop, and rudder

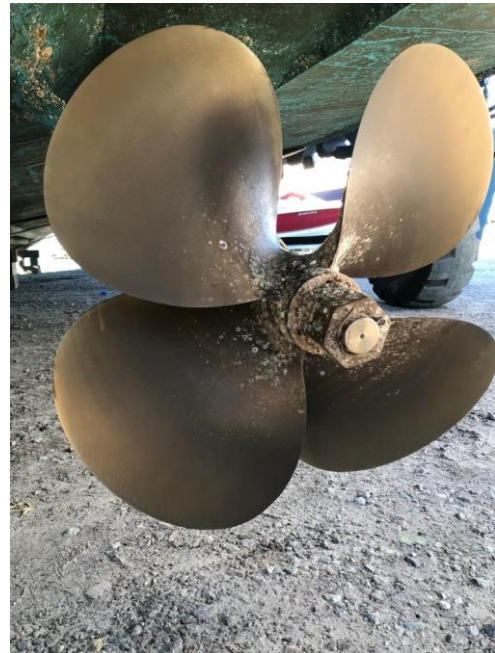
Photo # 6 – Starboard Propeller

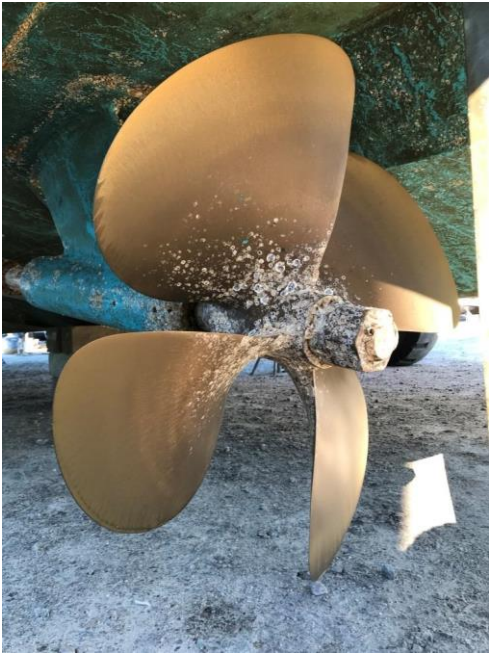
Photo # 7 – Port propeller

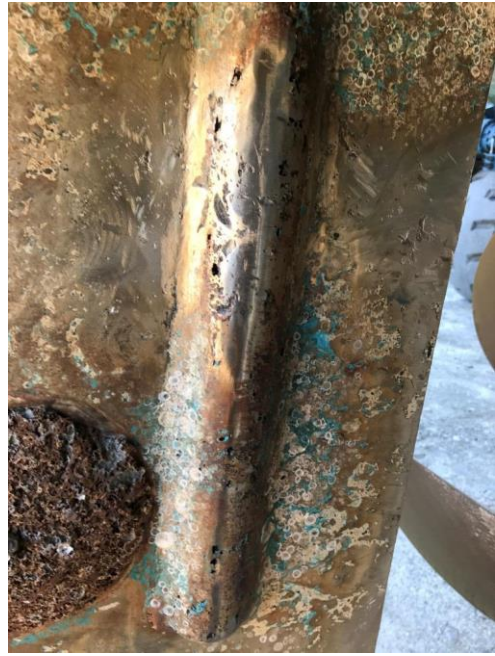
Photo # 8 – Port side rudder with 'pitting'

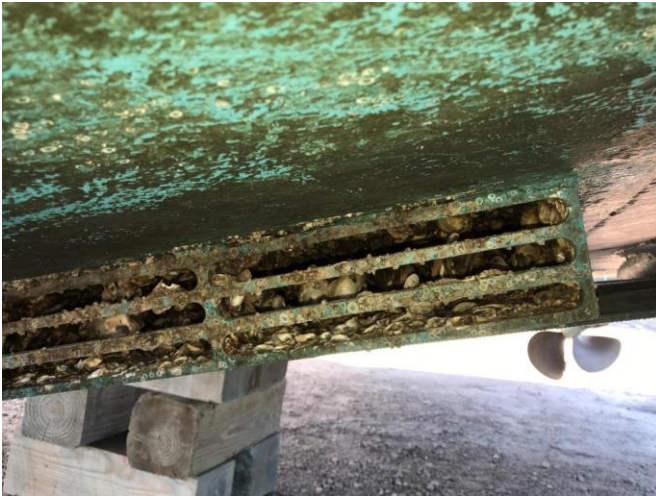
Photo # 9 – Main sea chest intake screen with heavy fouling

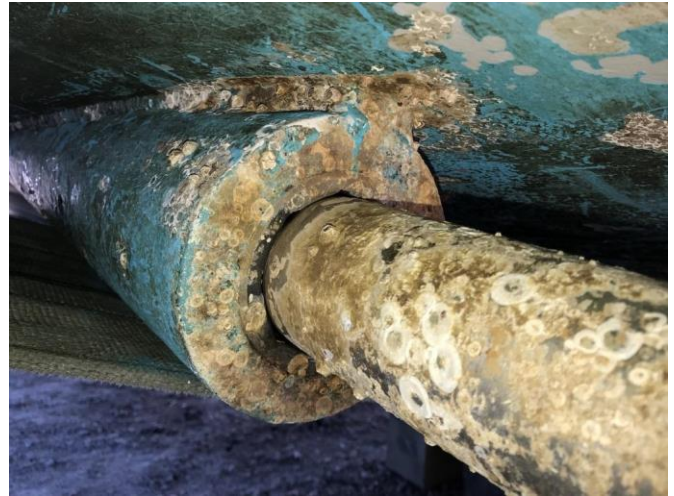
Photo # 10 – Port side tail shaft at stern tube

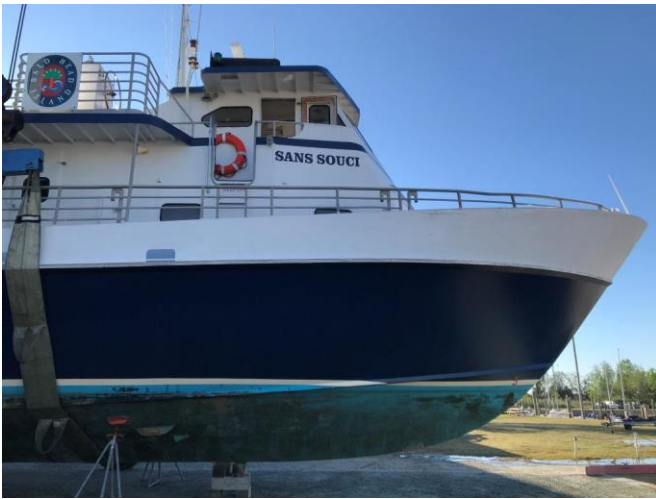
Photo # 11 – Starboard bow profile

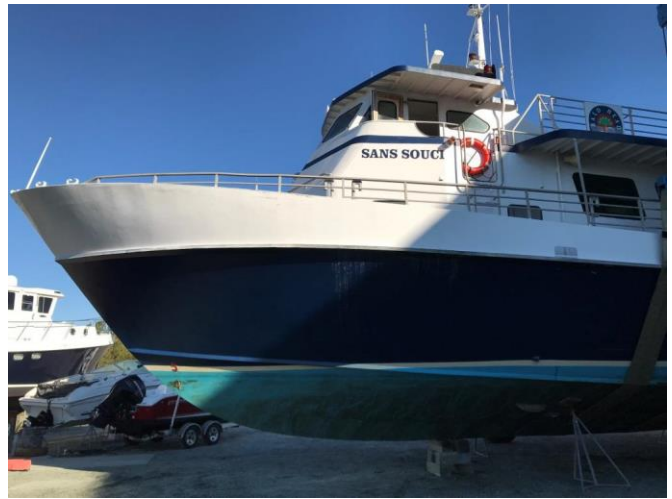
Photo # 12 – Port bow profile

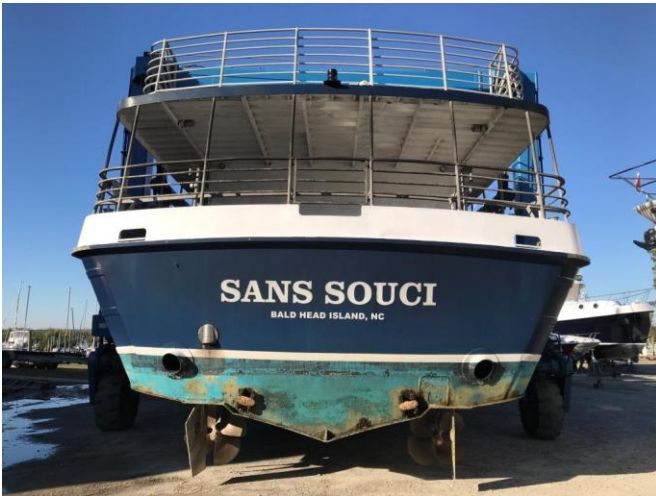
Photo # 13 – Stern View

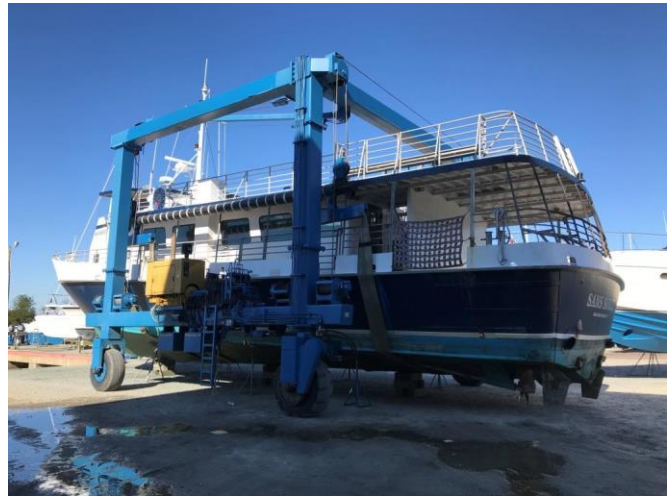
Photo # 14 – Port side elevation view

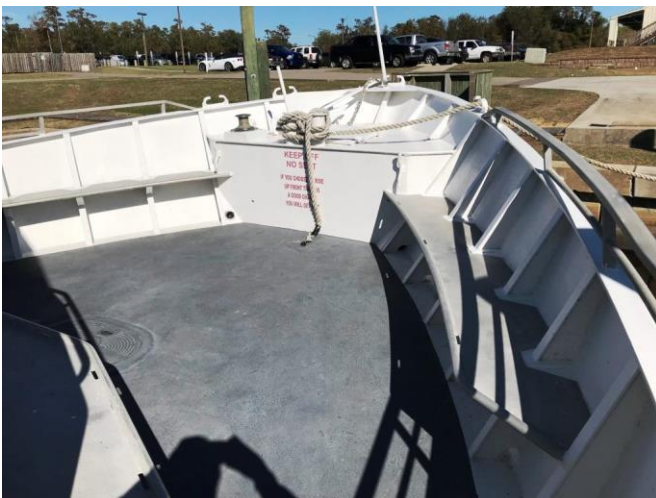
Photo # 15 – Bow Deck

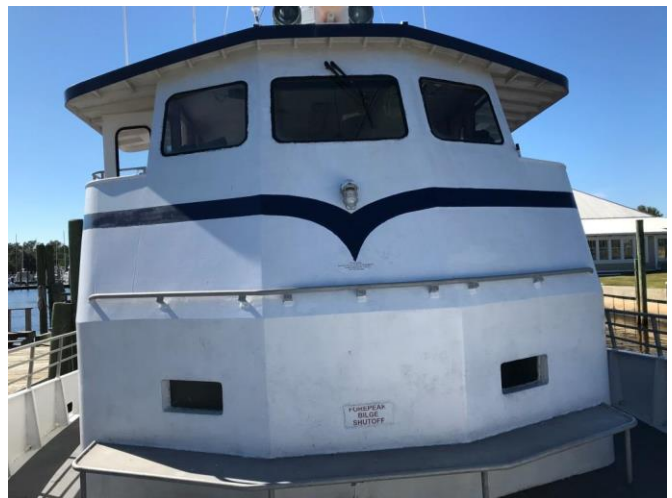
Photo # 16 – Deck house forward bulkhead

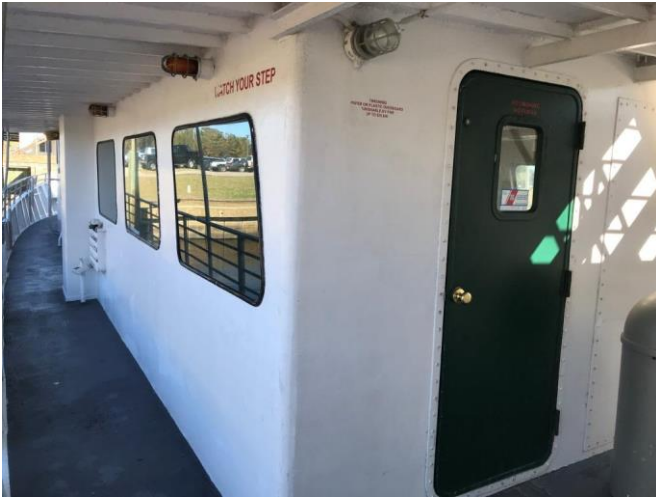
Photo # 17 – Port side deck house looking forward

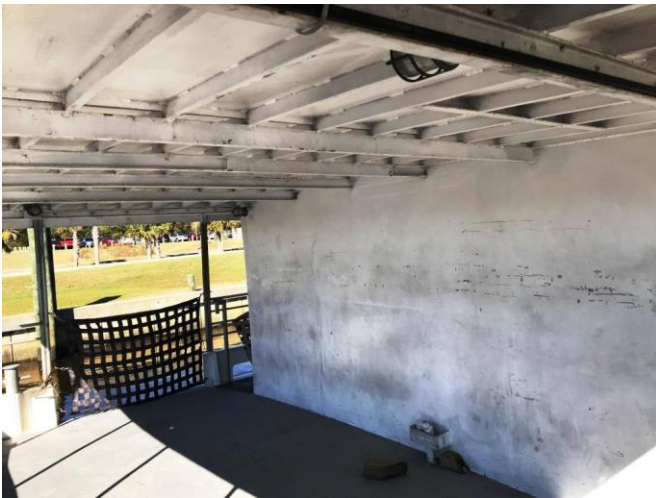
Photo # 19 – Aft deck looking to port

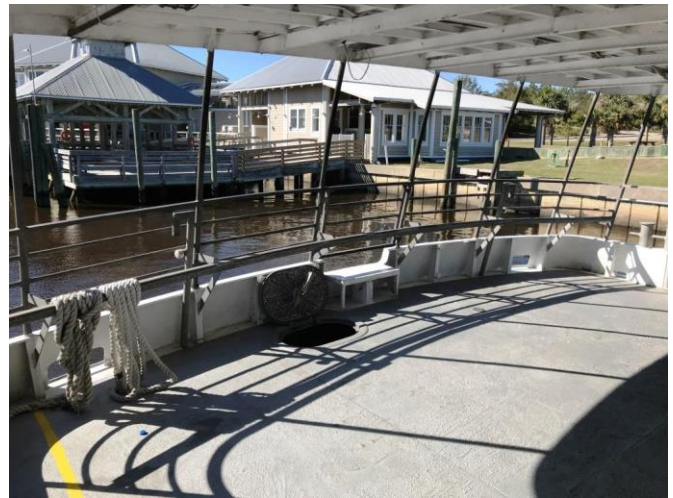
Photo # 20 – Aft deck

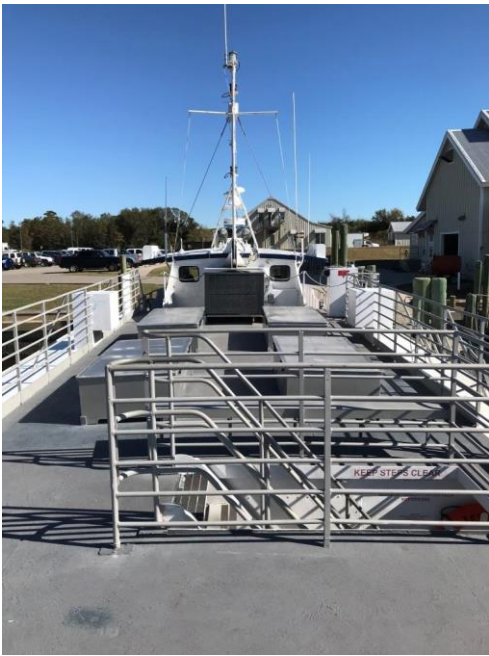
Photo # 21 – Bridge deck looking forward

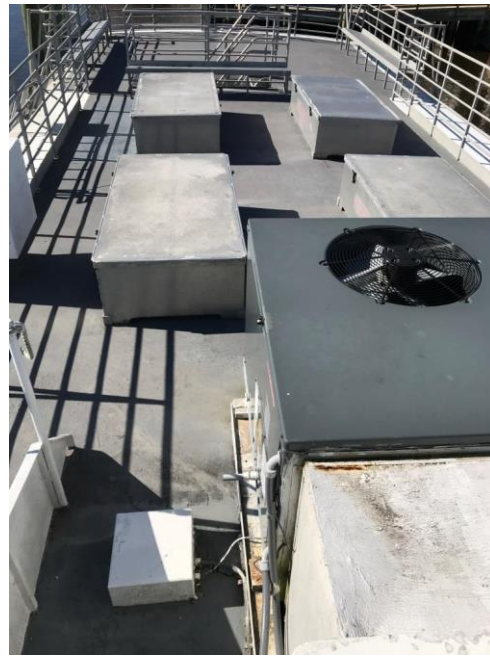
Photo # 22 – Bridge deck looking aft w/ life jacket boxes
