CONDITION & VALUATION SURVEY REPORT

**76 GRT / 61 NRT
Passenger Vessel**

ADVENTURE

November 26, 2018

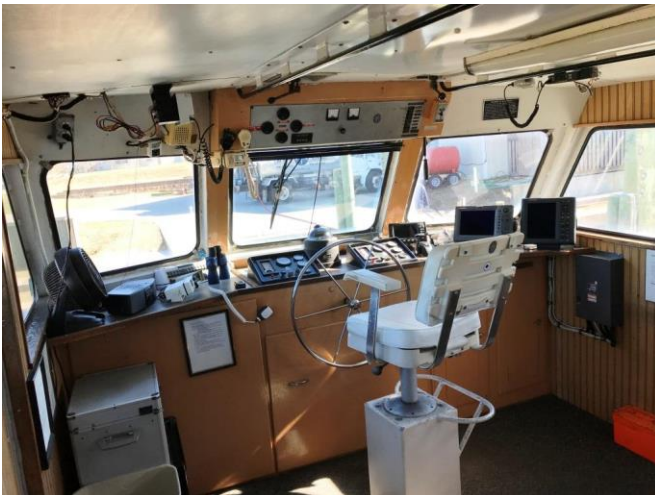
Photo # 23- Pilot house – forward view

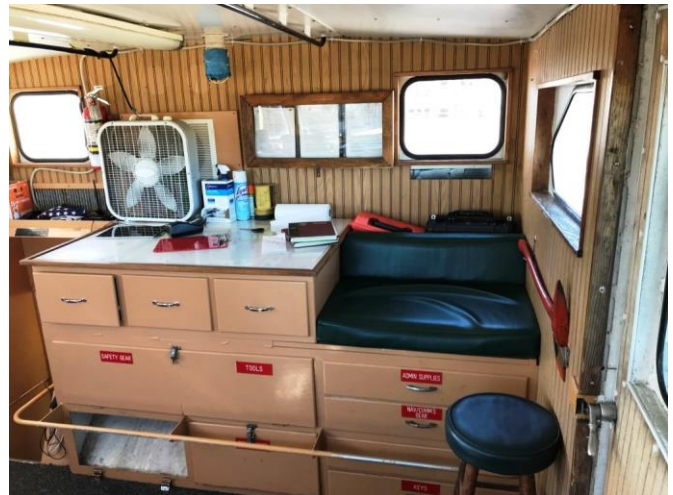
Photo # 24 – Pilot house chart table – aft view

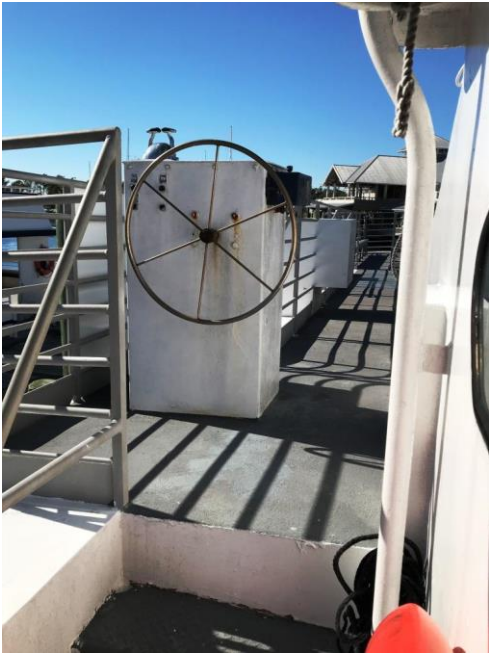
Photo # 25 – Aft steering station

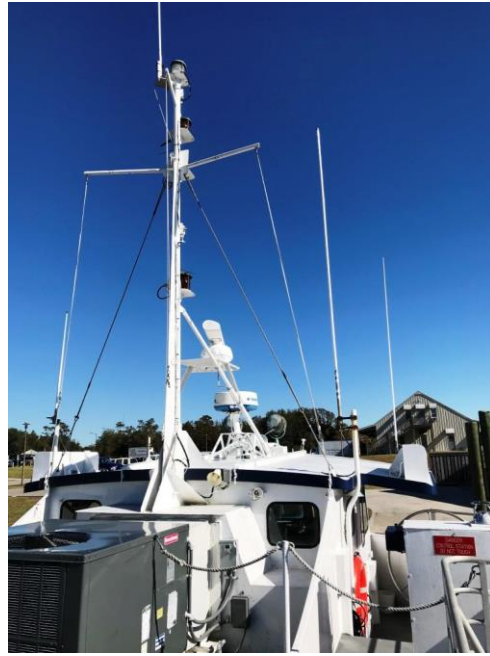
Photo # 26 – Pilot house roof and main mast

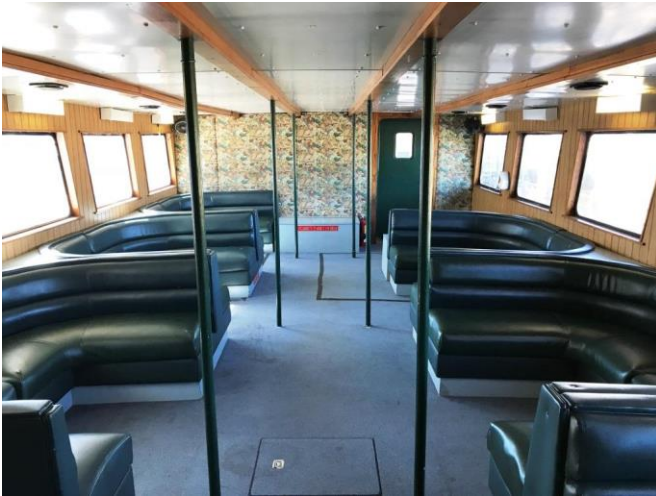
Photo # 27 – Main deck house – looking aft

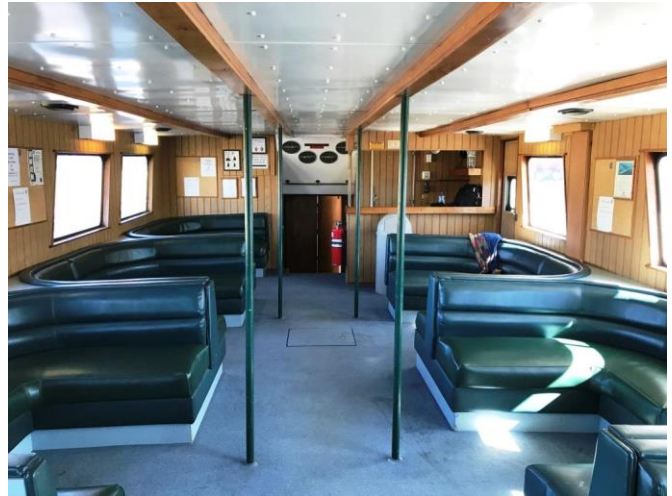
Photo # 28 – Main deck house – looking forward

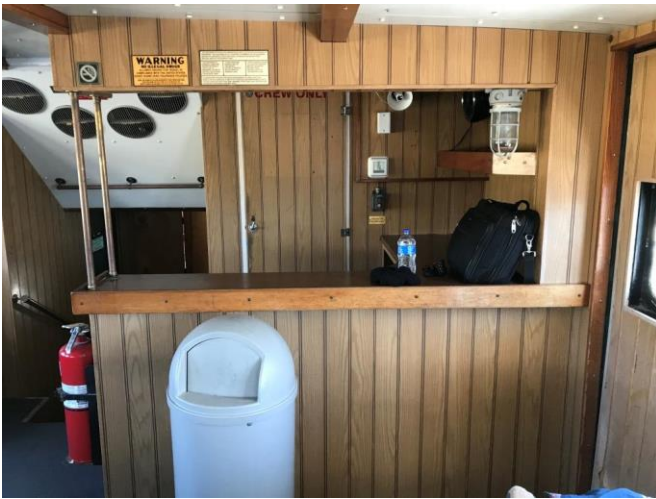
Photo # 29 – Main deck house – service counter

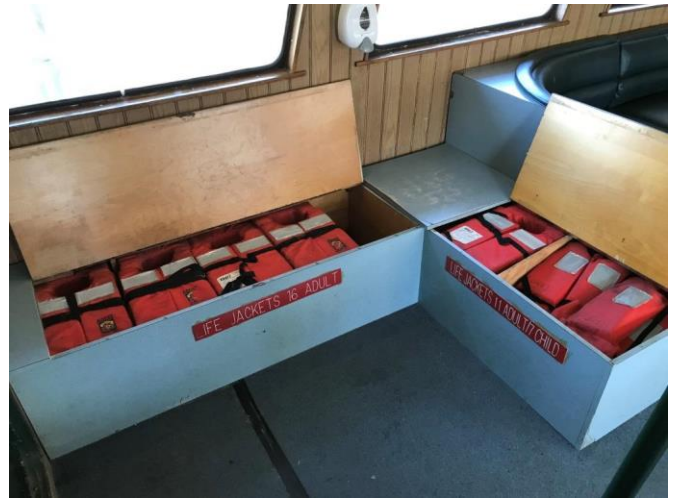
Photo # 30 – Main deck house – life jacket stowage

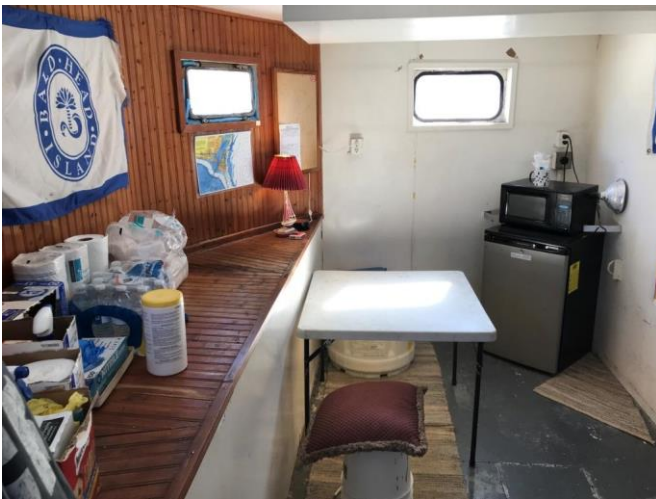
Photo # 31 – Forward crew lounge

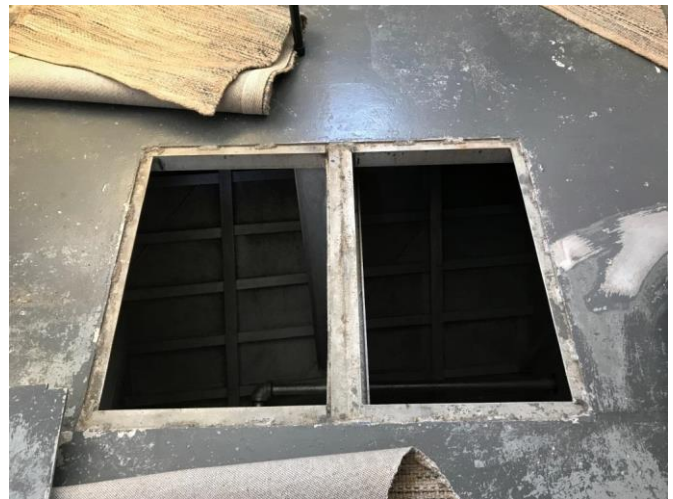
Photo # 32 – Access to hull compartment # 2

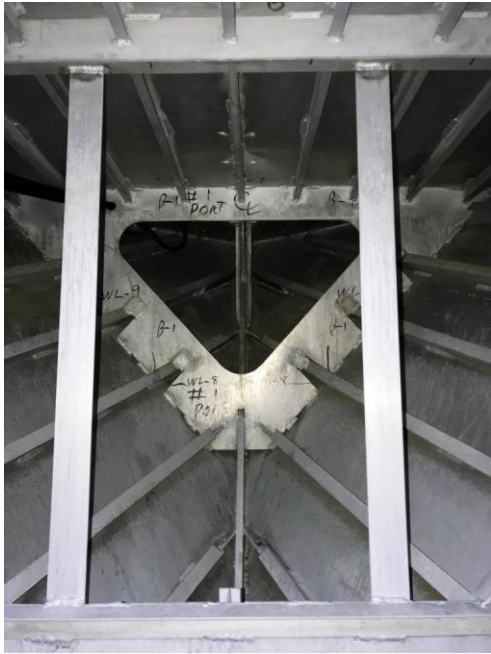
Photo # 33 – Fore peak compartment – looking fwd.

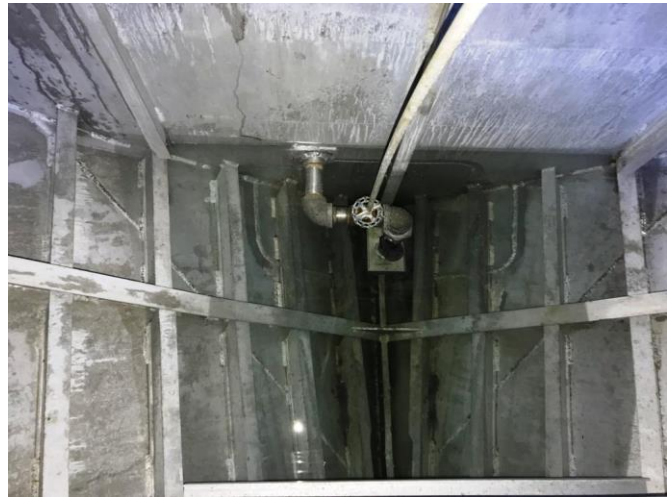
Photo # 34 – Fore peak bilge suction

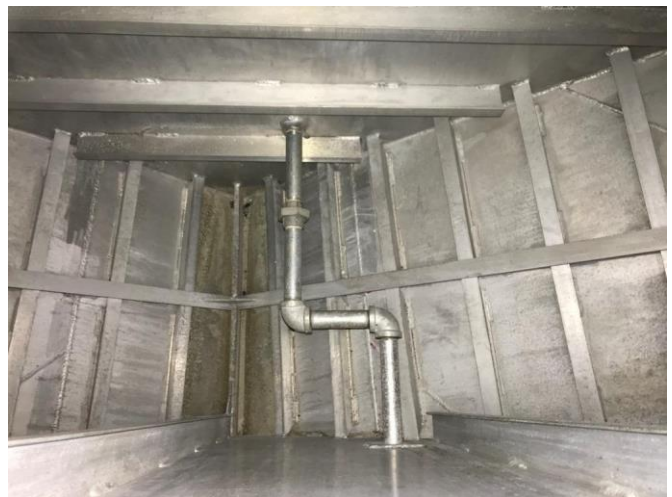
Photo # 36 – Compt. # 2 looking down from manhole

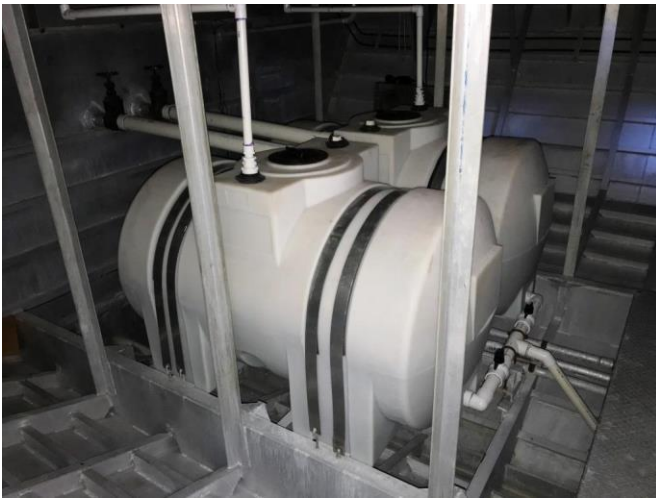
Photo # 37 – Comp. # 3 – Sewage holding tanks

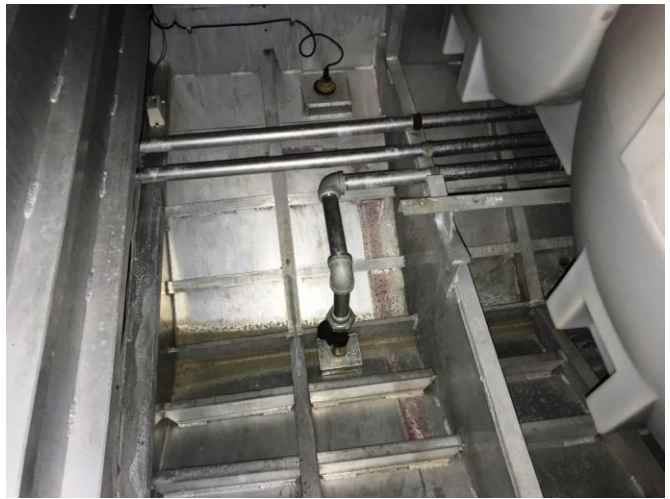
Photo # 38 – Comp. # 3 – bilge alarm, suction, & transducer

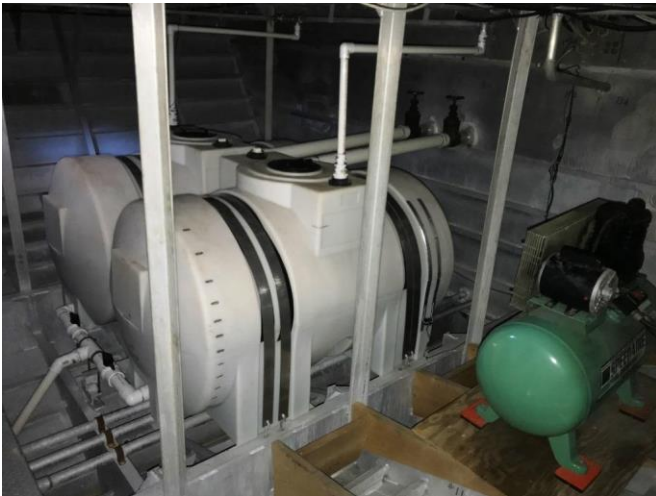
Photo # 39 – Comp. # 3 – Sewage tanks and air compressor

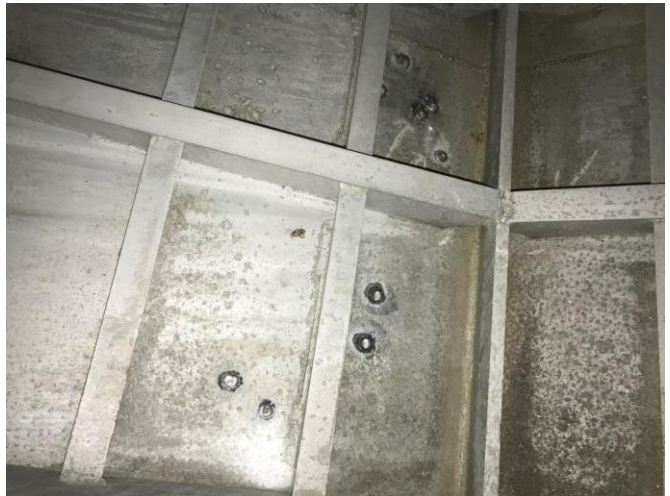
Photo # 40 – Comp. # 3 – clad welding on bottom hull

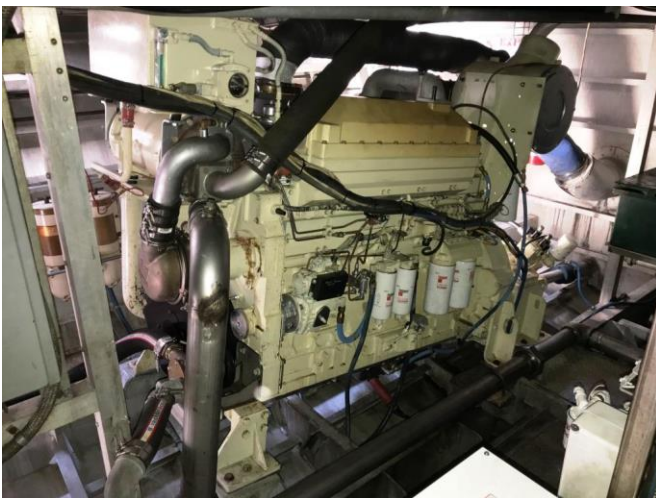
Photo # 41 – Comp. # 4 – Port side main engine – 640 HP

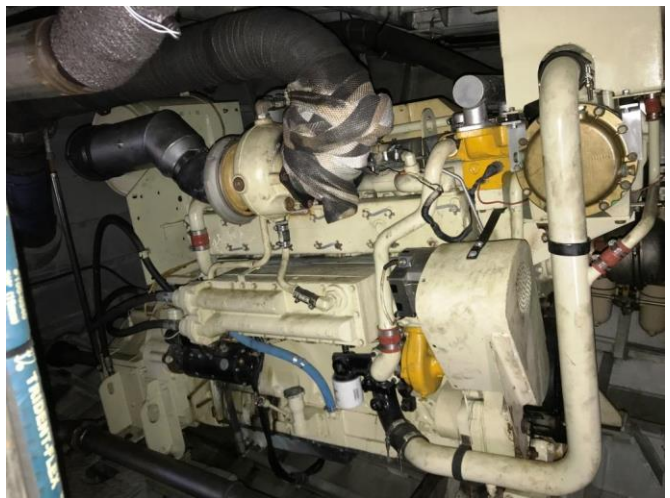
Photo # 42 – Comp. # 4 – Stbd. side main engine – 640 HP

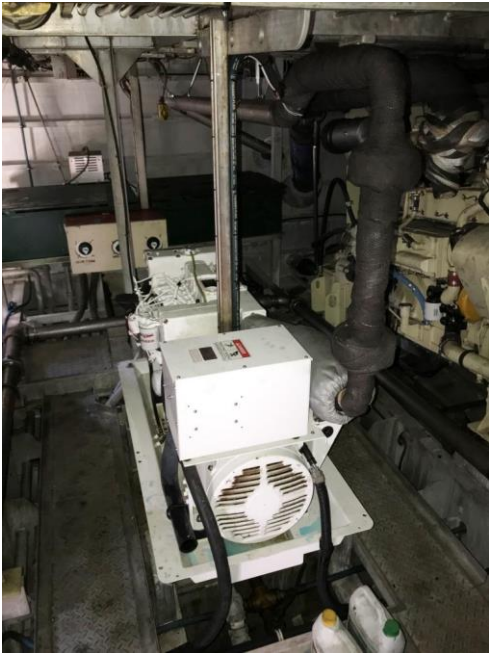
Photo # 43 – Comp. # 4 – Single gen/set – 30 kW

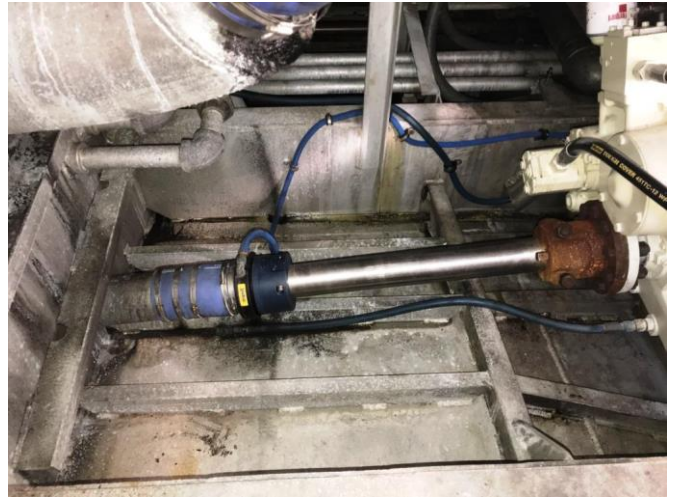
Photo # 44 – Comp. # 4 – Port propeller shaft

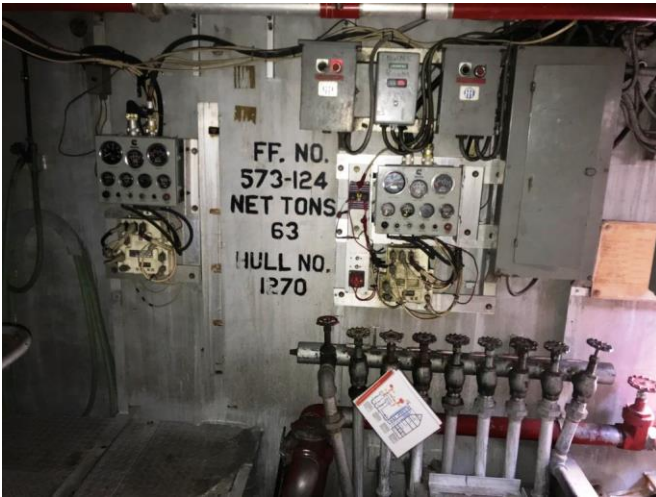
Photo # 45 – Comp. # 4 – Bilge manifold

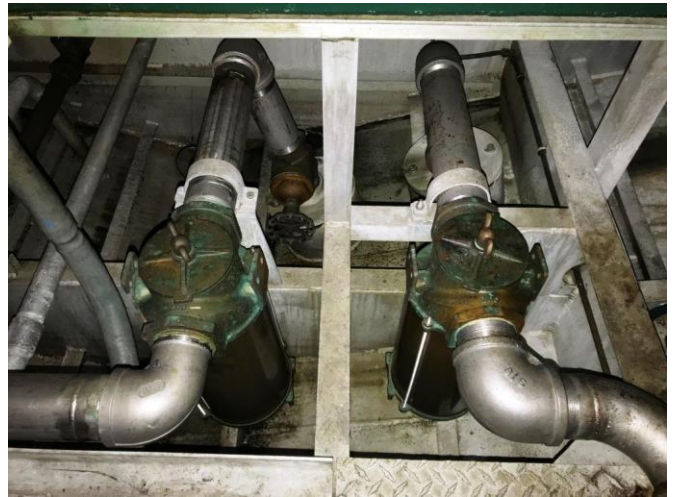
Photo # 46 – Comp. # 4 – M/E sea chests and strainers

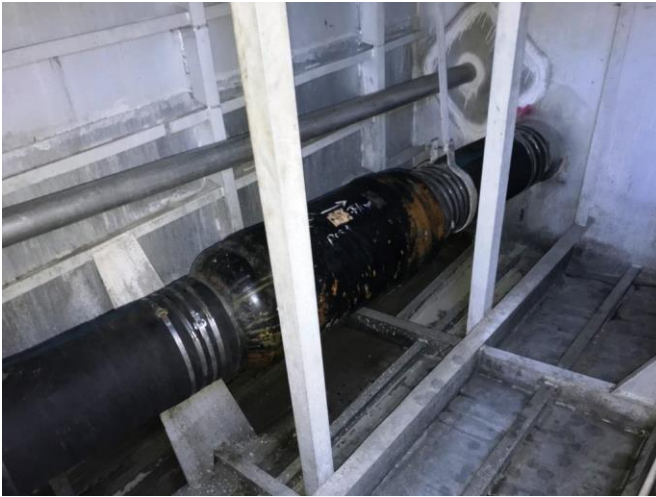
Photo # 47 – Comp. # 5 – Port side M/E exhaust muffler

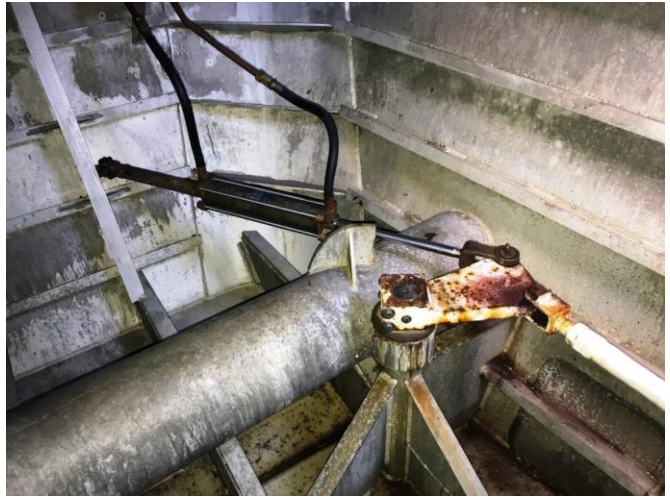
Photo # 48 – Comp. # 6 - Port tiller-head and engine exhaust

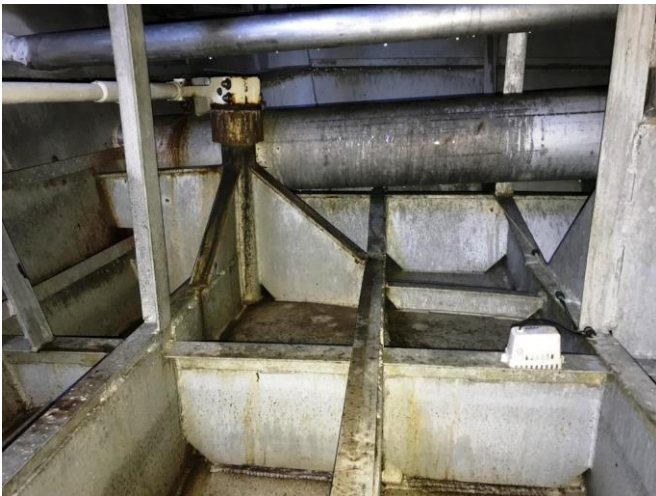
Photo # 49 – Comp. # 6 – Steering room looking to port

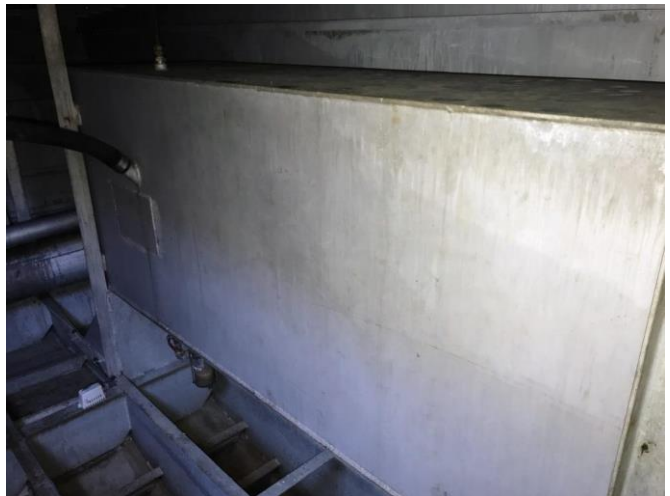
Photo # 50 – Comp. # 6 – Fresh water storage tank

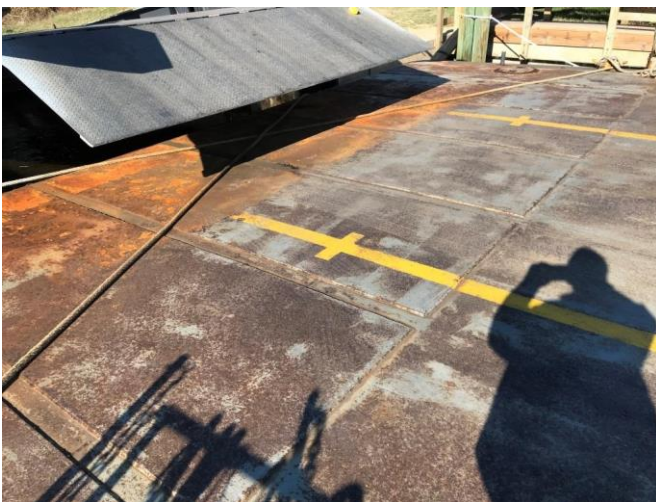
Photo # 1 – Main Deck at bow showing wear plates

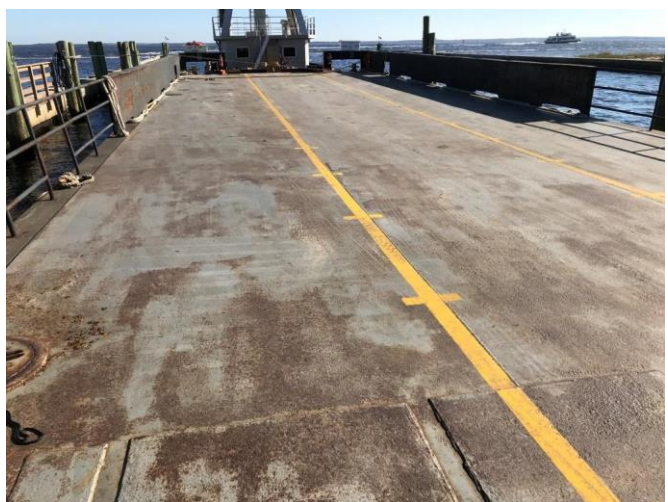
Photo # 2 – Main deck looking to stern

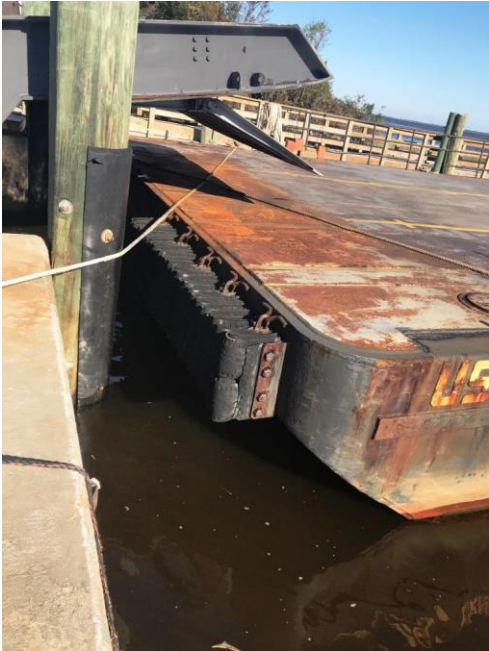
Photo # 3 –Port side forward corner

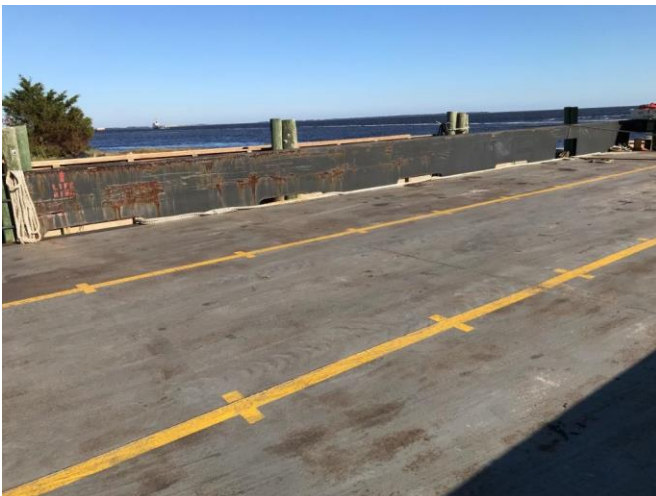
Photo # 5 – Starboard bulwark

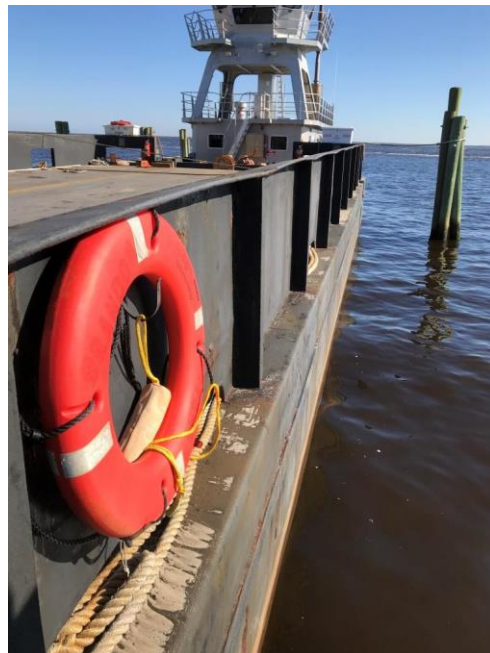
Photo # 6 – Port bulwark

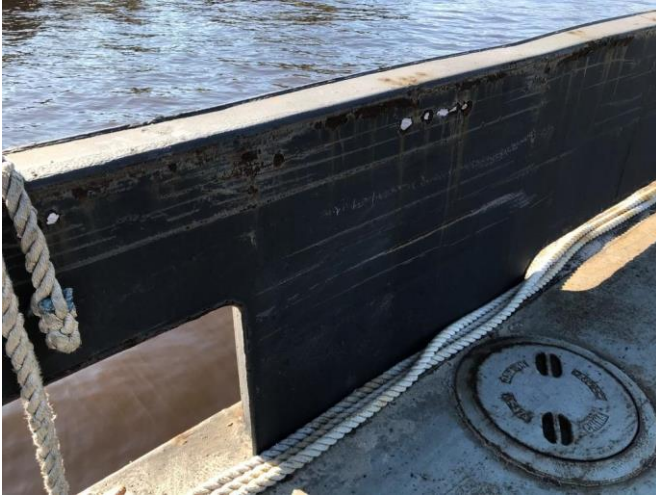
Photo # 7 – Typical wastage at port side bulwark

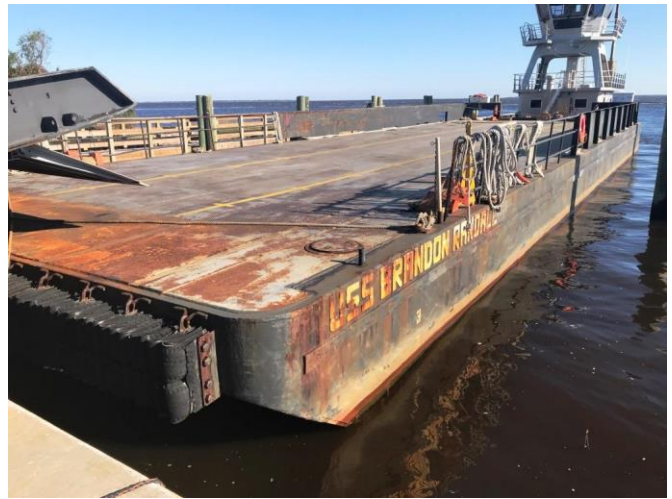
Photo # 12 – Port bow & Side shell elevation

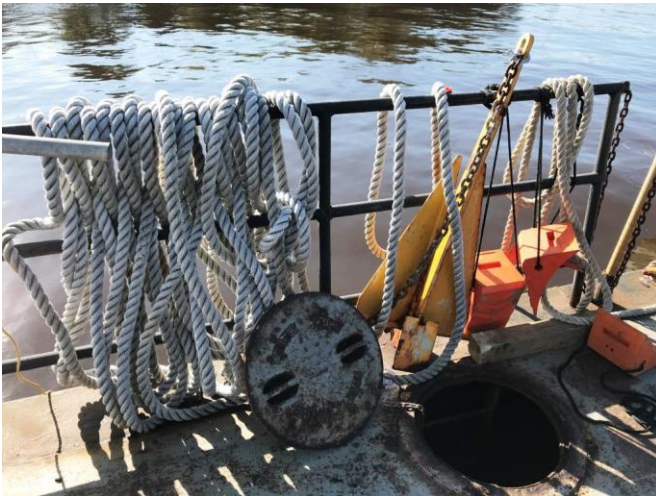
Photo # 13 – Anchor position at port side hand-railing

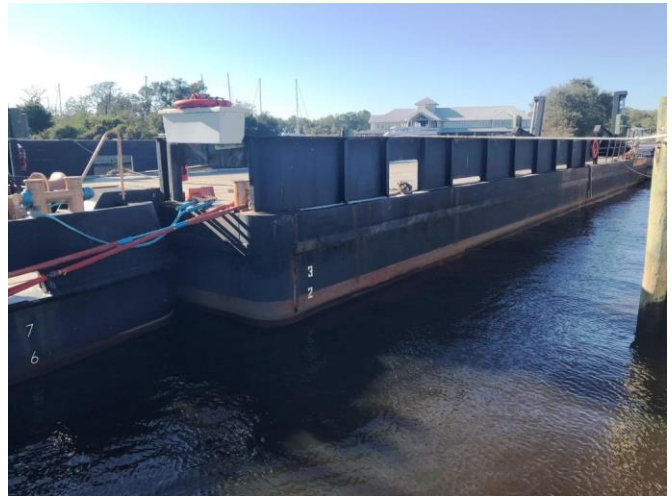
Photo # 14 – Starboard aft corner & Side shell elevation

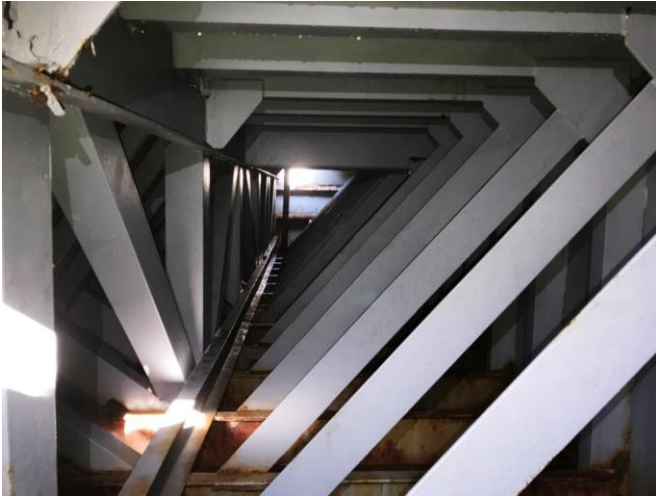
Photo # 15 – Bow rake trusses between frames 1 & 2

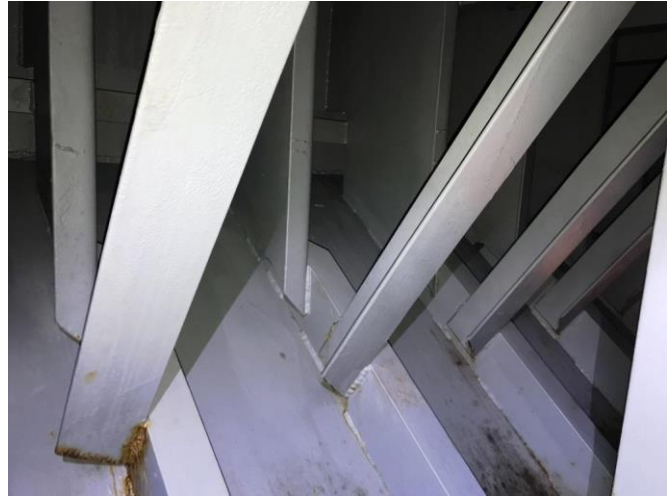
Photo # 16 – Bow rake trusses at the Headlog

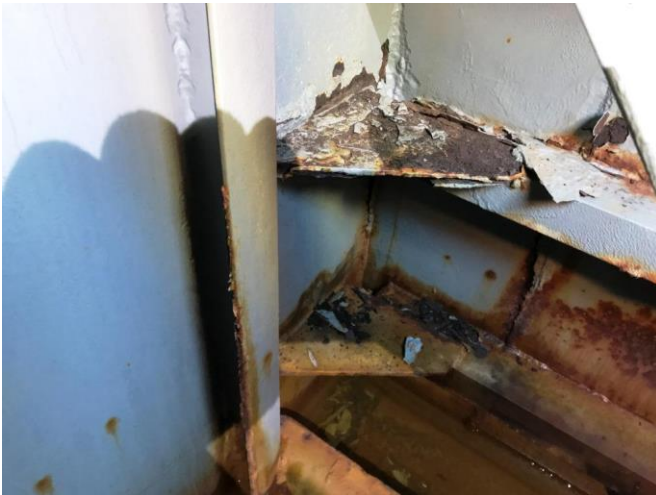
Photo # 17 – Port side shell brackets in fwd. rake at WTB # 2

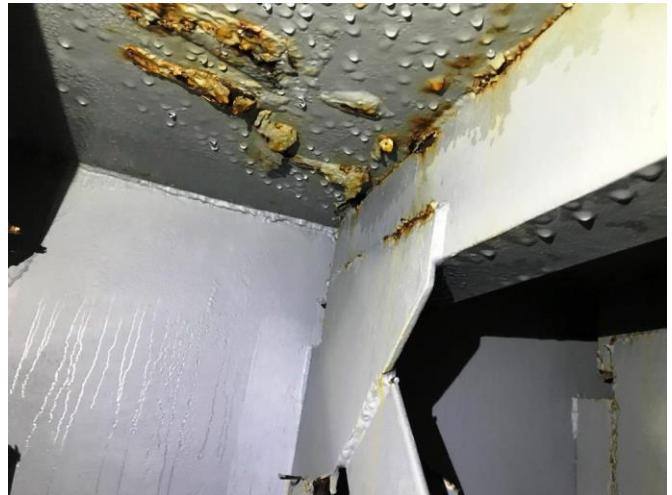
Photo # 18 – Typical condition of overhead in the fwd. rake.

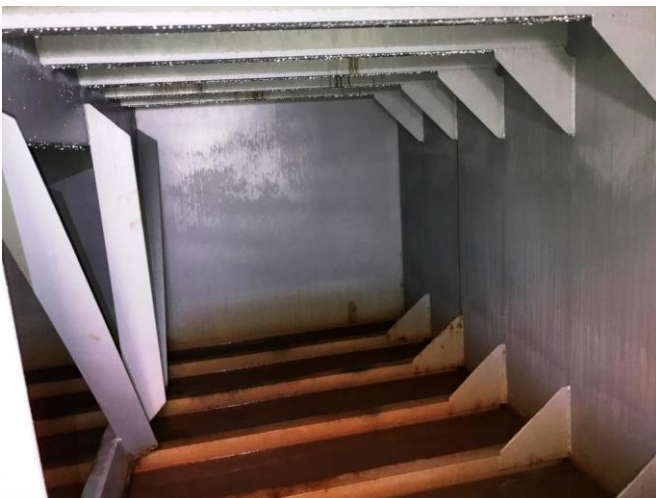
Photo # 19 – Starboard # 2 looking to CL between Frs. 2 - 3

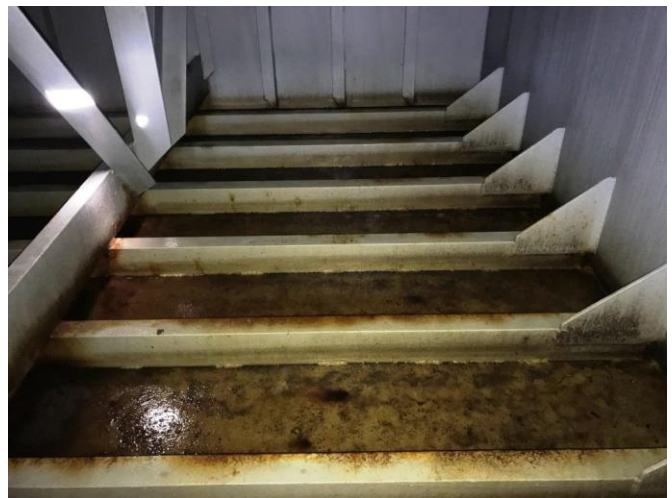
Photo # 20 – Port # 2 - looking to CL between Frs. 4 - 5

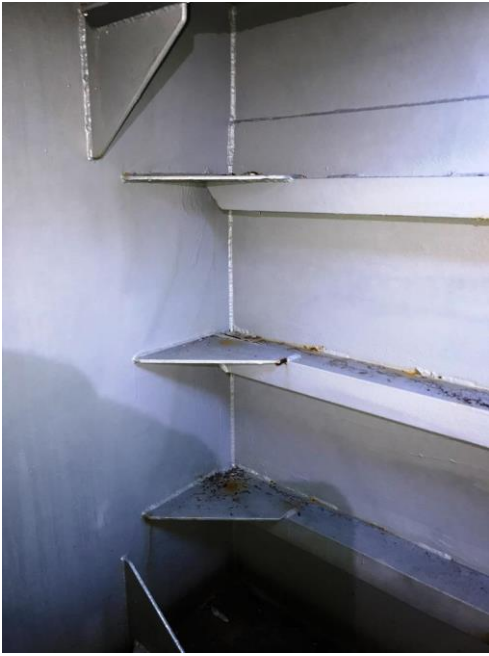
Photo # 21 – Port # 3 side shell brackets at WTB # 12

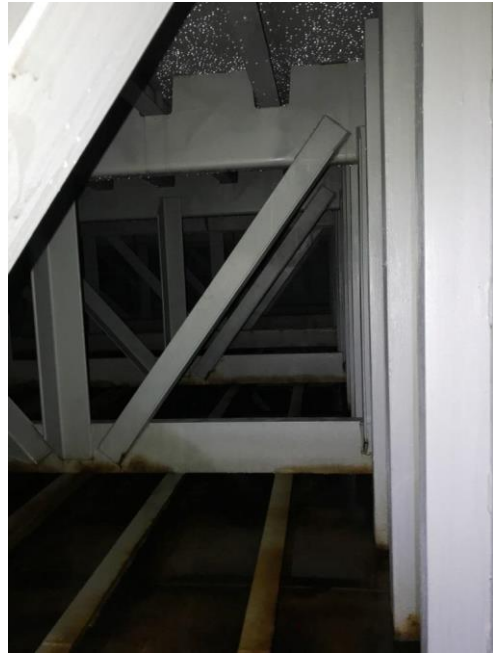
Photo # 22 – Port # 3 at CL – looking fwd. at Fr. 10

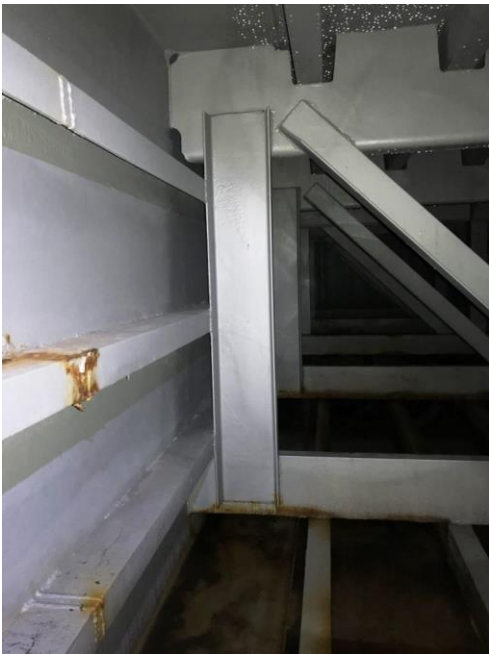
Photo # 23- Port # 3 at Side shell – looking fwd. at Fr. 9

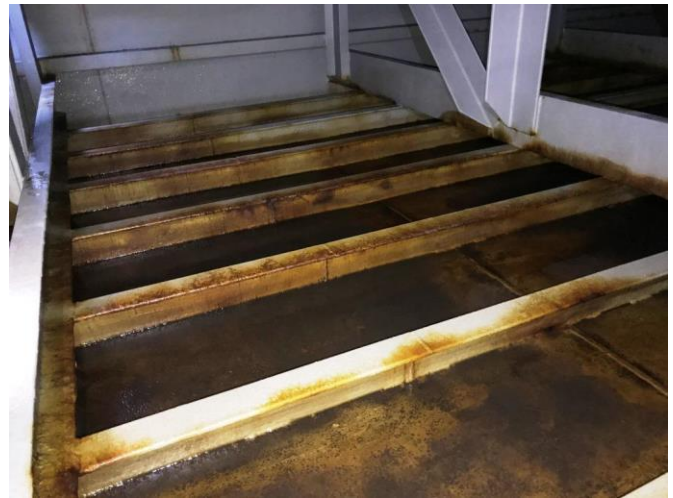
Photo # 24 – Port # 3 – looking towards Side Shell

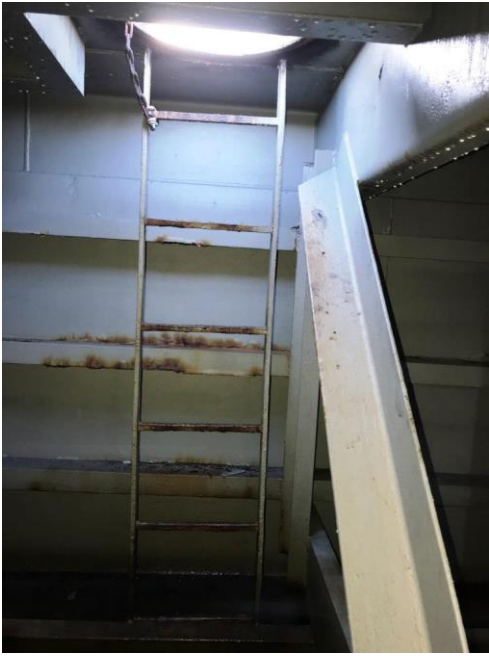
Photo # 25 – Typical access ladder to hull tanks

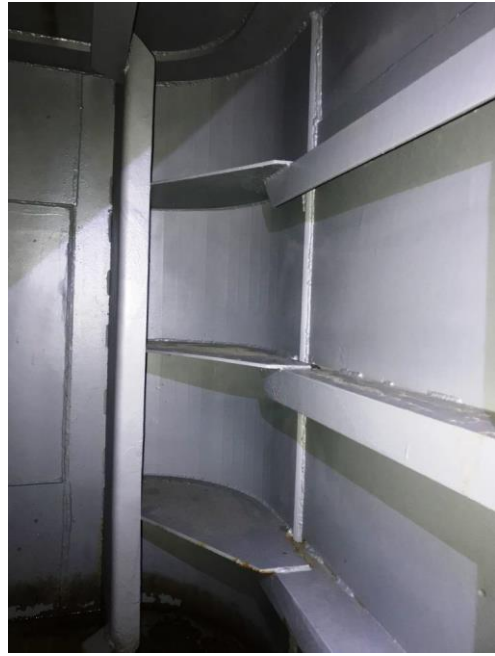
Photo # 26 – Port side shell at corner to sternlog

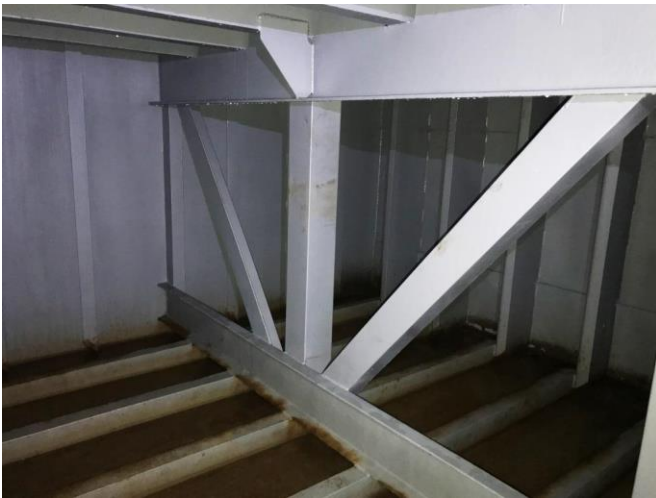
Photo # 27 – Port side aft peak – looking to CL and Fr. 16 & Fr. 17 (Sternlog)

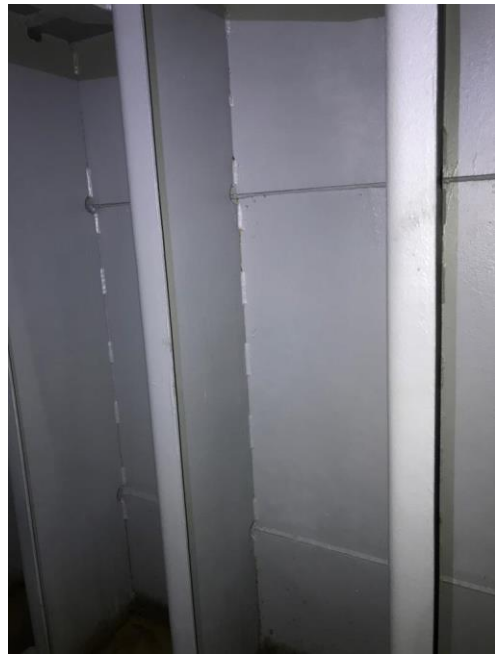
Photo # 28 – Sternlog construction with 1” x 18” PL top & bottom and vertical 15” x 3” x 5/16” Flg. PL stiffeners.
